## Accident

| <b>Aircraft Type and Registration:</b> | EV-97 teamEurostar UK, G-CDNM | |
| <b>Location:</b> | Athey's Moor Airfield, Northumberland | |

## Synopsis

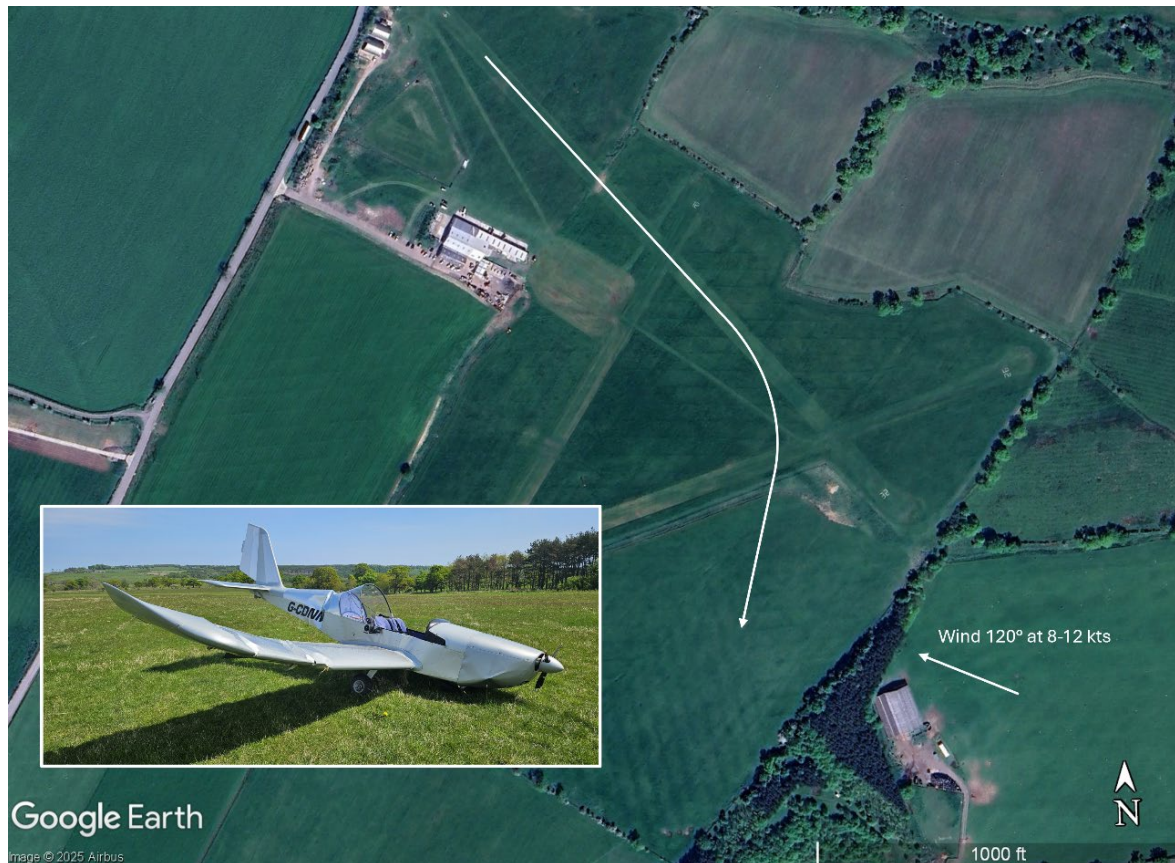
**Figure 1**

The demonstration was concluded at around 15-20 ft agl and full power was applied to climb away. The engine responded normally, but the aircraft suffered significant sink with wing drop, and the right wingtip contacted the ground. The aircraft yawed to the right and slid sideways to the left, with the left landing gear hitting the ground and collapsing. This was followed by the nose landing gear collapsing and the propeller striking the ground at high power. The tail plane hit the ground resulting in significant damage, with additional damage to the left wing due to the landing gear collapse (Figure 1).

Ground strike during engine failure after takeoff demonstration

The instructor had conducted this exercise many times before and believed that turbulent air over the trees caused the sink and subsequent wing drop. The instructor stated that he should have initiated a climb away earlier as the EFATO procedure had been adequately demonstrated to the student.
