AAIB Bulletin

3/2026

Aircraft Type and Registration:	ATR 42-500, G-LMRC	
No & Type of Engines:	2 Pratt & Whitney Canada PW127E turboprop engines	
Year of Manufacture:	1996 (Serial no: 480)	
Date & Time (UTC):	27 August 2022 at 1018 hrs	
Location:	During climb 14 nm north-east of Aberdeen Airport	
Type of Flight:	Commercial Air Transport (Passenger)	
Persons on Board:	Crew - 3	Passengers - 25
Injuries:	Crew - None	Passengers - None
Nature of Damage:	None	
Commander's Licence:	Airline Transport Pilot's Licence	
Commander's Age:	39 years	
Commander's Flying Experience:	4,900 hours (of which 243 were on type) Last 90 days - 147 hours Last 28 days - 36 hours	
Information Source:	AAIB Field Investigation

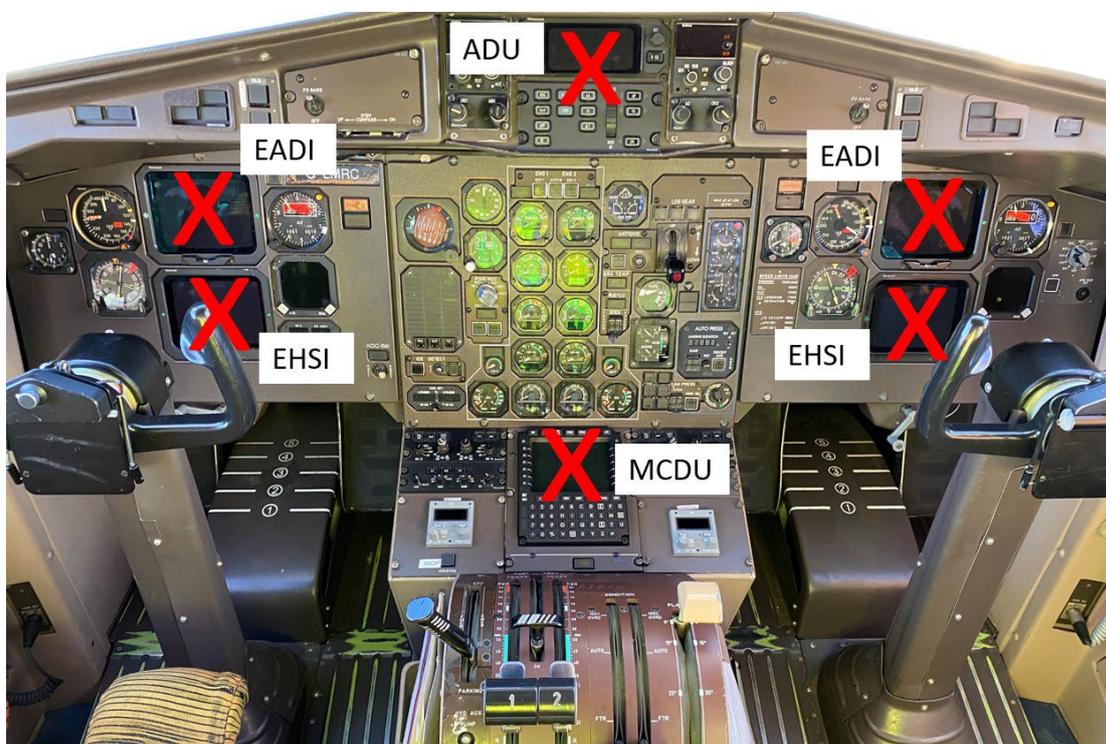
Figure 1

As the aircraft was climbing through FL100, in VMC, the co-pilot actioned the '*FL100 Procedure*', which included turning the landing lights off. As he did so, the crew heard a "clunk" that sounded similar to selecting external power and seemed to emanate from the electrical cabinet behind the co-pilot's seat. At the same time both Electronic Attitude Director Indicators (EADI) and Electronic Horizontal Situation Indicators (EHSI) went blank, the autopilot (AP) disengaged and both air conditioning packs de-powered. Additionally, they felt a momentary noticeable deceleration and saw the engine torque indications roll back to zero torque. The Multi-Function Control Display Unit (MCDU) and the Advisory Display Unit (ADU) also went blank (Figure 1). As a reaction to the failure, thinking that his action may have caused the failure, the co-pilot quickly turned the landing lights back on. The EADIs, EHSIs, MCDU and ADU were restored, with no additional action by the flight crew and the AP was re-engaged. The loss of power lasted about 3 seconds.

G-LMRC flight deck showing the displays that were reported lost during the failure

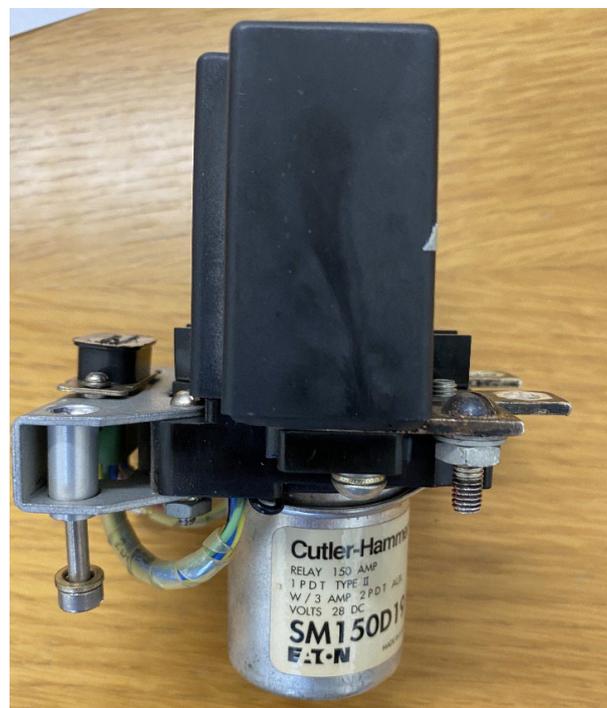
Investigations revealed a fault in the 1PA contactor, which was stuck in an intermediate position and unable to supply backup power to the emergency electrical network. This was a contributory factor but not a cause of the loss of power.

Figure 4
1PA electrical contactor

The operator then contacted the aircraft manufacturer who provided a list of troubleshooting procedures to perform. These procedures resulted in the discovery of a fault with the 1PA contactor; when it was energised, it was not supplying power from DC BUS 1. The contactor was replaced as was the battery switch. Both landing lights were also removed, its wiring inspected and then lights re-installed.

The only failure that could be identified from physical examinations and testing was the failure of contactor 1PA. When this contactor was energised the contacts did not move sufficiently to close the circuit of the lower contacts. It was effectively stuck in an intermediate position while energised and therefore could not supply backup power from DC BUS 1 to the emergency electrical network. The aircraft system was not designed to detect such a fault, as this type of fault had not been envisaged by either the contactor manufacturer or the aircraft manufacturer. The only test, at the time, that could have detected this fault was a test that was only carried out during a 2C check every 16,000 flight hours. This meant that the fault could have been dormant for a long time.

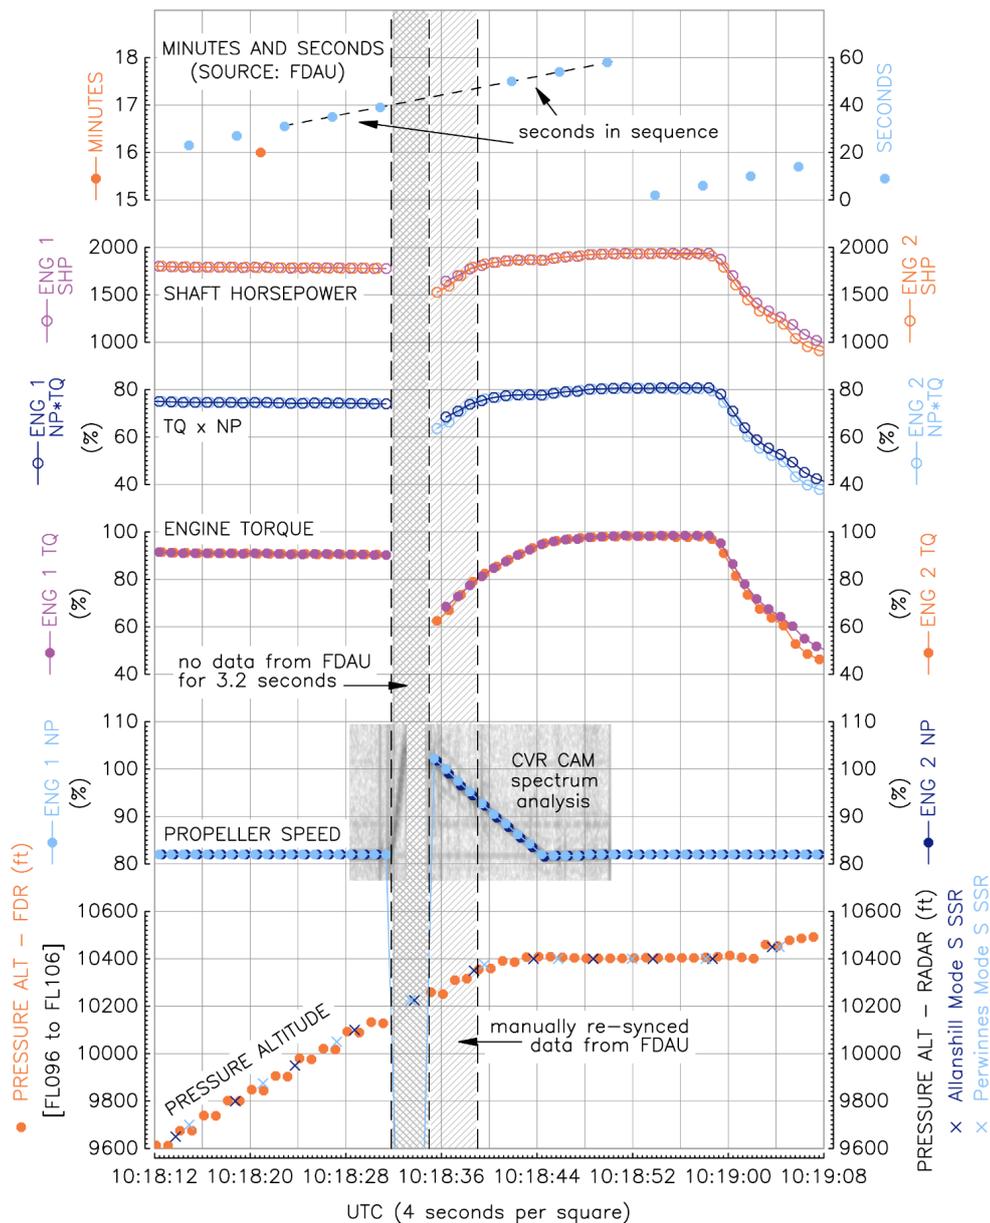
Figure 7 illustrates that during the flight no data was output from the FDAU, starting at time 10:18:32 hrs for a period of about 3.2 seconds. This meant that the FDAU lost power from the DC ESS BUS for 3.2 seconds. This was followed by 4 seconds of data that was found to be corrupted/unsynced on the FDR recording. The parameters plotted in the figure during these 4 seconds have been manually re-synced.

Recorded flight and radar data around the time of the in-flight electrical failure

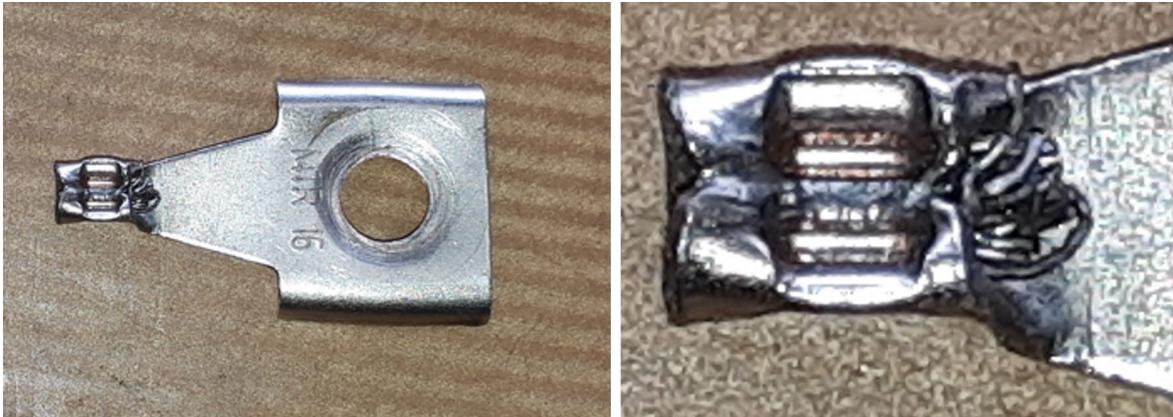
Figure 8

When the maintenance engineers started to remove DC Gen 2, they discovered that the cable connecting DC GCU 2 to the excitation field of DC Gen 2 only had one or two strands of wire holding it to the lug on the starter-generator, instead of ten. When the engineer wiggled the cable, the remaining wires broke (Figure 8).

However, the post incident resistance measurements between DC GCU 2 and DC Gen 2 had been in the normal range, indicating that there had been good continuity prior to the disturbance, but in-flight vibrations could have affected continuity with few wires remaining.

Remains of wires in crimped lug from the cable connecting the DC GCU 2 to the DC Gen 2

The aircraft manufacturer stated that there was no known common failure mode that would cause the simultaneous loss of the emergency electrical network and DC BUS 2. However, they considered that the damaged wire connected to DC Gen 2 could have been the cause of a voltage drop or a momentary loss of DC BUS 2 if the remaining wire strands had lost contact with the lug.

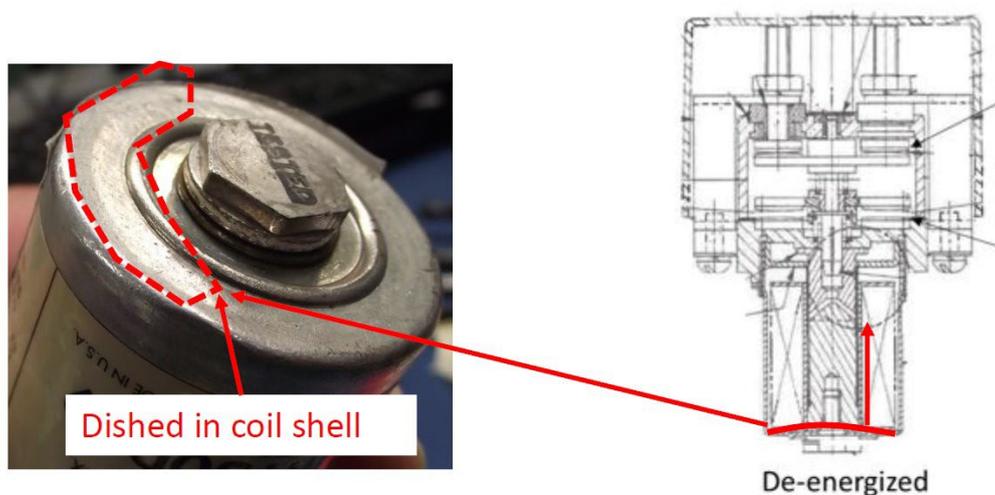
Figure 9

Internal examination of the contactor revealed that the coil had significant black discolouration from heat; however, the coil resistance was in the normal range so according to the component manufacturer it would have provided sufficient force to move the contact plates to make adequate contact. Plunger 'stall testing' revealed that the plunger was moving normally and smoothly and the contact surfaces only had slight wear. The significant finding was from internal measurements which revealed that there was insufficient stroke of the plunger caused by a geometric upwards shift of the plunger stop by about 0.4 mm – this was preventing sufficient downwards movement when the coil was energised. A close external examination of the coil casing revealed that it was dished inwards (Figure 9). This was the only damage found that could explain the 0.4 mm upwards shift of the plunger stop.

1PA contactor from G-LMRC showing dished in coil shell

The component manufacturer carried out some tests to determine if the 'dished in' shell damage could be caused by a hammer or mallet. Tests were carried out with a 113 g (4 oz) hammer and a 170 g (6 oz) mallet. After three strikes with the hammer, only 0.1 mm of upwards core movement was measured and there was no visible damage to the coil shell. However, after one strike with the mallet, 0.3 mm of upwards core movement was measured, and after two strikes 0.55 mm was measured, which was more than the 0.4 mm seen on the contactor from G-LMRC. Similar 'dished in' damage of the coil shell was also observed after strikes with the mallet.

The contactor failure was caused by the fact that the plunger stop had shifted upwards by about 0.4 mm, preventing sufficient downwards stroke of the contacts when the coil was energised. This upwards shift was most likely a consequence of impact damage to the coil casing which was seen to be dished in. Testing on another contactor revealed that striking the top of the coil casing with a mallet could produce similar dished-in damage and a similar upwards shift in the plunger stop. The cause of this damage could not be determined but it is possible that the contactor had been dropped or possibly hit with a mallet during troubleshooting. The aircraft operator's maintenance records did not reveal any issues with this contactor so if it had been hit, it may have been by a previous operator.

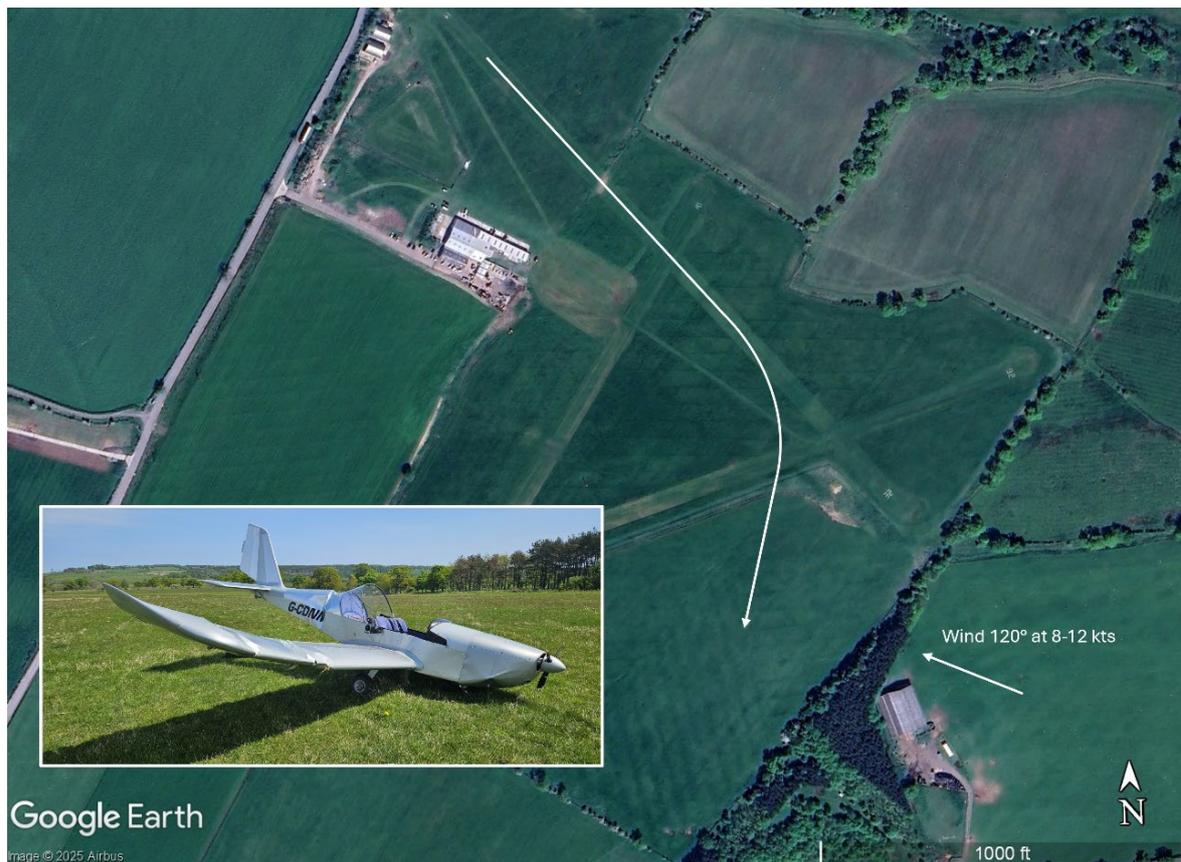
Figure 1

The demonstration was concluded at around 15-20 ft agl and full power was applied to climb away. The engine responded normally, but the aircraft suffered significant sink with wing drop, and the right wingtip contacted the ground. The aircraft yawed to the right and slid sideways to the left, with the left landing gear hitting the ground and collapsing. This was followed by the nose landing gear collapsing and the propeller striking the ground at high power. The tail plane hit the ground resulting in significant damage, with additional damage to the left wing due to the landing gear collapse (Figure 1).

Ground strike during engine failure after takeoff demonstration
