Accident

Aircraft Type and Registration:	Rockwell Commander 112 TCA, N4698W	
No & Type of Engines:	1 Lycoming TO-360-C1A6D piston engine	
Year of Manufacture:	1978 (Serial no: 13274)	
Date & Time (UTC):	23 December 2024 at 1135 hrs	
Location:	Kinglassie, Fife	
Type of Flight:	Private	
Persons on Board:	Crew - 1	Passengers - None
Injuries:	Crew - 1 (Fatal)	Passengers - N/A
Nature of Damage:	Aircraft destroyed	
Commander's Licence:	Private Pilot's Licence	
Commander's Age:	50 years	
Commander's Flying Experience:	187 hours (of which 92 were on type) Last 90 days - 19 hours Last 28 days - 0 hours	
Information Source:	AAIB Field Investigation

Synopsis

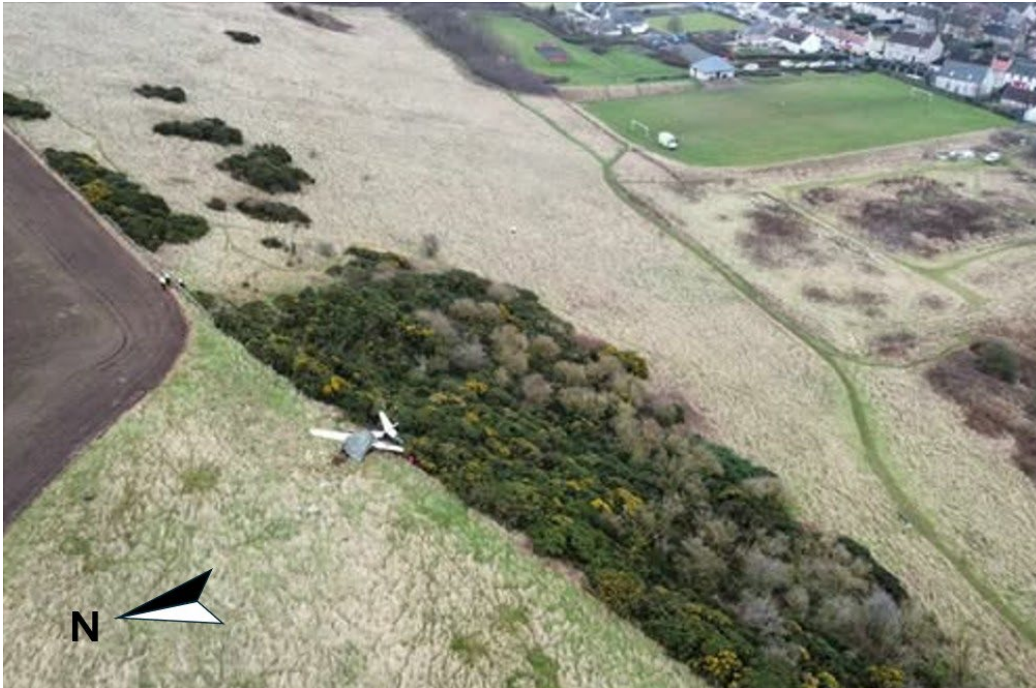
Figure 1
Accident site

N4698W struck an area of rising ground to the north of Kinglassie (Figure 1) with low forward speed and a high rate of descent. The left wing was more damaged than the right wing, indicating that the aircraft was in a shallow left roll attitude at impact. The landing gear was in the UP position. The propeller was in fine pitch and had stopped with one blade folded rearwards, beneath the nose, with the other two blades intact without any impact marks, consistent with the propeller windmilling whilst not being driven under power by the engine at impact. No fire had occurred. It was not possible to reliably determine the pre-accident positions of the magneto switch and fuel selector valve.

The left wing fuel tank was ruptured and no fuel remained within the tank. Approximately 20 litres of fuel was recovered from the right wing.

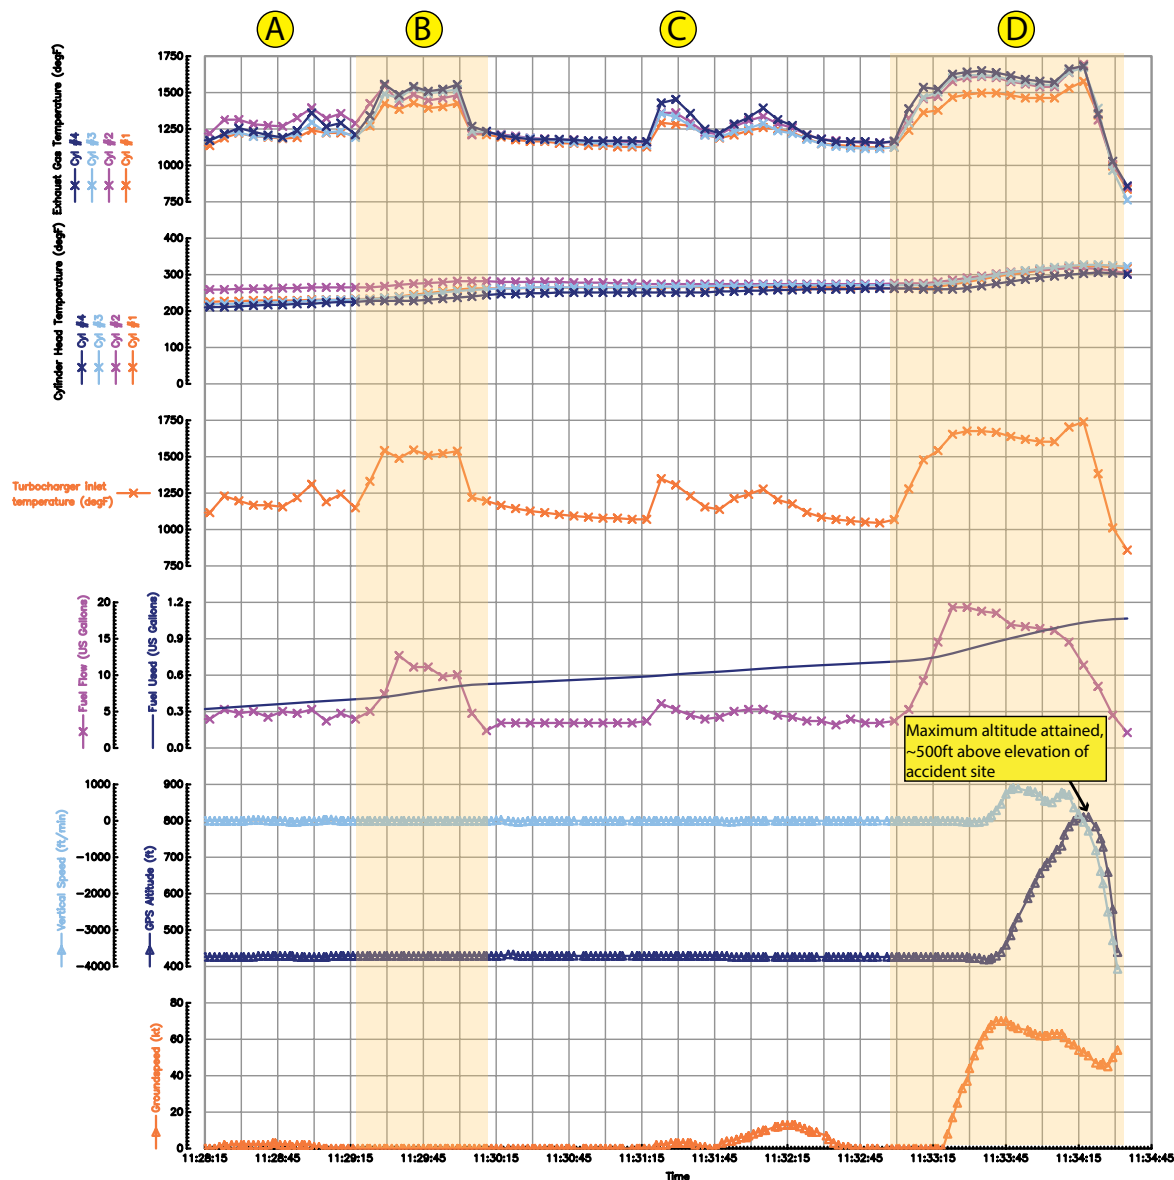
Pilot Aware and engine monitor data for the accident flight

Area A of Figure 2 shows N4698W taxiing to the area where engine run-up checks were performed, area B the actual engine run-up, area C the taxiing and back-tracking of the runway and area D the takeoff and initial climb-out. Of note is the solid blue line with no markers that represents the cumulative fuel used in US gallons (US gal). This shows that approximately 1.1 US gal of fuel was used before the engine parameters indicated that the engine was failing.

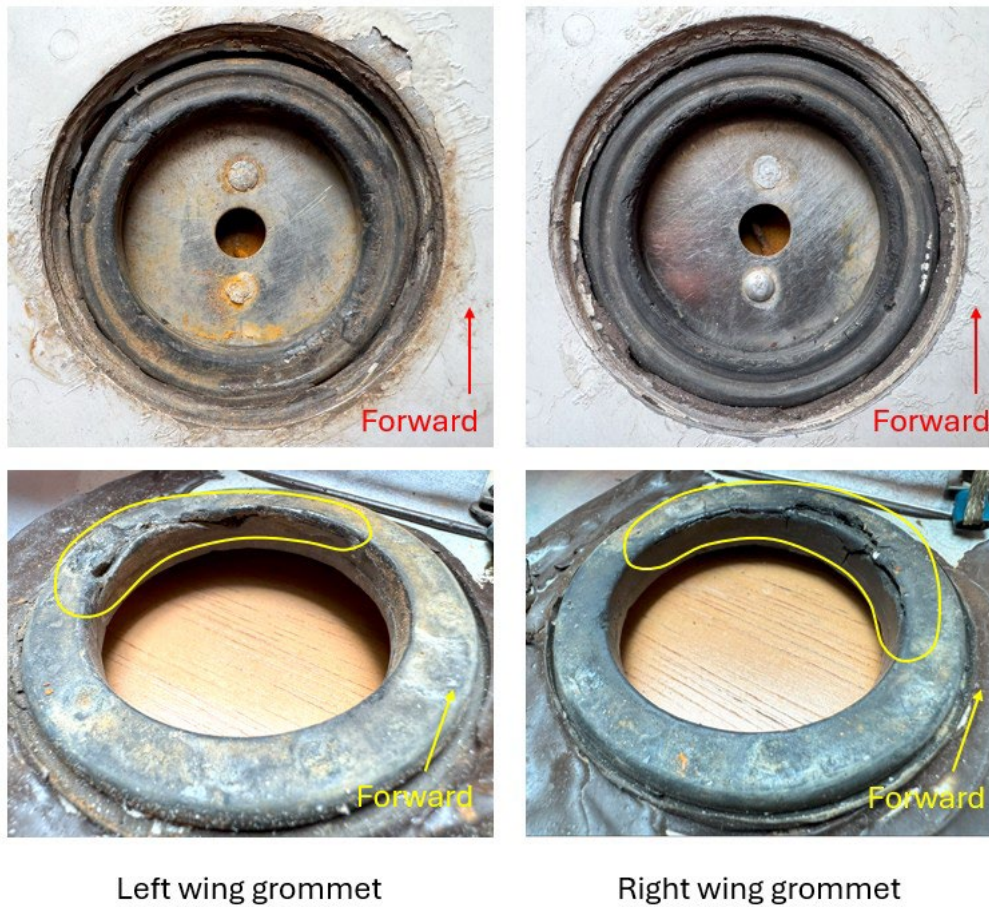
**Figure 6**

Visual condition of the fuel filler rubber grommets (upper surface of grommet shown above, lower surface shown below)

The manufacturer commented that the poor condition of the sealing grommets was well beyond typical normal ageing of in-service grommets, and that they were in a state inconsistent with continued airworthiness expectations. They stated that the degree of visible deterioration would ordinarily and reasonably be expected to trigger their removal and replacement under standard aviation maintenance practice, irrespective of whether explicit life limits or inspection criteria were published.

The time in service of the seals was not determined, however their poor condition is age-related and they were likely to have been fitted to the aircraft for many years. During this period, multiple maintenance organisations had performed annual inspections on the aircraft, none of which had rejected the seals based on their appearance. The lack of any recommended service life or inspection criteria for the seals was a contributory factor in maintenance personnel not rejecting the seals before they deteriorated to the point they had when the accident occurred.

The wing fuel tank filler seals were found to be in poor condition, allowing water to leak into the wing fuel tanks whilst the aircraft was parked outside. This defect had not been rectified at recent annual inspections and the aircraft's maintenance manual did not contain a recommended service life or inspection criteria for the acceptable condition of the seals.

It is recommended that Commander Aircraft Corp. publishes maintenance information that provides specific inspection criteria for the acceptable condition of Rockwell Commander 112/114/115 fuel tank rubber grommet seals.

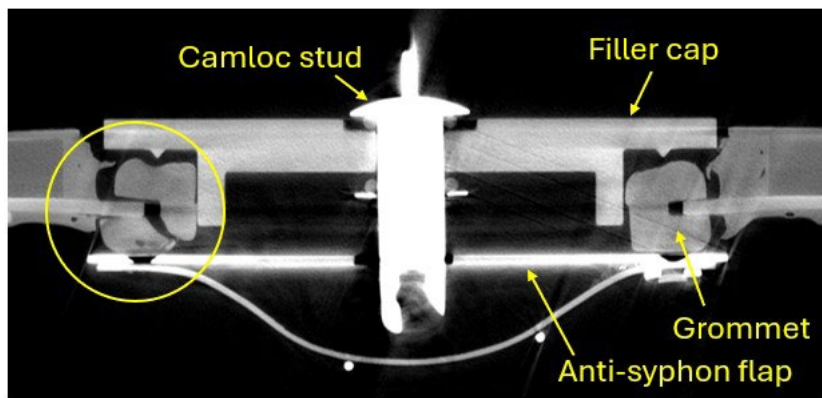
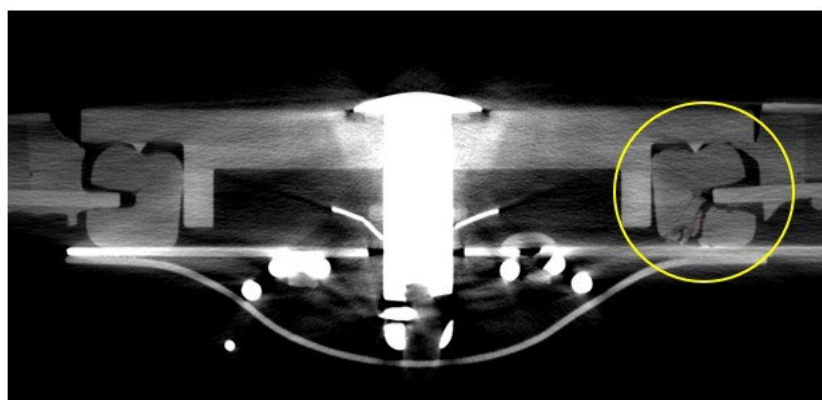
Figure 7

The internal condition of the sealing grommets was examined using CT X-ray⁴, with the filler cap fitted. The right filler cap was fitted in the locked position, but this was not possible with the left filler cap due to the Camloc stud retaining wire having broken in the accident, so the filler cap was loosely inserted into the grommet without being locked down. The CT X-ray images showed that the cracks in both rubber grommets extended through their thickness (Figure 7).

CT X-ray images of the left and right fuel filler cap assemblies, showing through-thickness cracking (circled yellow) of the rubber grommet seals

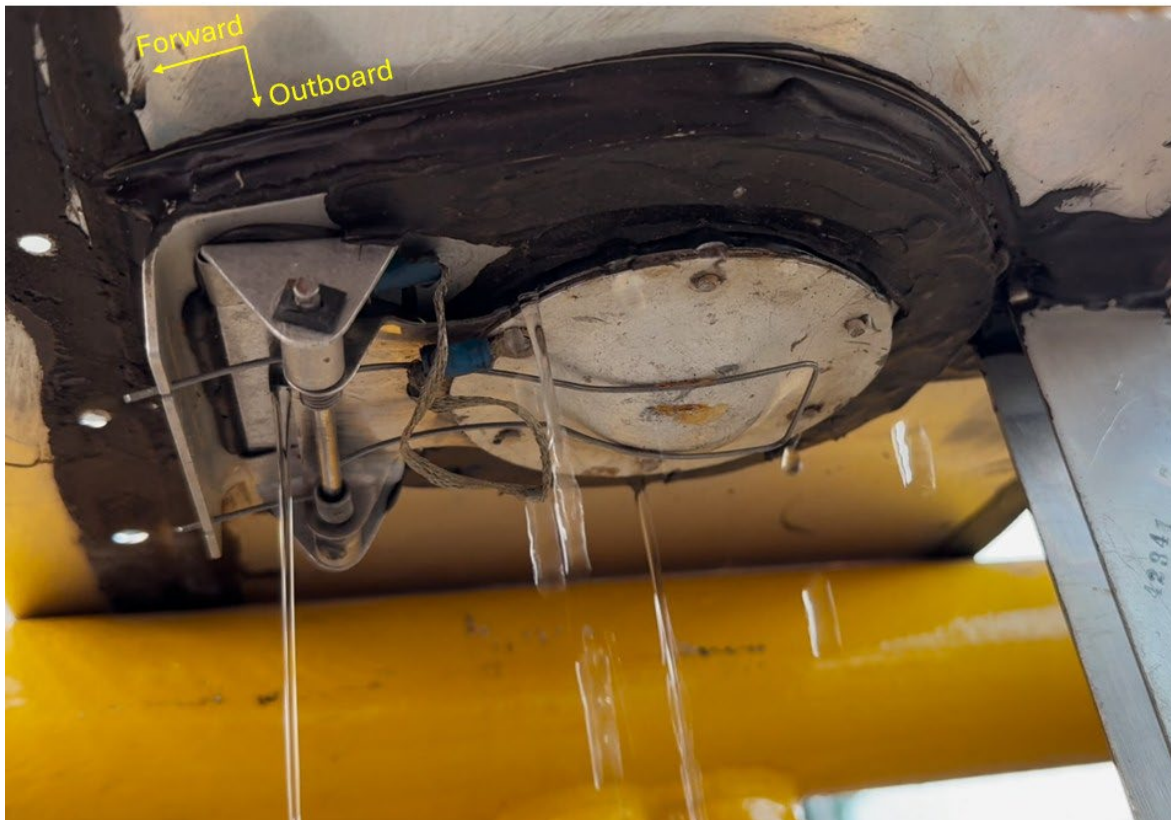
Figure 8

The right filler cap assembly was locked down and checked for leakage when water was applied to the upper wing skin. No leakage occurred when water was applied locally to the Camloc stud, showing that the O-rings replaced in July 2024 created an effective seal between the stud and the filler cap. When water was applied to the whole filler cap assembly, significant leakage past the filler cap was observed (Figure 8). It was not possible to conduct a similar leakage test on the left filler cap assembly due to the broken Camloc stud retaining wire.

Water leaking past the right filler cap seal when exposed to water, supported on trestles and viewed from below

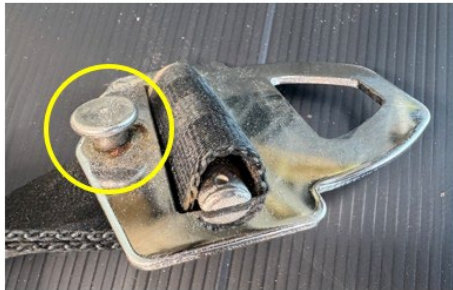
(a) Pilot lap strap

The aircraft was fitted with AmSafe three-point seat belts for all occupants. It was noted that the plastic collar on the pilot's lap strap buckle pin was missing (Figure 9 (a)). This collar is designed to provide a positive 'snap' location of the single shoulder strap where it attaches to the lap strap buckle pin, to prevent the shoulder strap from becoming inadvertently detached from the lap strap. Despite the missing collar, the pilot's shoulder strap had

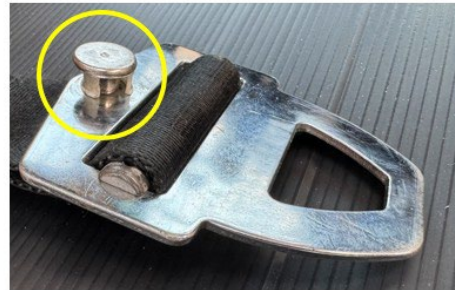
(b) Co-pilot lap strap

remained attached to the lap belt during the accident. The co-pilot lap strap buckle had a plastic collar fitted, but this was cracked and loose on the pin (Figure 9 (b)). The passenger lap belts had plastic collars fitted and these were in good condition (Figure 9 (c) and (d)).

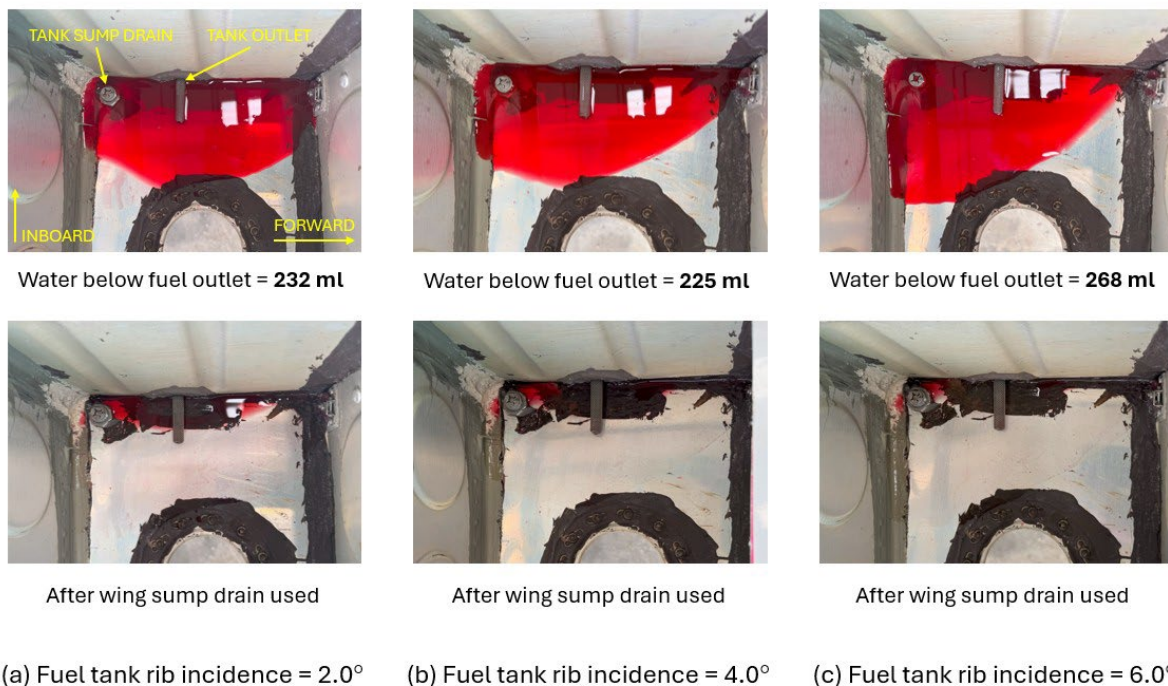
Figure 12

Nine other Rockwell Commander 112/114/115⁹ aircraft were measured to assess the typical range of wing pitch attitudes (measured at the rib at the inboard end of the wing fuel tank) when parked, and what the dihedral¹⁰ angle of wings was at the inboard end of the wing fuel tank. The average wing dihedral measured was 6.2°, and the incidence of the inboard fuel tank rib ranged between 2.0° and 5.7°. N4698W's right wing was supported at a dihedral angle of 6.2° and at three different pitch angles, 2.0°, 4.0° and 6.0°, to cover the range observed in the other aircraft assessed. For each pitch angle, a measured volume of water, coloured red to aid visibility, was added to the fuel tank to assess how much water could collect at the inboard end of the tank before it began to flow out of the tank outlet fitting (Figure 12). The amount of water able to collect in the wing tank varied between 225 ml and 268 ml, depending on the wing pitch attitude.

The effect of draining the water from the fuel tank using the tank sump drain was also assessed for each pitch angle. In every case, the tank sump drain was effective in removing all but a very small residue of the water in the fuel tank.

Water retained in the wing fuel tank at varying wing pitch angles and effect of using the fuel tank sump drain. Water coloured red to aid visibility

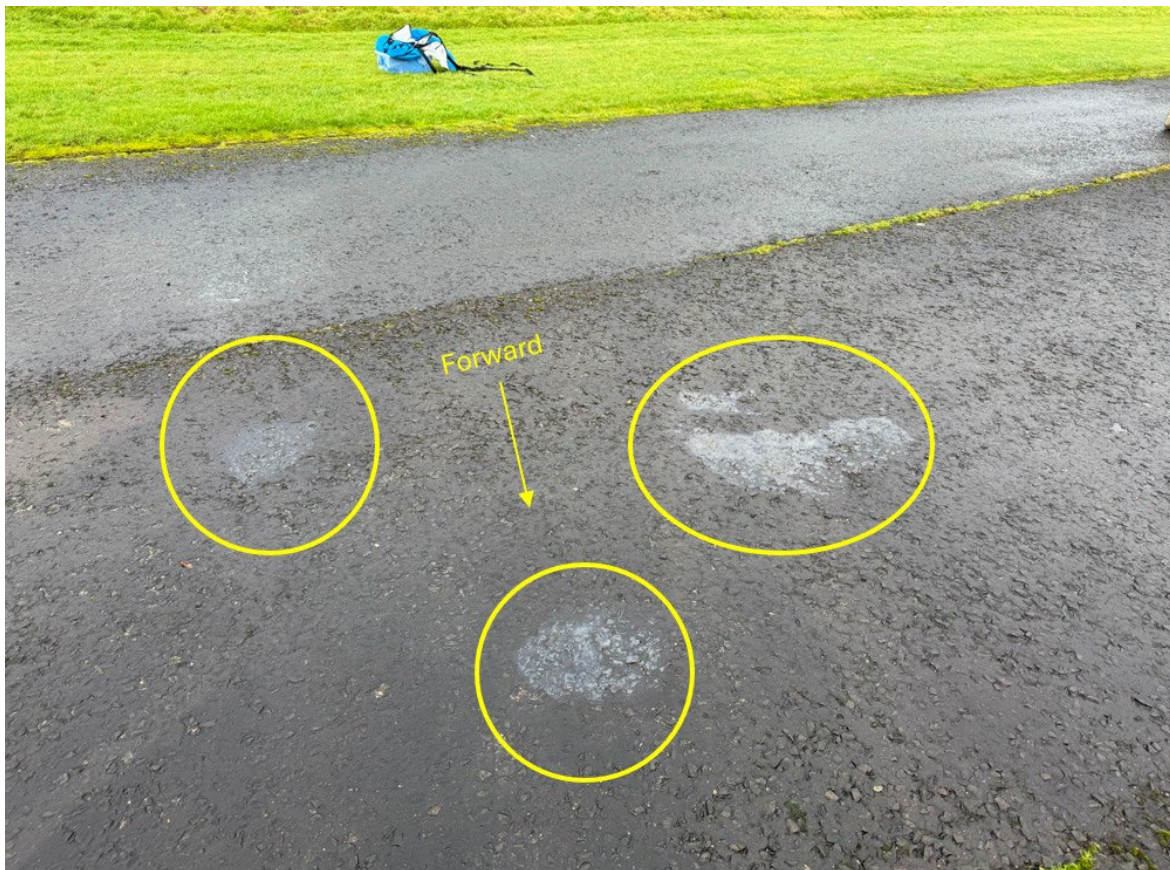
Figure 13

A photograph of the apron area where N4698W had been parked was taken in the morning of the day after the accident by the AAIB (Figure 13). This photograph showed a triangular pattern of fuel staining at a similar spacing and orientation to the aircraft's wheel well fuel drains and firewall-mounted fuel gascolator. No similar fuel staining was present outboard of the three fuel stain marks. Fife Airport had remained closed since the accident had occurred and no other aircraft had occupied this area of the apron since N4698W departed.

Fuel stain marks, circled in yellow, on the Fife Airport apron where N4698W had been parked

The triangular pattern of fuel staining on the apron surface where N4698W had been parked may indicate that the wing sump drains were not used during the pre-flight inspection, or if they were drained, a full sample tube of water may have been drawn and that this may have been assessed as clean fuel, rather than water¹¹.
