# Near miss at Helpston manually controlled barrier level crossing, 21 October 2025

At 08:16 on Tuesday 21 October 2025, a near miss occurred at Helpston manually controlled barrier (MCB) level crossing, situated near Peterborough.

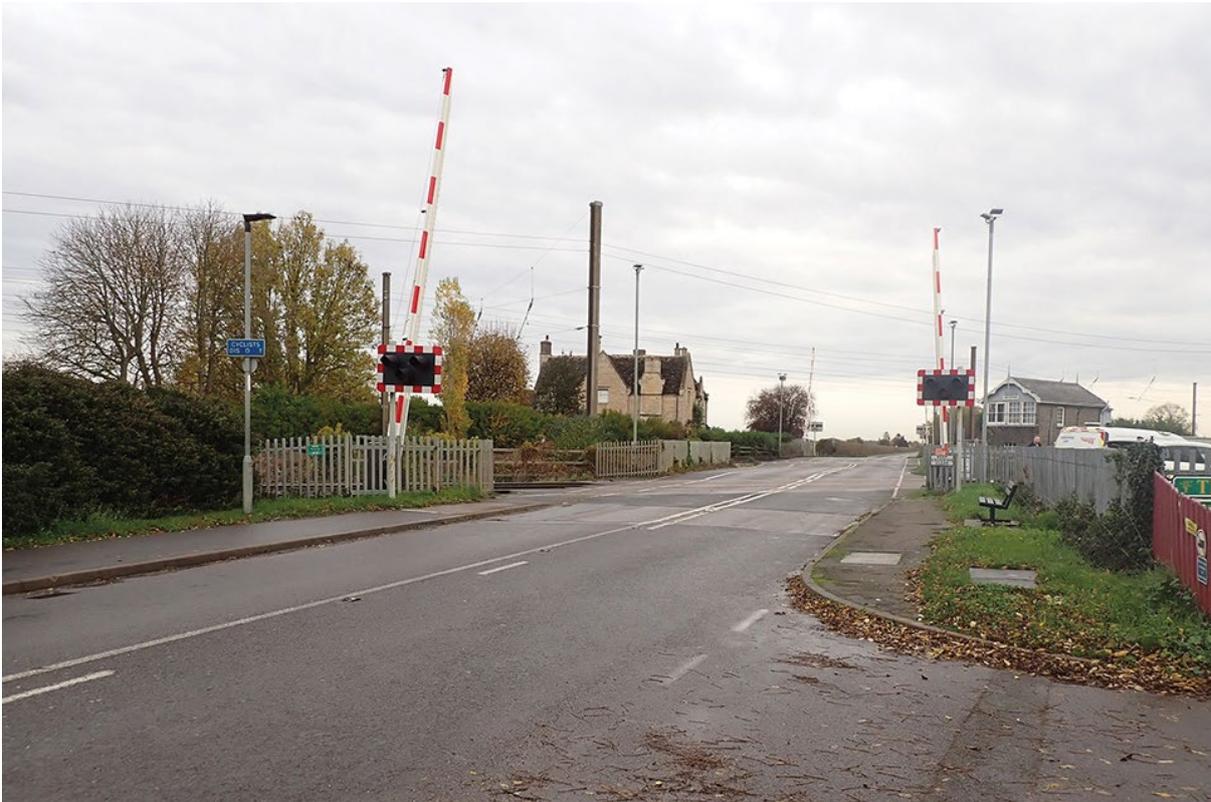
**Helpston MCB level crossing with (on right side) Helpston signal box.**

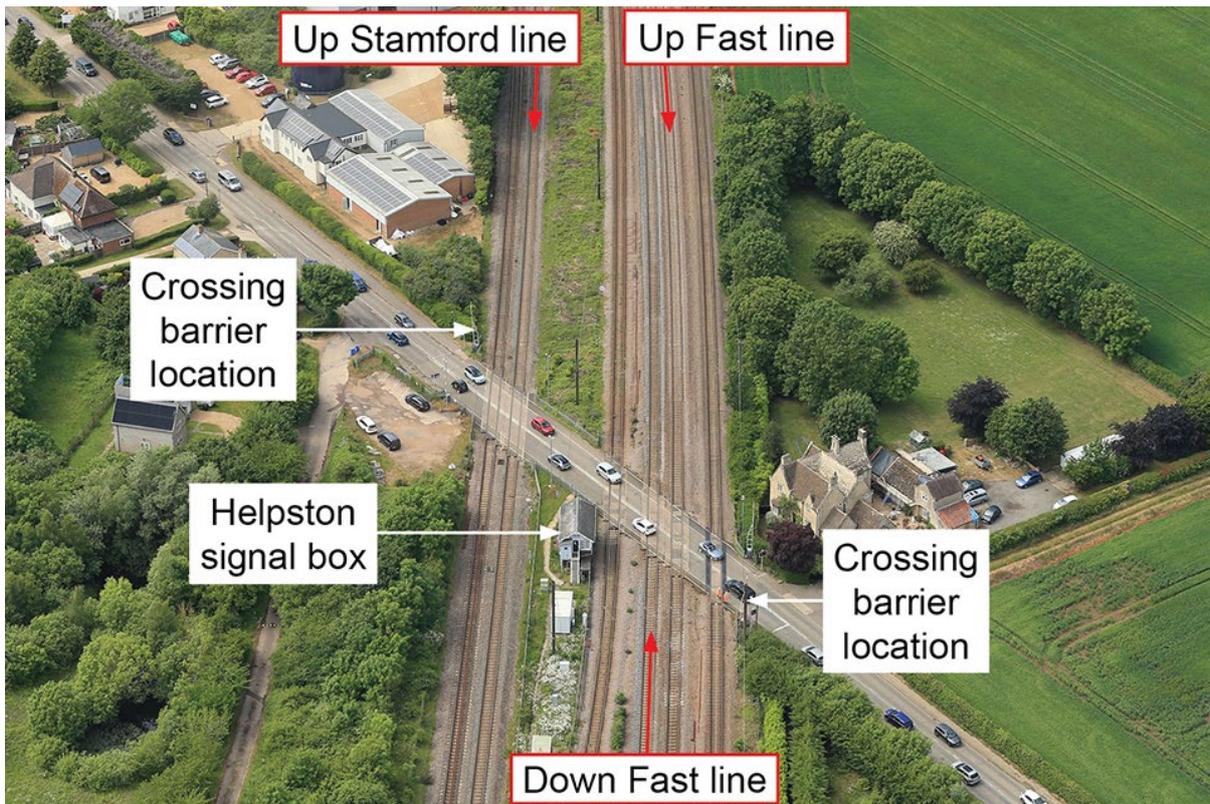
Helpston MCB level crossing spans six railway lines on a skew. These are the Up and Down Fast and Up and Down Slow lines of the East Coast Main Line, and the Up and Down Stamford lines. The crossing is controlled by Helpston signal box which also controls a further four level crossing which are sited remotely and which are monitored using CCTV. The signal box is located between the East Coast Main Line and the Stamford lines.

**Helpston MCB level crossing with the directions of approach of the trains involved (courtesy of Network Rail with RAIB annotations).**

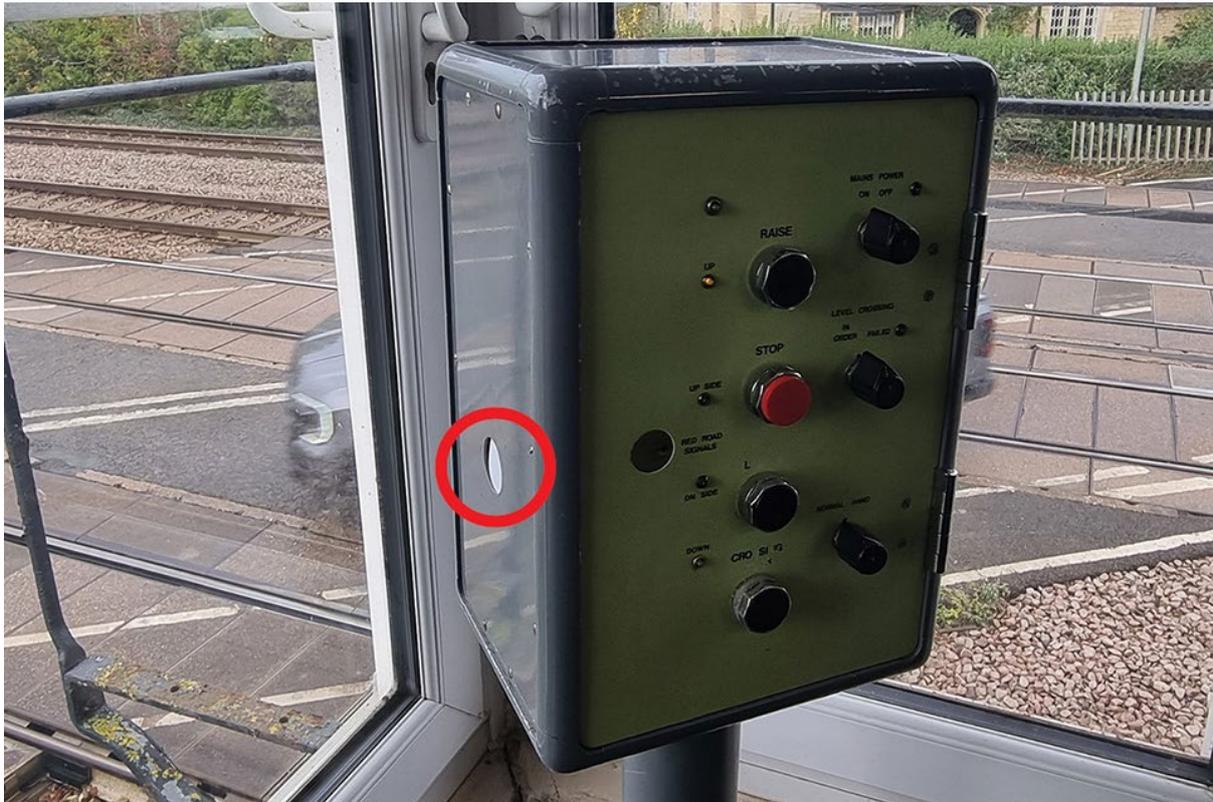
**The crossing controls – the hole to access the sealed release plunger is on the left of the box (circled).**

The sealed release plunger at Helpston signal box is accessed via a hole on the side of the box containing the crossing controls and can only be used when the crossing controls are switched to manual mode. This access hole should be covered by a paper seal. The purpose of the paper seal is to act as a deterrent to unauthorised use, and to indicate when the release plunger has been used. To override the safeguards and raise the barriers, the signaller must break the seal and then press the plunger at the same time as the crossing raise button, making it a two-handed action. The sealed release plunger bypasses the safeguards for manually raising the barriers provided by the interlocking.

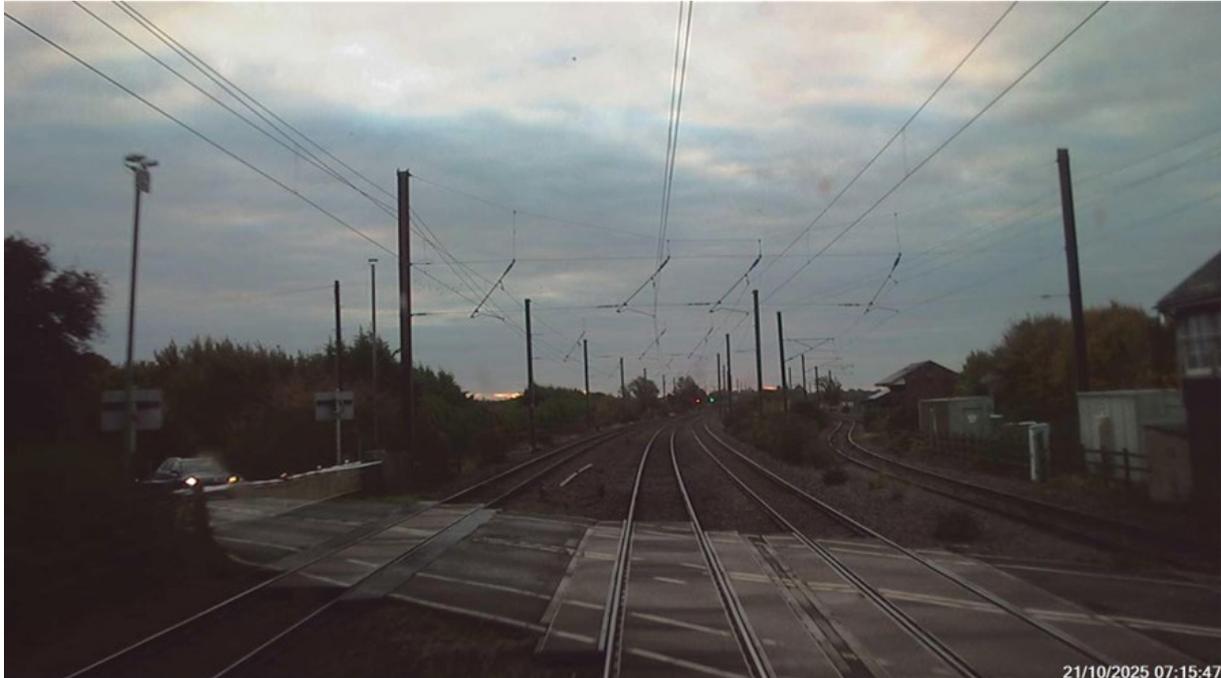
By 08:15:13, just over 2 minutes later, the passenger train on the Down Fast line had passed over the crossing. The second passenger train had passed the crossing on the Up Fast line by 08:15:53. Signalling data records the barrier controls being set to manual mode at 08:15:46, shortly before the second train passed over the crossing. At this point the freight train was still approaching the crossing, with signalling data showing that it occupied the track section on approach to the crossing at 08:15:44.

**Forward-facing CCTV from the second passenger train as it passed over the crossing (courtesy of Hull Trains).**

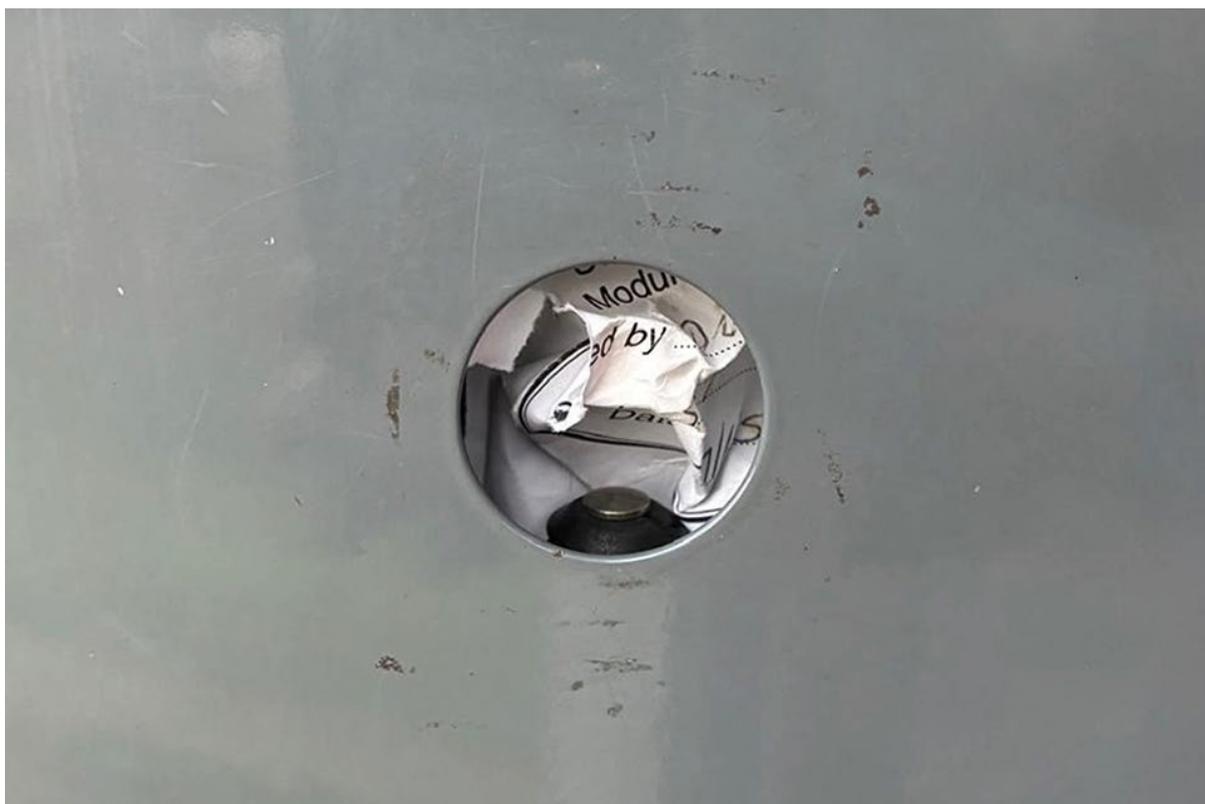
**The remains of the paper seal inside the hole which allows access to the sealed release plunger.**

Believing that they were dealing with an equipment failure, the signaller decided to use the sealed release plunger to raise the barriers. The paper seal which should have covered the plunger was already broken and had been left inside the plunger access hole. Documentary evidence shows that this seal had been broken on 4 July 2025 and that, while this had been logged by the signaller on duty, it had not been reported for repair.

The 4-month period when the seal over the plunger was broken and not replaced also suggests that there was an acceptance of a non-compliant local practice regarding sealed release use by staff in this signal box.
