Abbreviated Vibration Monitoring Report

Monitoring Period: 02 February 2026 to 01 March 2026

Project: Grenfell Tower

Document Ref: EEMC-VMR-201/106 – Grenfell Tower Rev 00

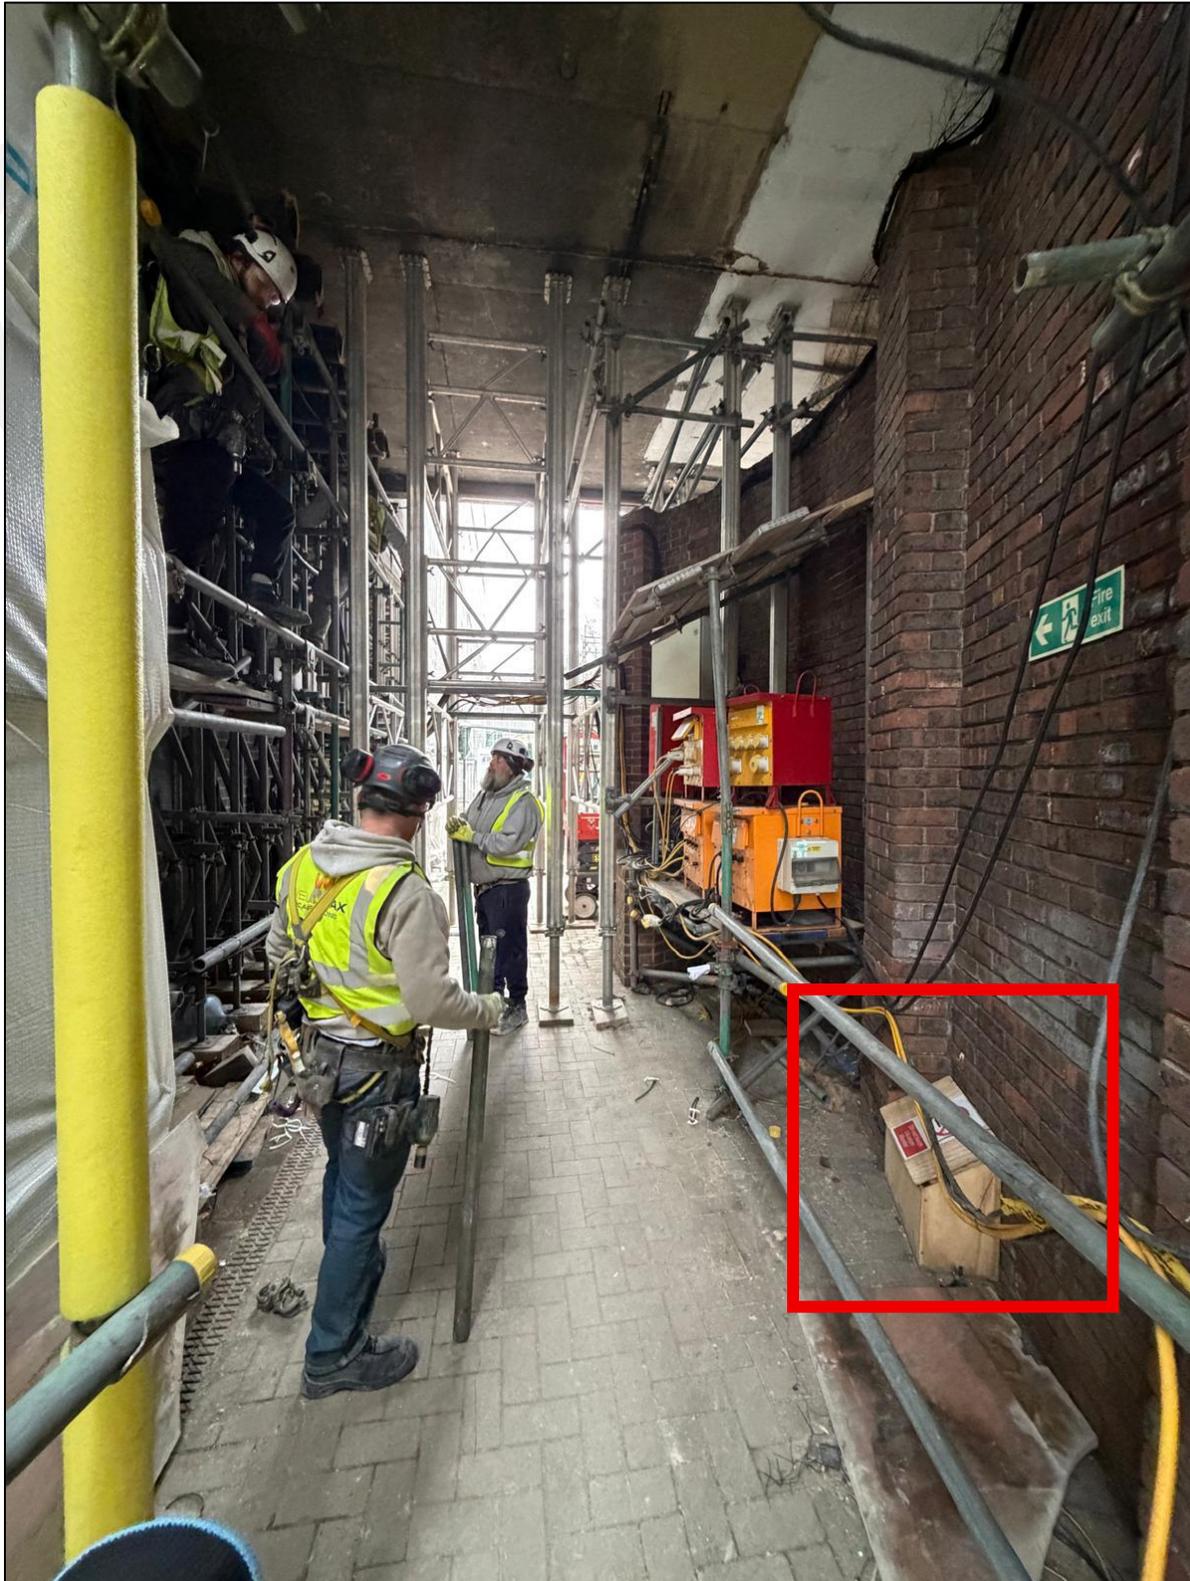
Image 1 – Works Location throughout the monitoring period, adjacent to VMP1

There were works adjacent to VMP1 throughout this monitoring period as outlined in Tables 0.1 and 0.2, and the location of works and the monitor are shown in Image 1.

Wooden box on the right hand side houses the vibration monitor – highlighted with a red box
