Accident

Aircraft Type and Registration:	Taylor Monoplane, G-AYSH
No & Type of Engines:	1 Volkswagen 1600 piston engine
Year of Manufacture:	1973 (Serial no: PFA 1413)
Date & Time (UTC):	17 June 2025 at 0936 hrs
Location:	Nayland Airfield, Suffolk
Type of Flight:	Private
Persons on Board:	Crew - 1 Passengers - None
Injuries:	Crew - 1 (Fatal) Passengers - N/A
Nature of Damage:	Broken canopy and damage to propeller, left main landing gear and spat
Commander's Licence:	National Private Pilot's Licence
Commander's Age:	82 years
Commander's Flying Experience:	1,522 hours (approximately 1,375 on type) Last 90 days - 11 hours Last 28 days - 4 hours
Information Source:	AAIB Field Investigation

Synopsis

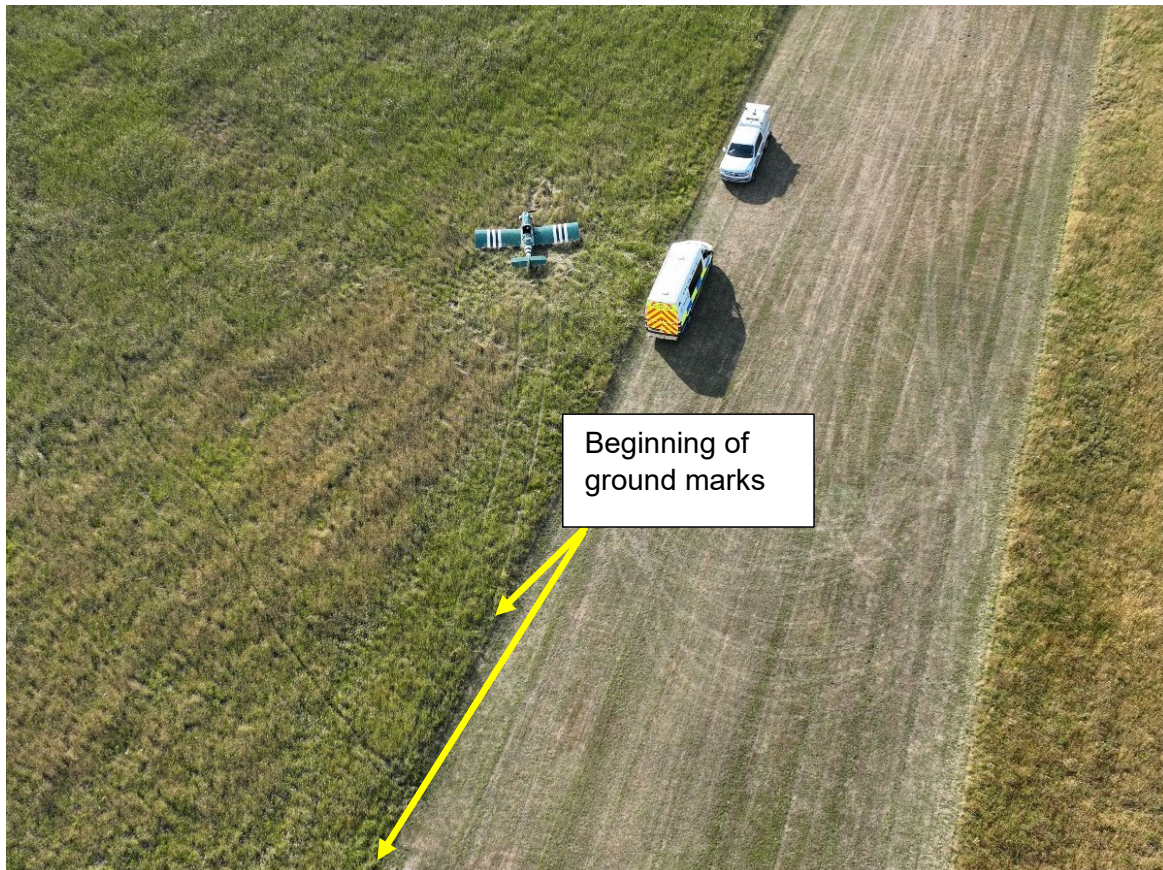
Figure 1

The aircraft had travelled approximately 30 m through long grass to the left of the runway, before nosing over. The aircraft's main landing gear left tracks in the long grass where it departed the runway, starting at approximately 250 m from Runway 32's southern end.

The canopy had broken, with all pieces of transparency found next to the aircraft. There had been a fuel leak, but no fire. The aircraft was righted by first responders.

Aircraft position (after righting), viewed from the Runway 32 direction

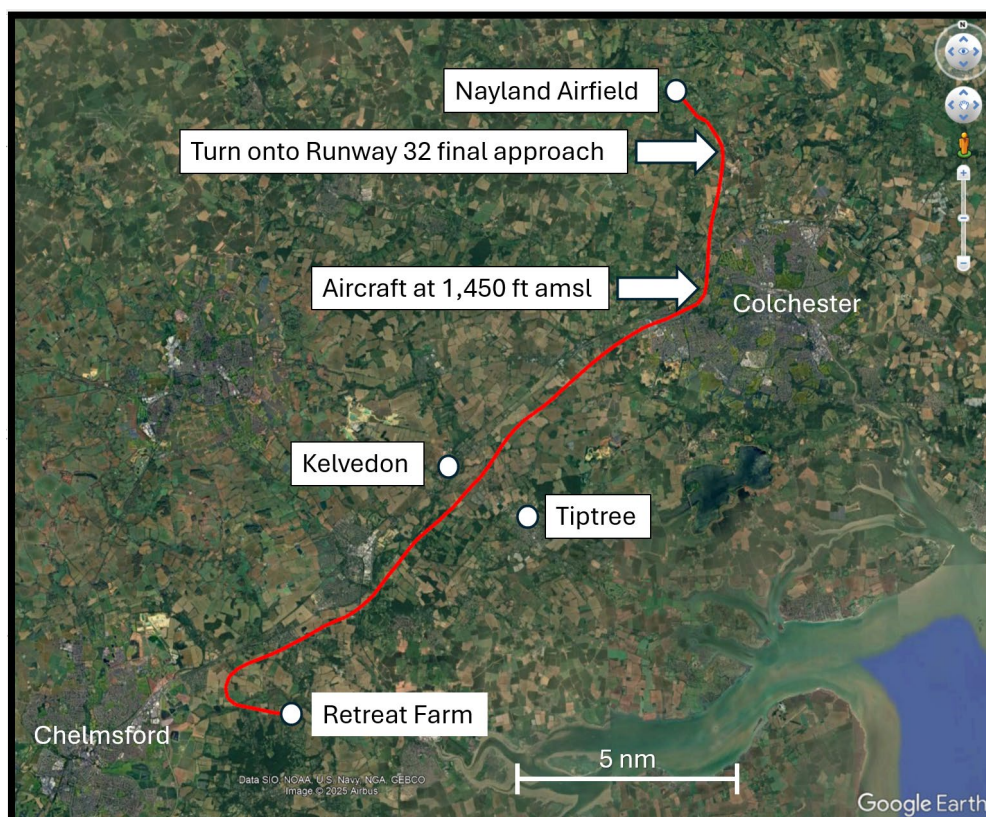
Figure 2

The aircraft took off from Retreat Farm, Runway 28 at 0922 hrs and made a gradual climbing right turn onto a north-easterly heading towards Colchester. It initially climbed to about 800 ft amsl but about five minutes into the flight, when at a distance of about 5 nm from Retreat Farm, the aircraft started to gradually descend at a rate of about 480 ft/min. As it passed between the villages of Tiptree and Kelvedon (Figure 2) the aircraft had descended to 320 ft amsl (about 200 ft agl), but then climbed away progressively; the time was 0928:15 hrs. As the aircraft reached Colchester, it reached an altitude of about 1,450 ft amsl, at which point it altered course towards the north, whilst also starting to gradually descend.

GPS track from Retreat Farm to Nayland

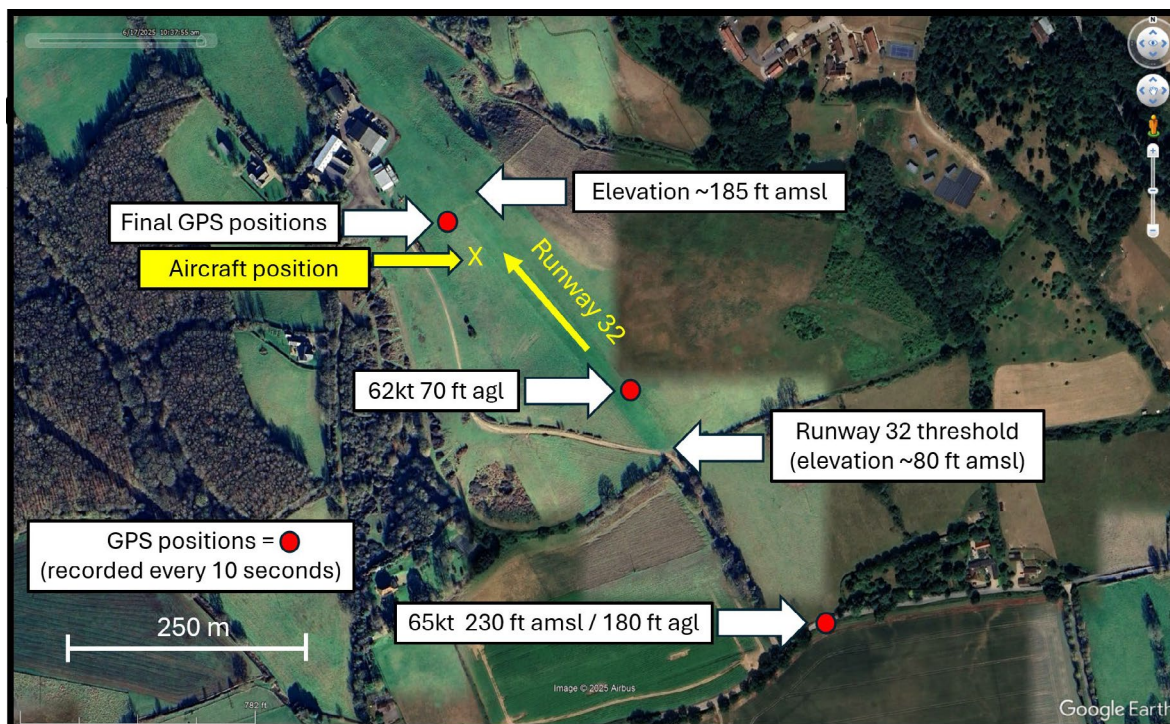
Figure 3
Final GPS points

When the aircraft was 1.6 nm from the airfield, it turned onto an inbound course for Runway 32. At this point the aircraft was at an altitude of 1,050 ft amsl and its average descent rate was about 580 ft/min. As the aircraft approached the runway, its airspeed gradually started to reduce and when it was approximately 250 m from the runway threshold (Figure 3), its estimated airspeed was about 64 kt and it was at approximately 230 ft amsl (a height of about 180 ft agl). The next GPS-derived data point was positioned overhead the runway, with the aircraft at a height of approximately 70 ft agl and with an estimated airspeed of 62 kt. The next GPS data point, recorded 10 seconds later, showed that the aircraft was no longer on the runway, but in the long grass to the left of it, and travelling at a ground speed of 40 kt; the time was 0935:55 hrs. The next GPS data points were recorded at the identical position but with the aircraft no longer moving.

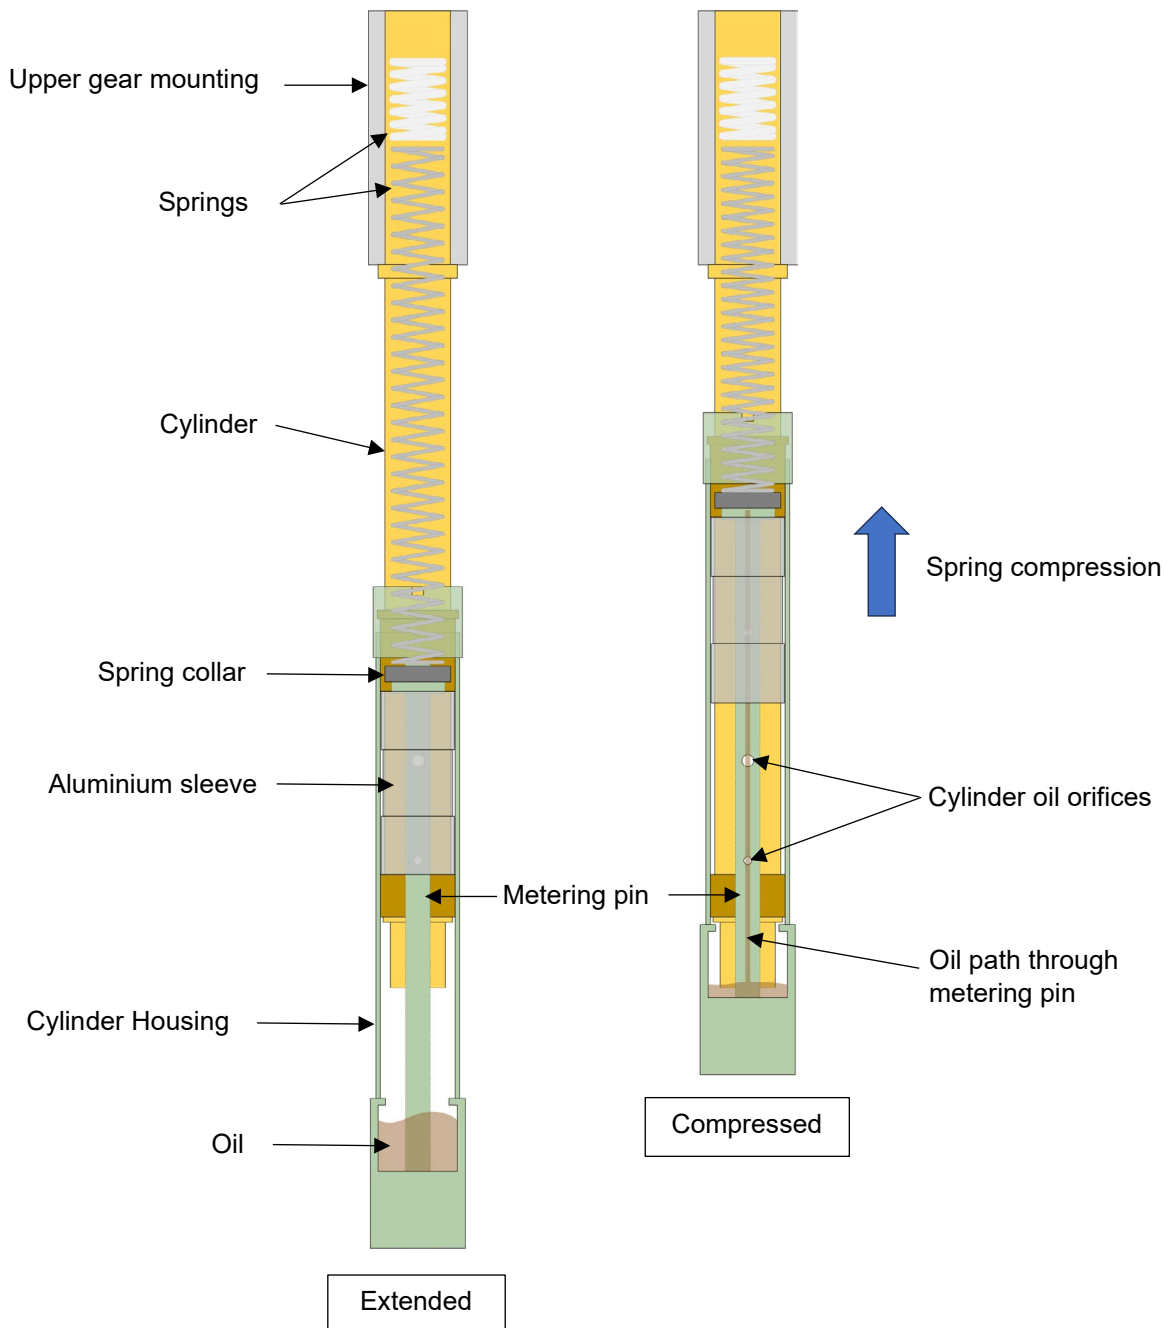
Figure 4

Upon compression, the cylinder housing slides over the cylinder. A metering pin in the cylinder housing pushes against a collar in the cylinder, compressing the springs to provide shock absorption. An aluminium sleeve fitted to the outside of the cylinder moves with the compression within the cylinder housing, exposing orifices along the cylinder's length. Oil travels up through the metering pin, exiting via the orifices to provide lubrication and a level of damping. This action is shown in Figure 4.

G-AYSH main landing gear shock absorber operation

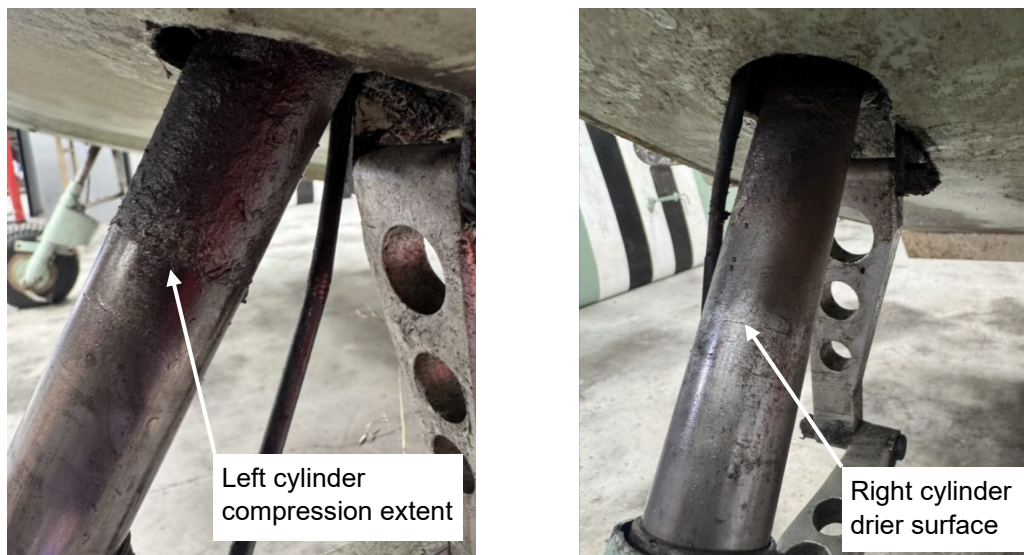
Figure 5

The left main landing gear cylinder showed evidence of compression, identified by a defined line in the grease accumulation (Figure 5). There was a cleaner, lightly oiled section of outer surface where it slides into the cylinder housing. With light downward force applied, the gear compressed freely and returned to its extended position unaided.

Left and right gear cylinders

The right main landing gear's cylinder surface in comparison was drier with a poorer finish. Light downward force was applied, but the cylinder was found to be seized in position. With

further force, the gear compressed but did not rebound, remaining in its compressed state. It was possible to re-extend the cylinder by hand. Approximately 35 ml of oil was drained from the left cylinder housing, and 15 ml of oil from the right.

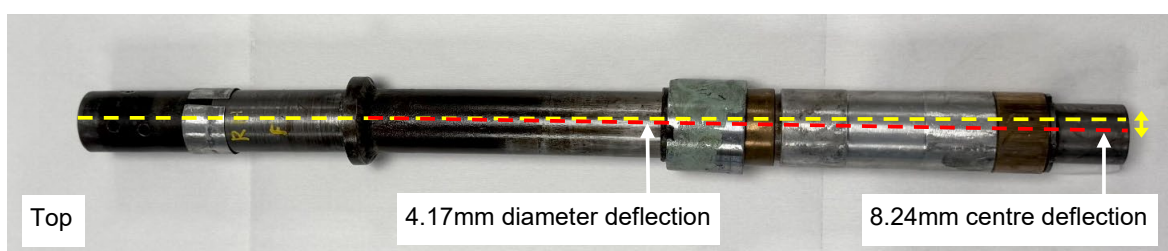
Figure 6
Right cylinder measurement

The right cylinder was found to be out-of-true by 8.24 mm between centres over its length. The mid-point deflection from centreline to outer surface was 4.17 mm (Figure 6).

The right main landing gear shock absorber was found to be partially seized and had no rebound. Examination revealed that both the cylinder housing and the cylinder were bent outboard, likely from a historic event due to the amount of main spring outer coil wear and the presence of an overpainted repair. The misalignment of the cylinder and housing led to reduced ability for the cylinder and sleeve assembly to slide within the cylinder housing, resulting in an imbalance in compression between the right and left landing gear assemblies. The condition of the right leg cylinder's outer surface in comparison to the left indicates it may have had restricted compression for some time. The reduced amount of oil recovered from the right cylinder housing would have had contributed to a lower level of damping available if the cylinder was moving normally.

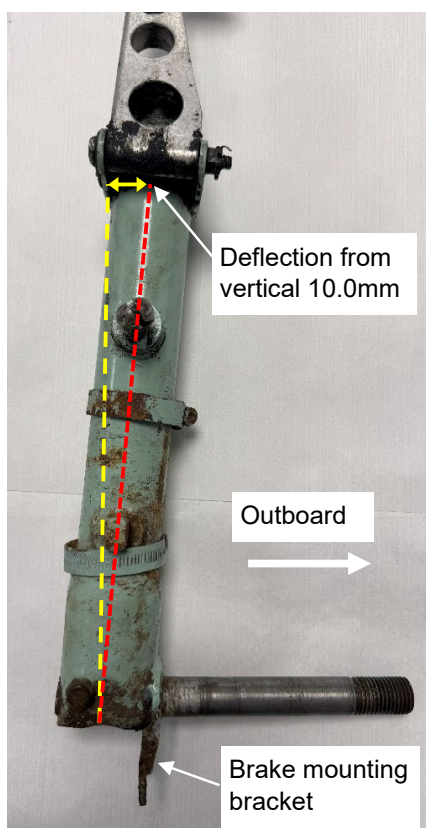
Figure 7
Right cylinder housing measurement

The top of the cylinder housing was deflected 10.0 mm outboard in comparison with the base (Figure 7). The brake mounting bracket on the bottom of the cylinder had been damaged previously and a welded repair applied, which was overpainted.

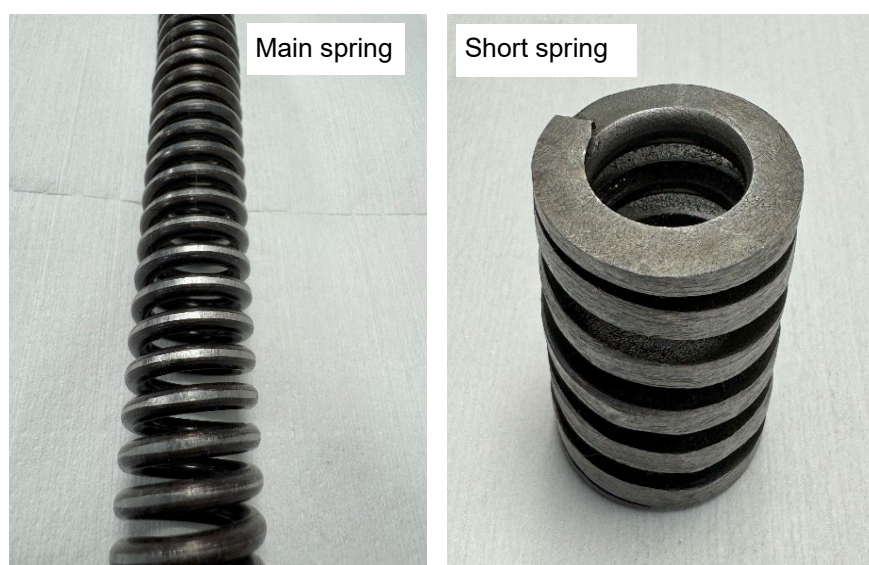
Figure 8

Inside the right cylinder, there were witness marks from the springs fretting against the inner surface. The longer main spring showed corresponding areas of wear on the outside of the coils (Figure 8). The shorter spring's outside edges had been ground to a squared-off finish; the inside edges of the coils were rounded. The outer coil surface finish was rough, and they were not consistently circular in shape.

Right landing gear springs

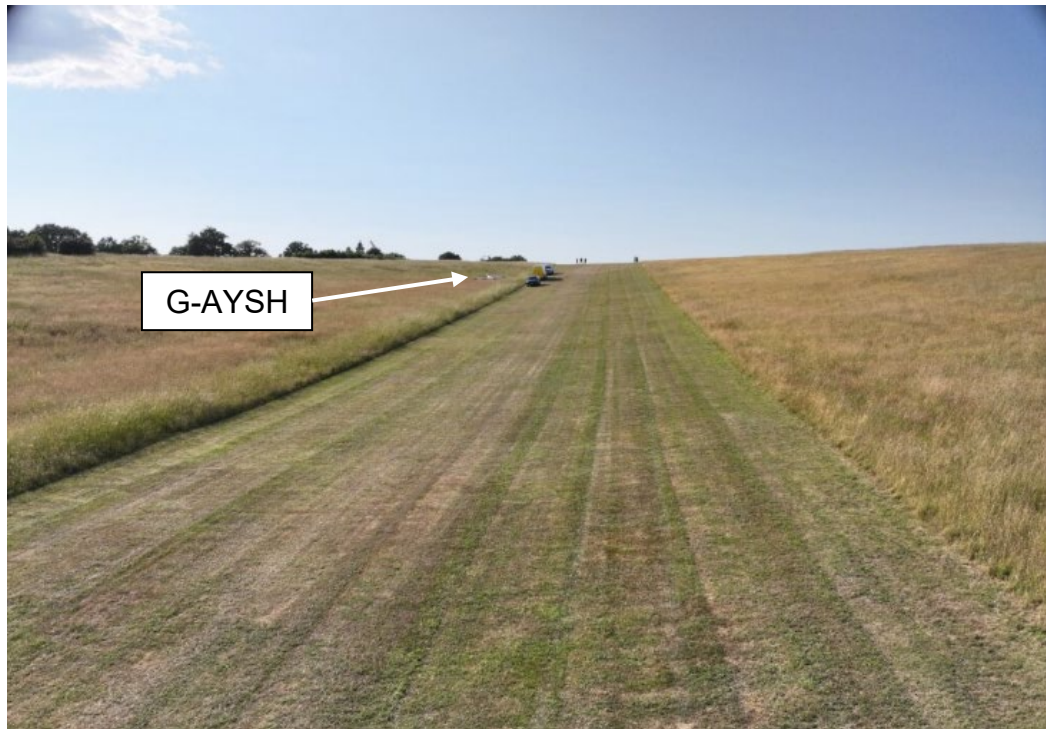
Figure 9

Nayland is a privately owned, unlicensed airfield located five nautical miles north-west of Colchester, at an elevation of 180 ft amsl. The preferred method of joining the circuit for Runway 32 is via the overhead, into a left-hand circuit. Runway 32 has an upslope gradient of approximately 5.5 % over its length. However, the initial 320 m has an upslope of about 9.5 %. The touchdown point and final position of G-AYSH were not visible from the clubhouse (Figure 9).

Nayland Airfield looking along Runway 32

The investigation concluded that the pilot likely suffered a fatal heart attack at some point after landing at Nayland. He was not discovered for approximately 39 minutes after landing because the aircraft was not visible from the clubhouse due to the upsloping runway, and his arrival was not expected until 1100 hrs. Consequently, the straight-in approach, landing and subsequent departure from the runway went unnoticed.
