Report on the investigation of
the fatal accident to a crew member on board the
roll-on/roll-off cargo vessel

Laureline

at Purfleet, England

on 13 July 2024

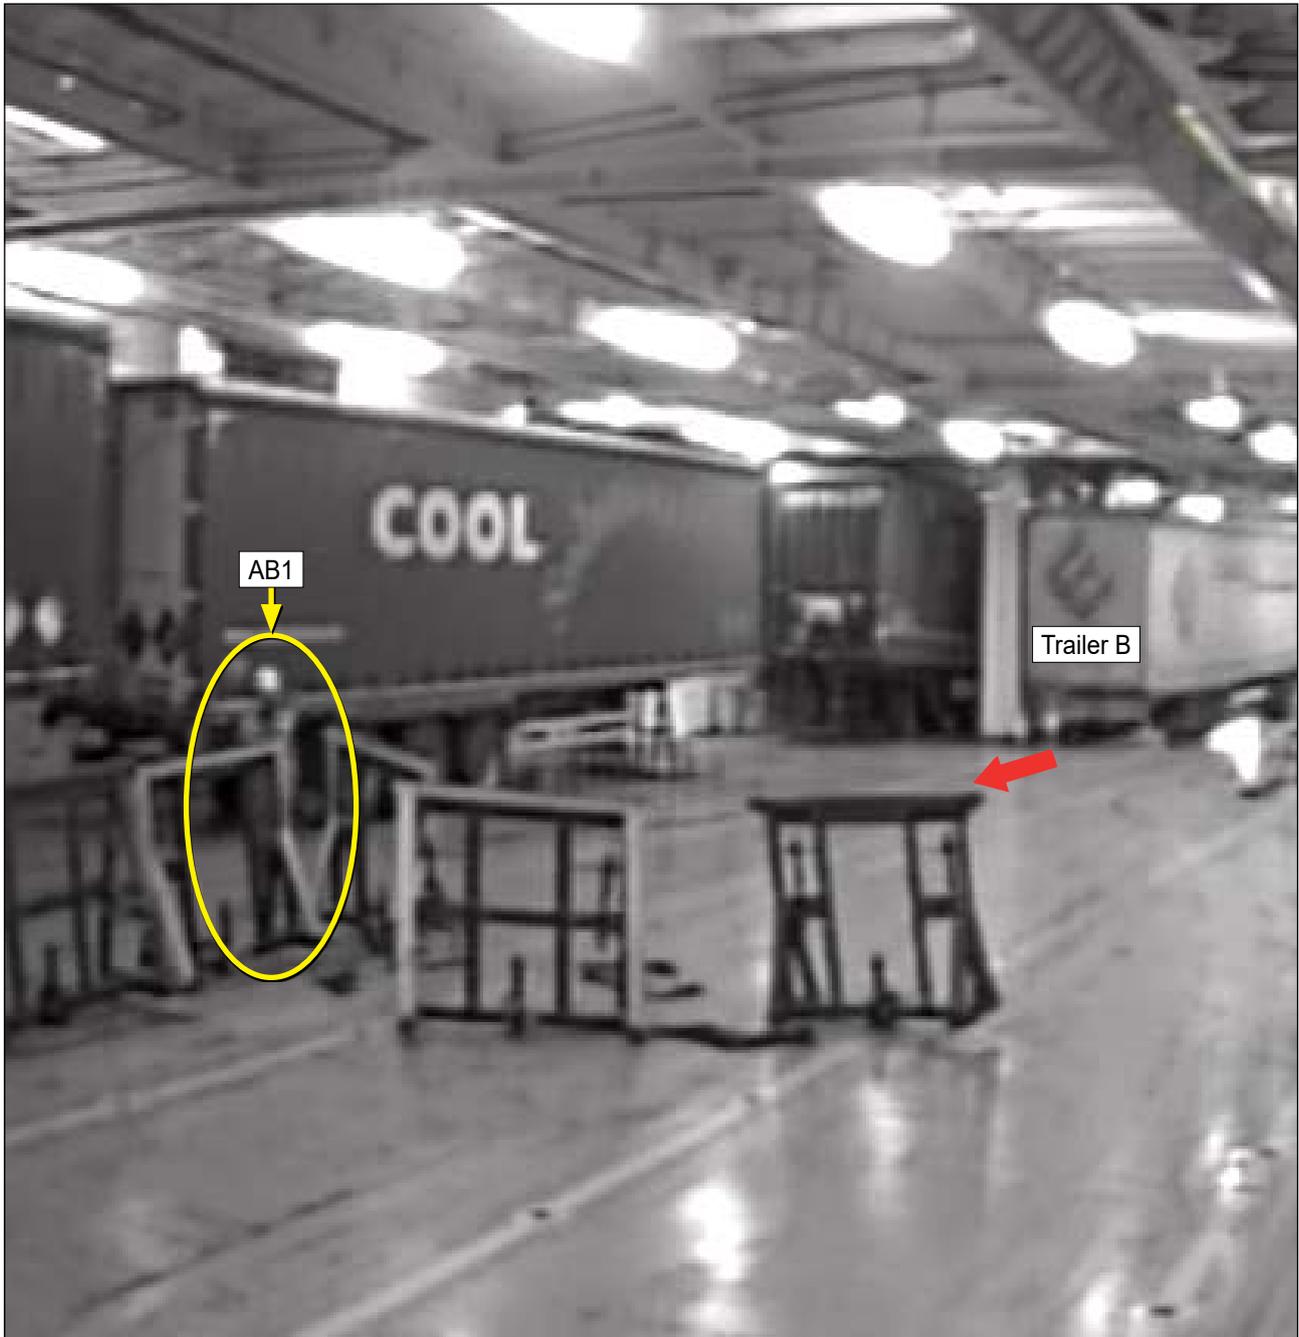
Figure 3: CCTV image of AB1 walking ahead of trailer B as the tug driver pushed it into position

As the tug driver manoeuvred trailer B into position, AB1 positioned himself on the port side of the lane, between the vent trunking and the rear of a stowed trailer (trailer C) (**Figure 4**). The tug driver began to push trailer B into position before momentarily stopping and pulling the trailer ahead to better position it within the lane. The tug driver then continued to push trailer B towards the aft end of the garage deck.

The tug driver paused for approximately 5 seconds as trailer B approached the vent trunking. At about this time, AB1 moved behind trailer B. The tug driver resumed pushing the trailer aft, crushing AB1 between the trailer and *Laureline's* structure. After feeling the trailer jolt, the tug driver pulled the trailer forward again. AB2, who had been lashing trailer A on the starboard side, saw that AB1 had been struck by trailer B and ran from in front of trailer A, waving their arms and shouting at the tug driver. AB2 then rushed towards the rear of trailer B, before returning to inform the tug driver that AB1 had been injured and was lying between the rear of trailer B and the vent trunking (**Figure 4**).

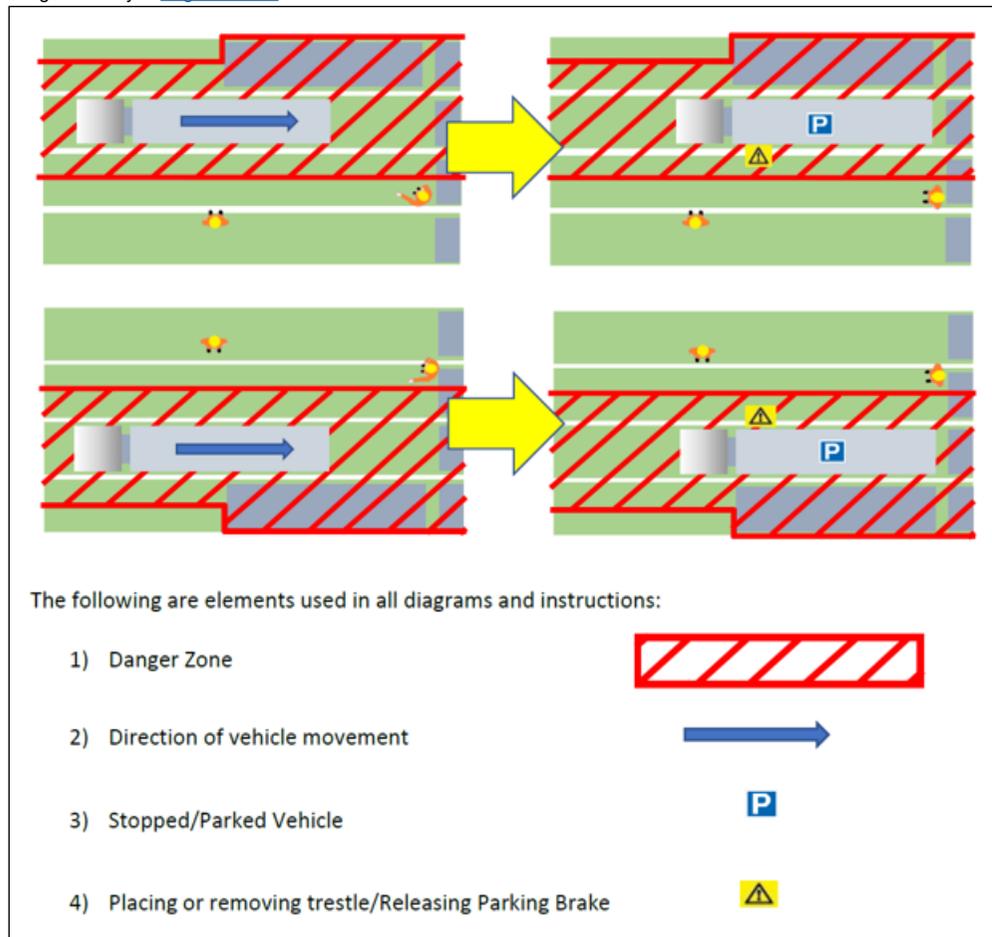
Figure 5: Extract from the new vessel procedure, showing danger zone and examples of crew placement

Section 4.7 described the personal protective equipment (PPE) to be worn by vessels' crews and required the duty deck officer to hold a toolbox talk with crew members at the beginning of each shift. The new vessel procedure also provided illustrated examples of crew placement and highlighted the danger zone (**Figure 5**) around manoeuvring vehicles, defining it as:

an area around a moving vehicle or trailer (or similar) when a tug is connected. The danger zone is also an area of no or limited escape.

- *The entire lane behind a vehicle*
 - *Crewmembers must always ensure that they avoid standing in this lane and must proceed to a position where they are visible by the Tug master*
- *The length of a cargo unit in front of the vehicle*
- *The width of half a lane on either side of the vehicle*

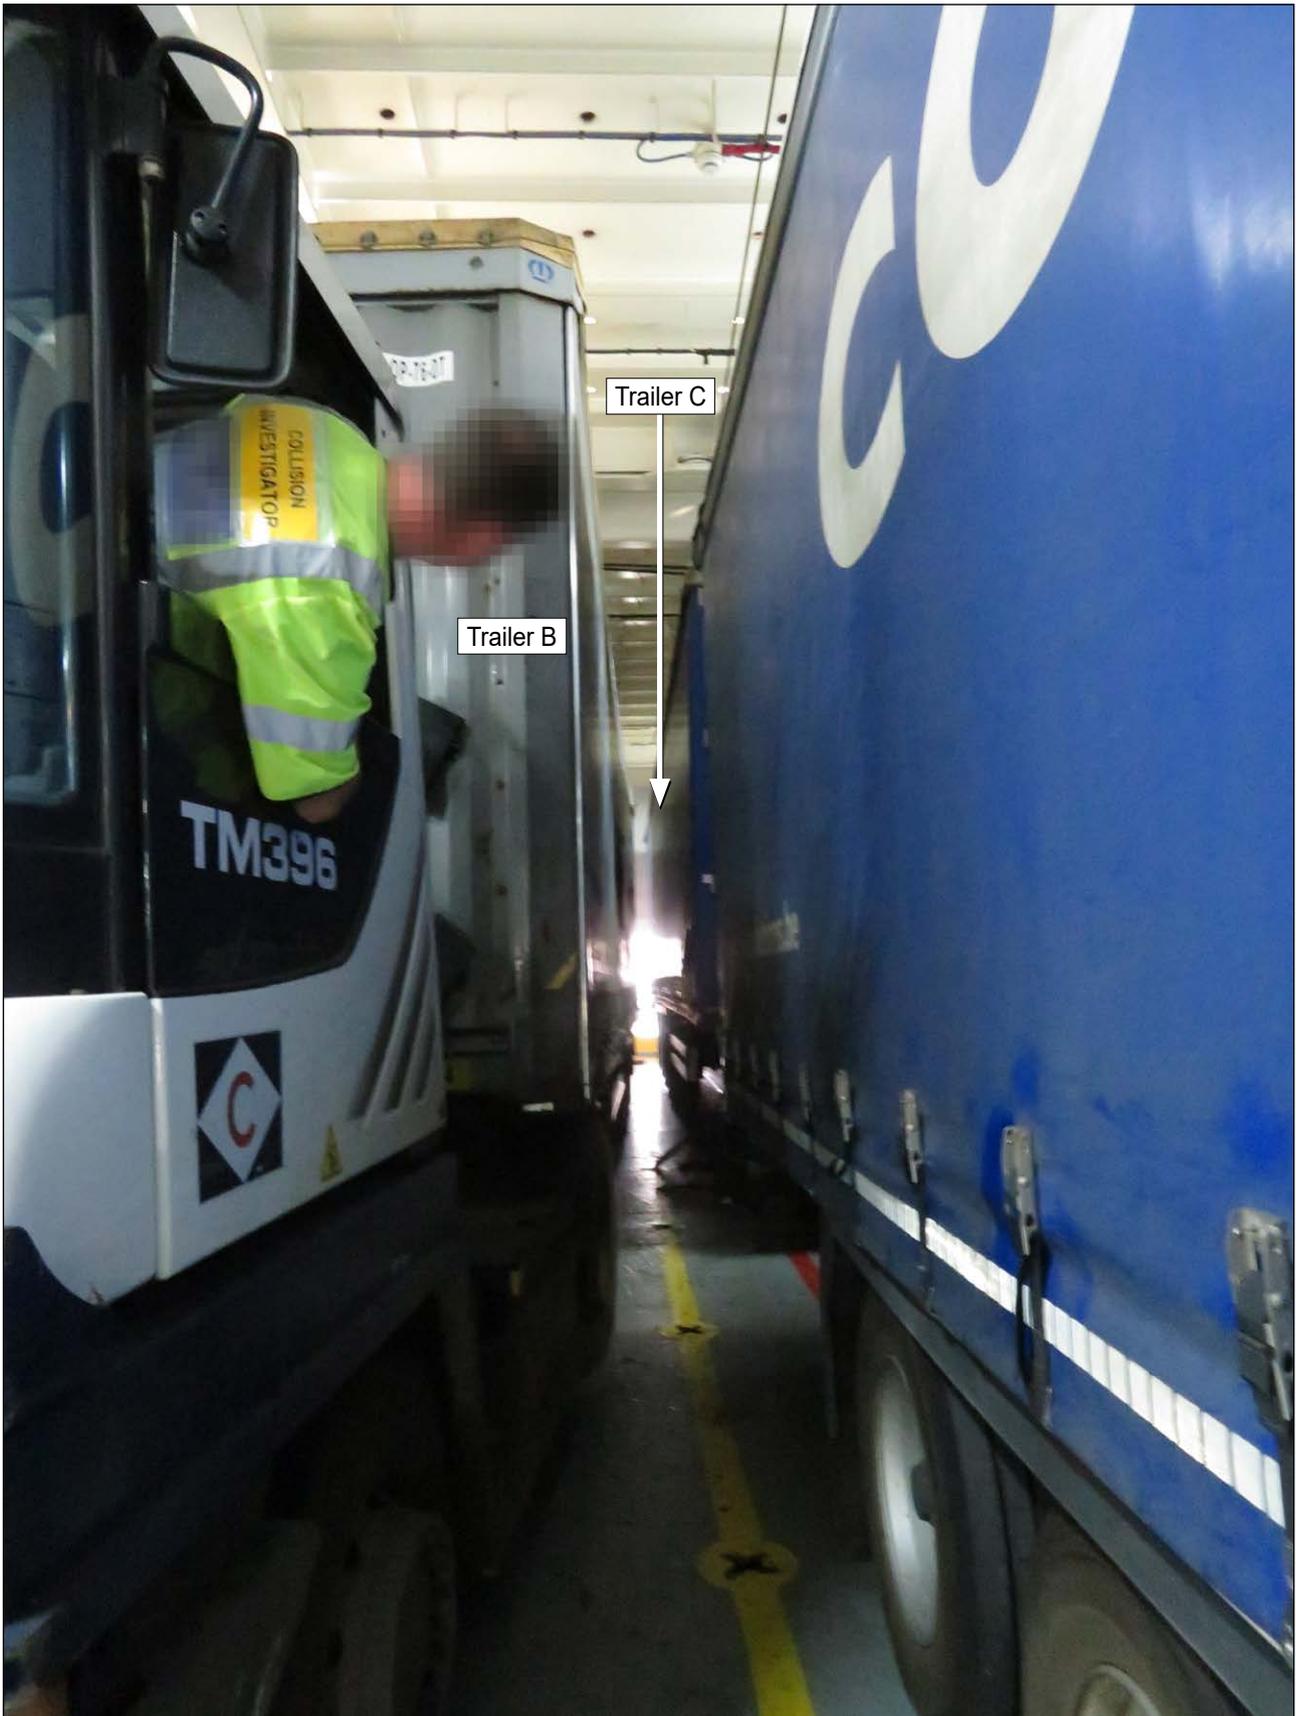
Figure 8: Reconstruction of the tug driver's visibility between trailer B and trailer C

A reconstruction of trailer positions at the accident scene indicated that the person driving the tug would have needed to lean their head out of the window to see a person standing between trailer C and trailer B (**Figure 8**). Post-accident, the gap between the rear of trailer C and trailer B was found to be 20.6cm.
