SAFETY FLYER TO THE FISHING INDUSTRY

Foundering of the fishing vessel *Freedom II* (CN 111)

11 nautical miles south-west of Oban, Scotland

on 21 February 2024

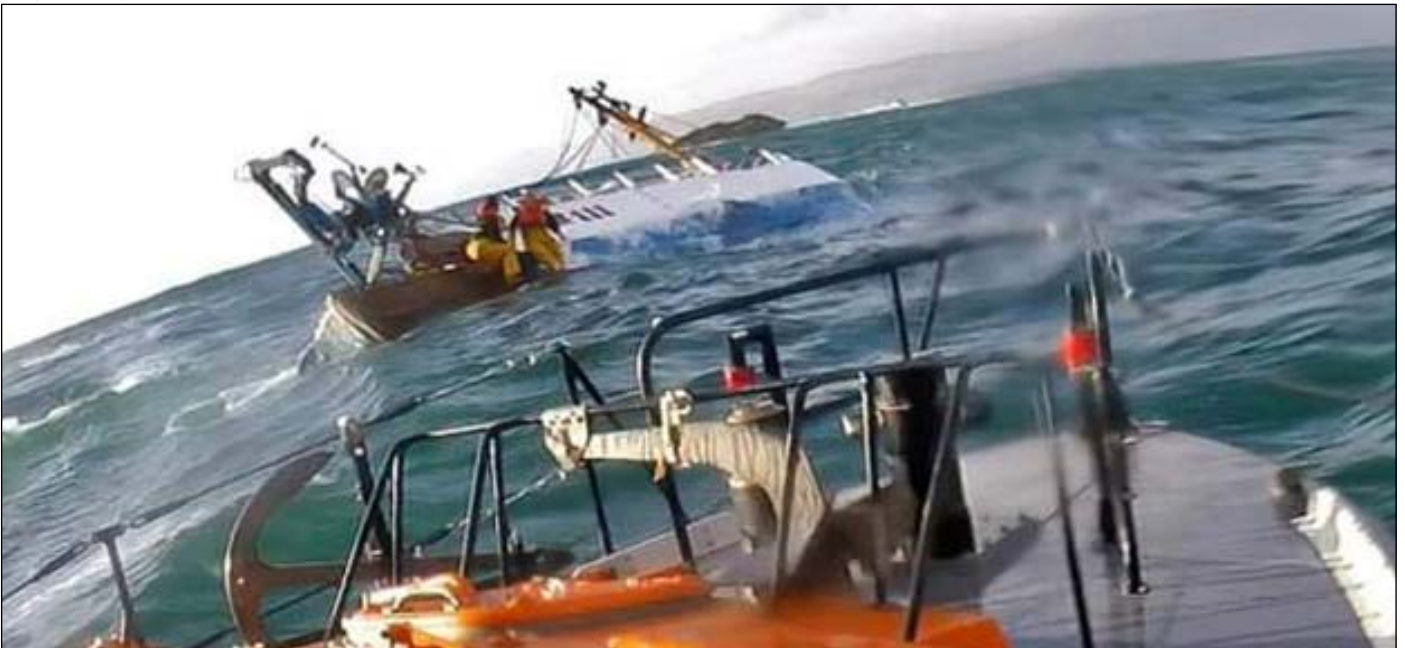
Video still of *Freedom II* as the vessel capsized to port

At 1535 on 21 February 2024, the 15.94m prawn trawler *Freedom II* foundered and sank to the east of the Garvellach Islands in the Firth of Lorn off the west coast of Scotland. *Freedom II* had suffered an uncontrolled flood into the engine room. The crew were initially alerted to the flood by the activation of the bilge alarms but did not isolate any sea cocks as they believed that the flood was due to a failed stern seal. The flood, likely caused by the failure of a seawater pipe, overwhelmed the available bilge pumps and passed into the fish hold.

1. Flooding is preventable, but if it occurs can be controlled in most cases. If discovered early, leaking pipes can be isolated and the flooding controlled by pumping out the affected space. Flooding can be rapid, and late discovery leaves no time to treat the cause. An efficient bilge alarm can be critical in providing early warning of flooding.

4. Regular checks and function tests of bilge alarms and pumps, together with regular examinations of vessel hulls and pipework will assist in preventing potential leaks or failures occurring.
