Report on the investigation of the
foundering of the fishing vessel

Freedom II (CN 111)

11 nautical miles south-west of Oban, Scotland
on 21 February 2024

REPORT NO 8/2026

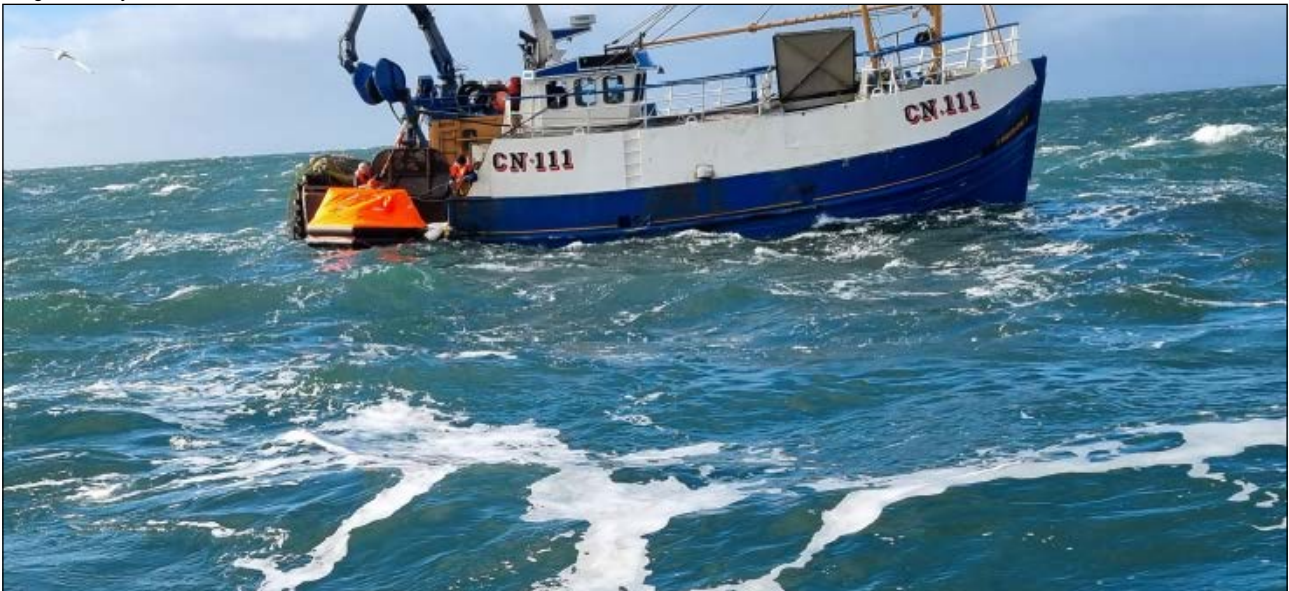
Figure 3: *Freedom II* at time of Oban ALB arrival

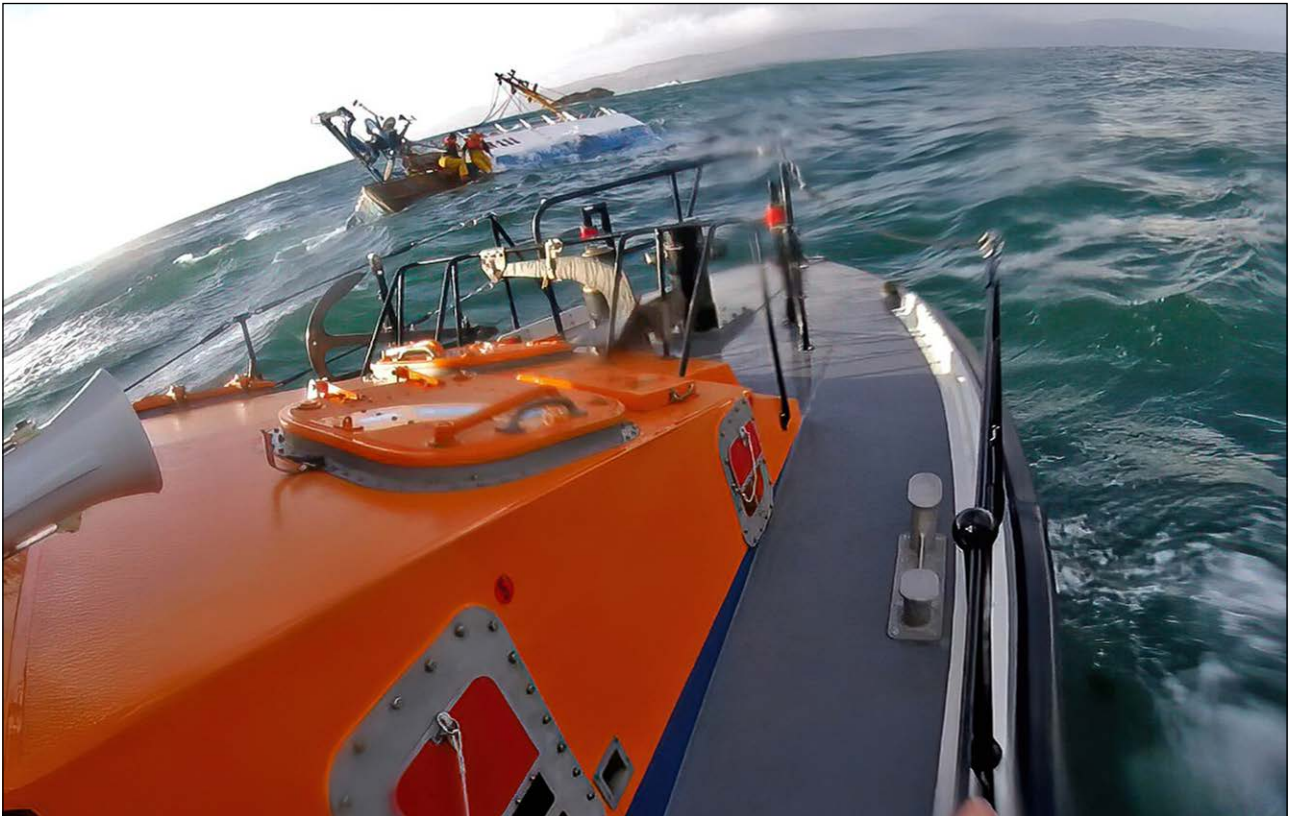
Figure 4: Video still of *Freedom II* as the vessel capsized to port

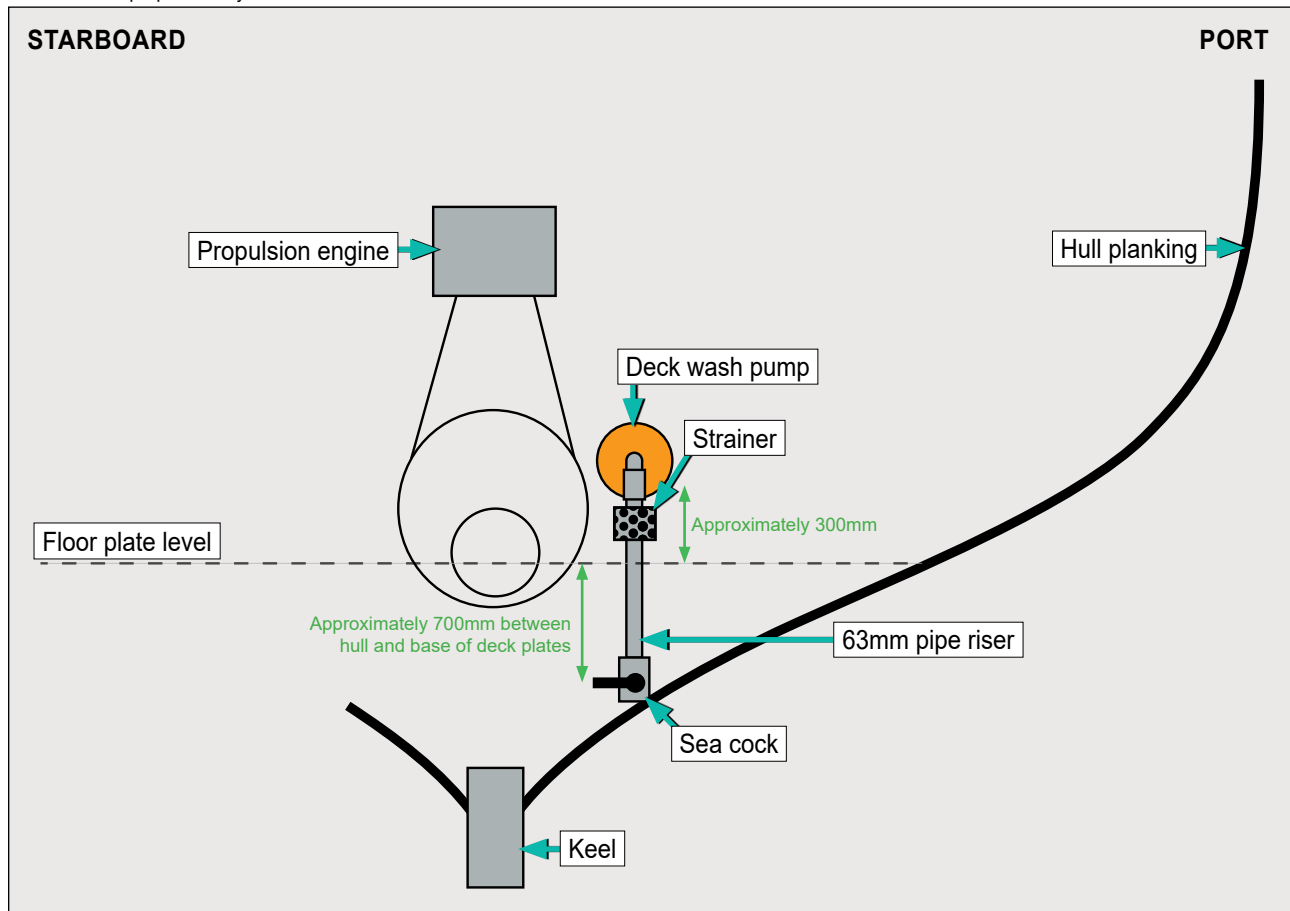
The copper alloy suction pipework did not contain a flexible coupling or bellows piece to allow for any relative movement of the deck wash pump assembly. The available evidence indicated that the pipe assembly leading from the hull fitting to the engine-driven deck wash pump was unsupported.

Figure 6: Deck wash pump supply system (not to scale)

The evidence indicated that the copper alloy pipe leading from the hull fitting to the deck wash pump was neither secured nor fitted with a flexible connection as a means to allow for relative movement between the pump, which was mounted on the flexibly mounted engine, and the rigidly mounted hull fitting. This made the pipe susceptible to fatigue, a risk highlighted in MGN 190 (F). Any cyclic stresses in the pipework caused by the movement of the pump were exacerbated by the vibration experienced and likely resulted in its failure.

The most likely source of the flooding was a fatigue failure of the engine-driven deck wash pump suction pipe. The unsupported pipework was vulnerable to vibration-induced stress that increased the risk of failure and flooding of the vessel.

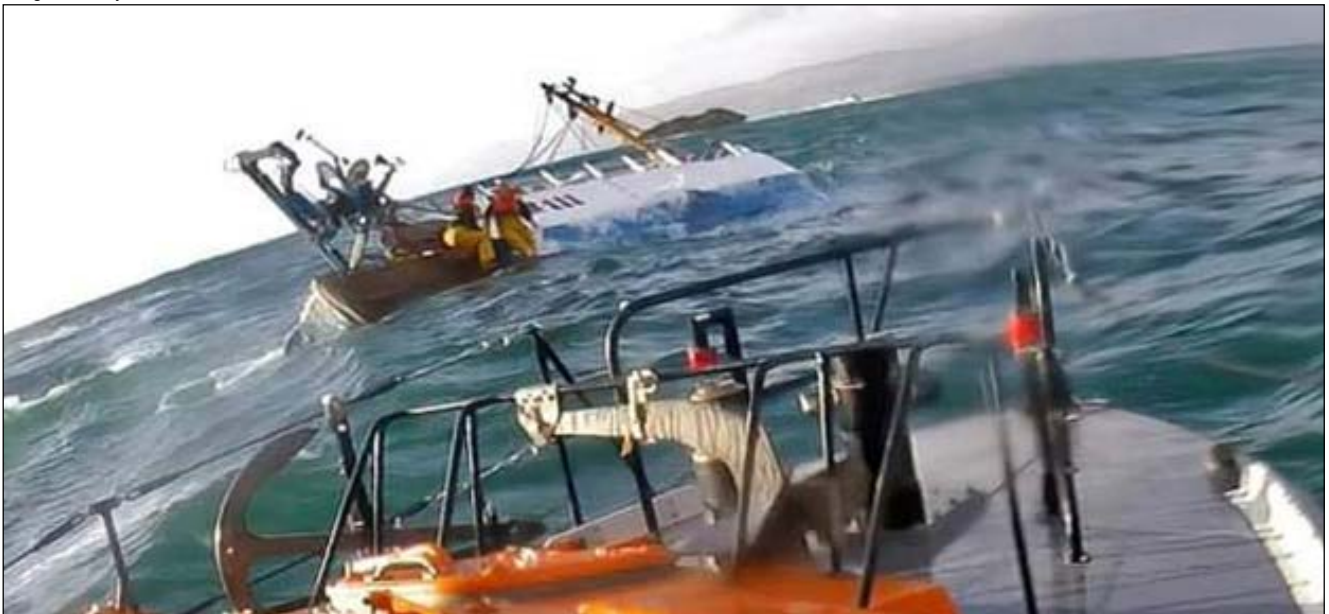
Video still of *Freedom II* as the vessel capsized to port
