**Accident**

<b>Aircraft Type and Registration:</b>	Hoffmann H36 Dimona, G-CIMC	
<b>No &amp; Type of Engines:</b>	1 Limbach L 2000-EB1C piston engine	
<b>Year of Manufacture:</b>	1988 (Serial no: 36269)	
<b>Date &amp; Time (UTC):</b>	8 April 2025 at 1025 hrs	
<b>Location:</b>	Darley Moor Airfield, Derbyshire	
<b>Type of Flight:</b>	Introductory flight	
<b>Persons on Board:</b>	Crew - 1	Passengers - 1
<b>Injuries:</b>	Crew - 1 (Fatal)	Passengers - 1 (Fatal)
<b>Nature of Damage:</b>	Aircraft destroyed	
<b>Commander's Licence:</b>	Airline Transport Pilot's Licence (Aeroplanes)	
<b>Commander's Age:</b>	66 years	
<b>Commander's Flying Experience:</b>	17,185 hours (of which 9 were on type) Last 90 days - 74 hours Last 28 days - 16 hours	
<b>Information Source:</b>	AAIB Field Investigation

**Synopsis**

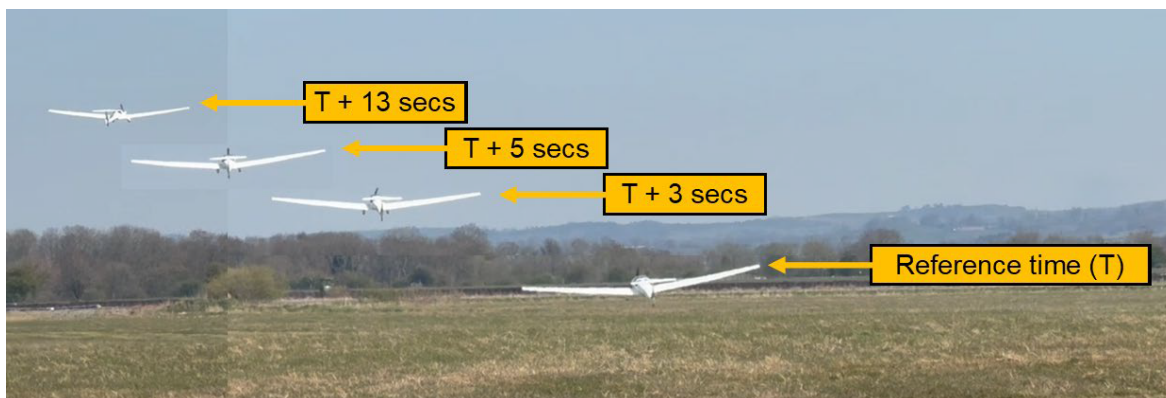
**Figure 1**

Recorded data showed that G-CIMC's lift off from the runway was as expected, but the aircraft then began yawing to the right and was subsequently unable to maintain a safe climbing speed or trajectory. The "wallowing" observed by several eyewitnesses was suggestive of an aircraft at or close to the aerodynamic stall. The investigation was unable to determine why the aircraft did not climb normally or what factors contributed to the pilot not being able to carry out a successful forced landing when the achieved climb performance was not as expected. The investigation did not find evidence of any technical issue that might have limited engine performance. An anthropometric study found the potential for fouling of the controls meant that an inadvertent throttle reduction was a possibility and that inadvertent movement of the trim was possible but not likely.

Composite image showing initial yaw and heading change after lift off  
(Reference time (T) is close to, but not precisely coincident with, lift off)

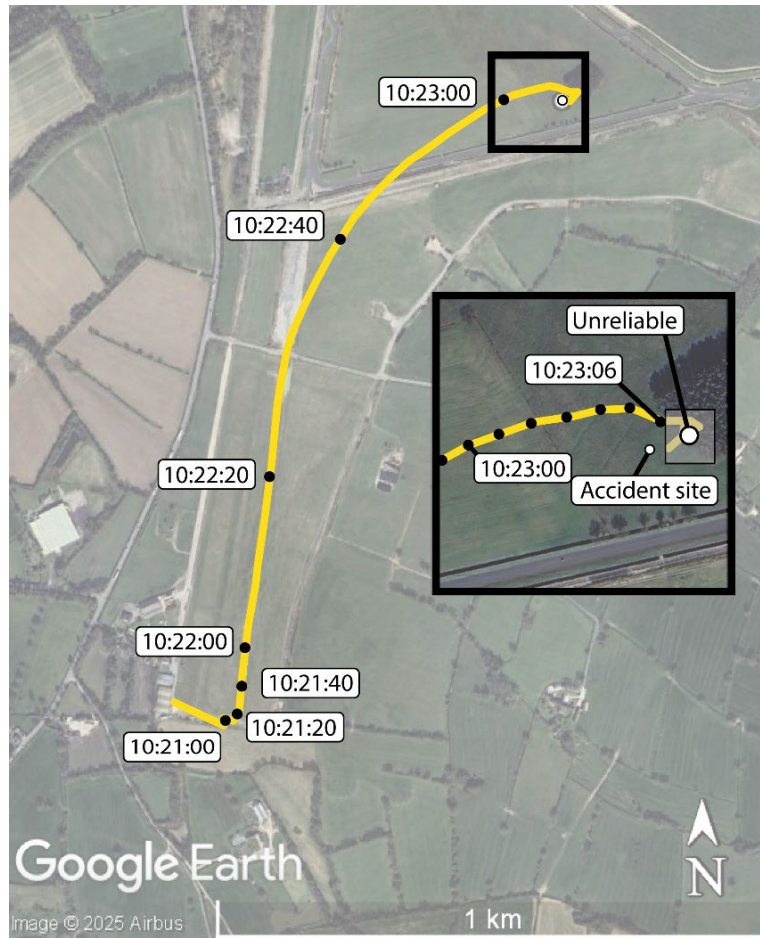
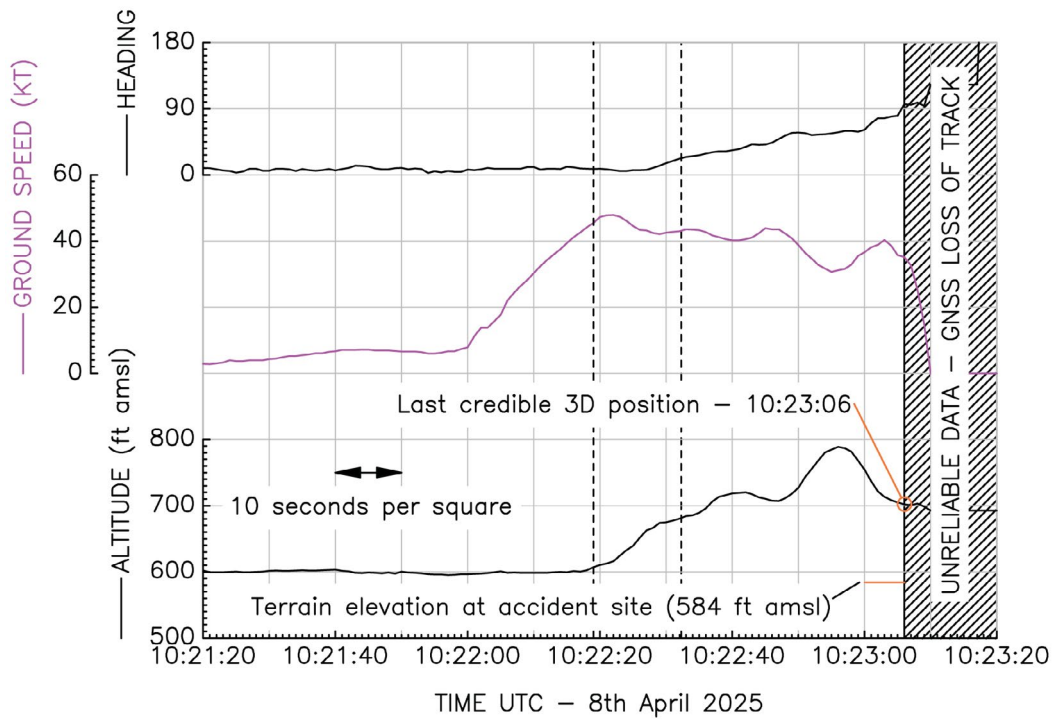
Figure 2

Flight path and data. The left dashed line in the data plot is the rotation point captured by the video and the right dashed line marks the end of the video

The aircraft position was sensed using GNSS technology, which is not designed for accurately tracking dynamic flight. The data associated with the final seconds of the accident flight were found to be unreliable. This is indicative of the GNSS antenna no longer being able to detect satellite signals, either because it moved to an unfavourable place in the cockpit (if for example using the tablet's GNSS sensing capability) or the attitude of the aircraft itself changed significantly, pointing the antenna away from the sky.

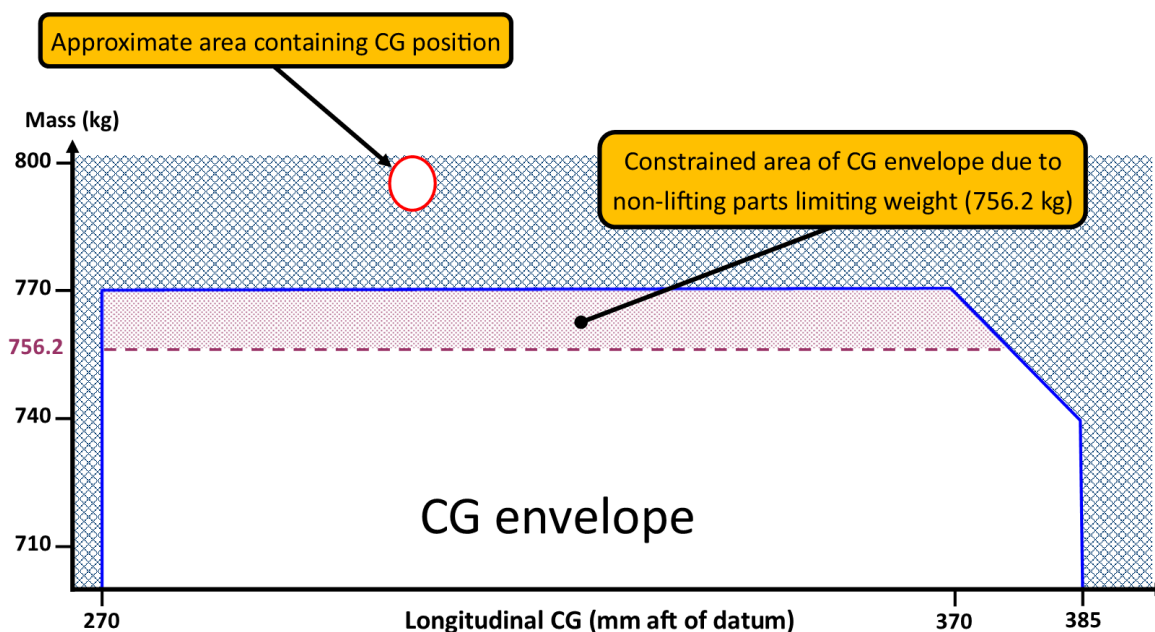
**Figure 5**

Postmortem examinations found the pilot's boarding weight to be 75 kg, and that of the passenger to be 113 kg. Each seat in the aircraft has a maximum mass limit of 110 kg. While the investigation was unable to determine the exact fuel load, 25 litres (18 kg) of Mogas were recovered from the aircraft. Based on the payload weights above, G-CIMC's gross weight at takeoff was at least 791.6 kg<sup>7</sup>, approximately 35 kg above the maximum allowable takeoff weight for non-lifting parts. The investigation calculated that the aircraft's longitudinal centre of gravity (CG) position would have been between the fore and aft datum limits, but the aircraft's takeoff weight being above the maximum gross weight limit placed the aircraft outside the approved CG envelope (Figure 5).

Dimona CG envelope showing the approximate longitudinal CG position for G-CIMC on the accident flight

<sup>7</sup> Aircraft empty weight 585.6 kg + pilot 75 kg + passenger 113 kg + recovered fuel 18 kg = 791.6 kg.

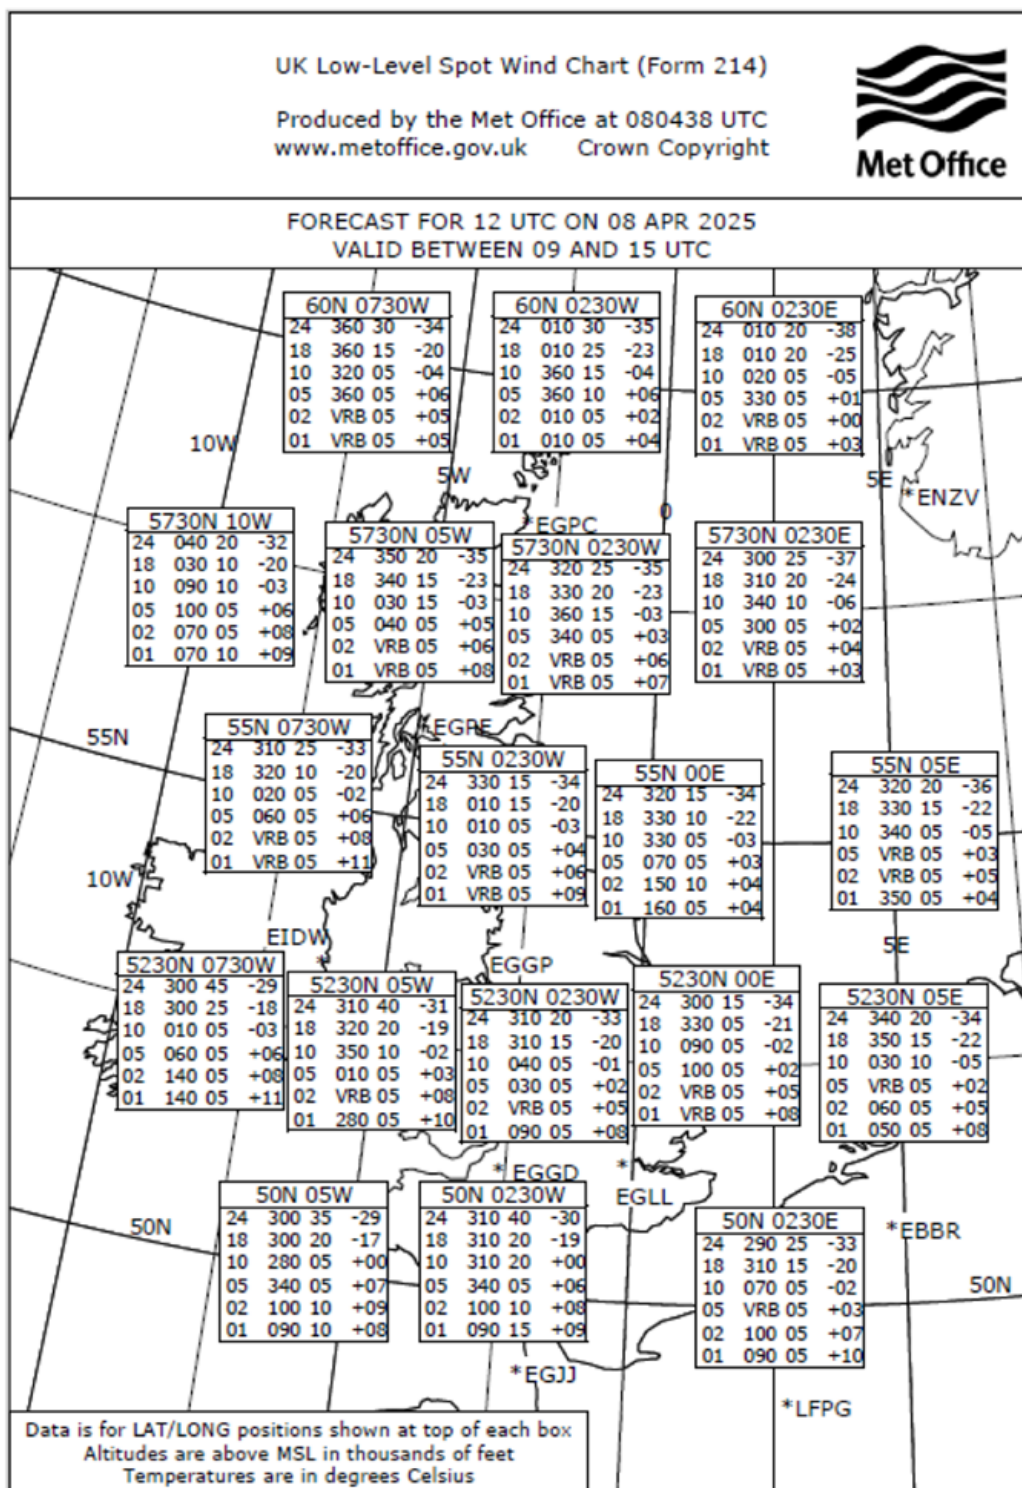
Figure 6 reproduces the UK low-level spot wind forecast (Form 214) for 1200 hrs on 8 April 2025 which was published by the Met Office and valid for the period 0900-1500 hrs. Darley Moor Airfield's location is approximately 53°N/001°45'W. Interpolation using the spot wind tables around that latitude and longitude indicated that below 5,000 ft the mean wind speed was forecast to be 5 kt. The wind direction would have been variable, most likely trending from an easterly, rather than westerly, direction. At 1020 hrs East Midlands Airport, 17 nm south-east of Darley Moor, reported their surface wind as 080°(variable between 030° and 170°)/5 kt. An automatic weather recording station 18 miles east of Darley Moor recorded wind velocities of 110°/5 kt at 1000 hrs and 080°/6 kt 1100 hrs.

Met Office Form 214 valid between 0900 and 1500 on 8 April 2025

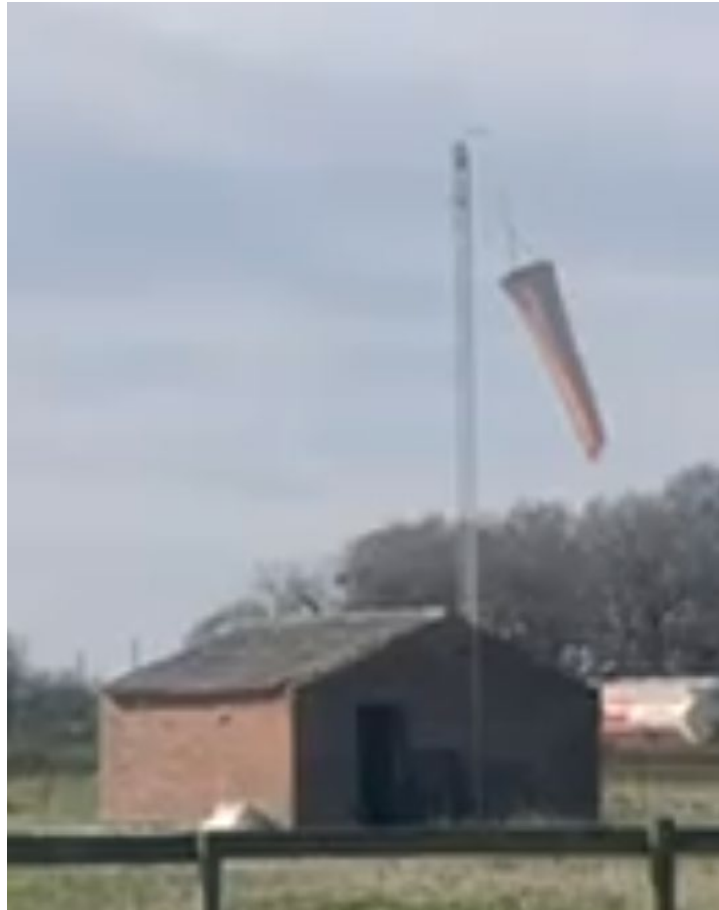
**Figure 7**

in the immediate vicinity of the airfield but was provided with video evidence of the local environmental conditions, filmed approximately 10 minutes after the accident. Figure 7 is a screenshot from that video, captured when the camera was facing in a south-south-westerly direction towards the airfield windsock. Referencing the fence in the foreground which is aligned approximately east-west, this image indicates the surface wind was easterly at around 5 kt when the video was taken.

Screenshot showing airfield windsock at approximately 1035 hrs on 8 April 2025

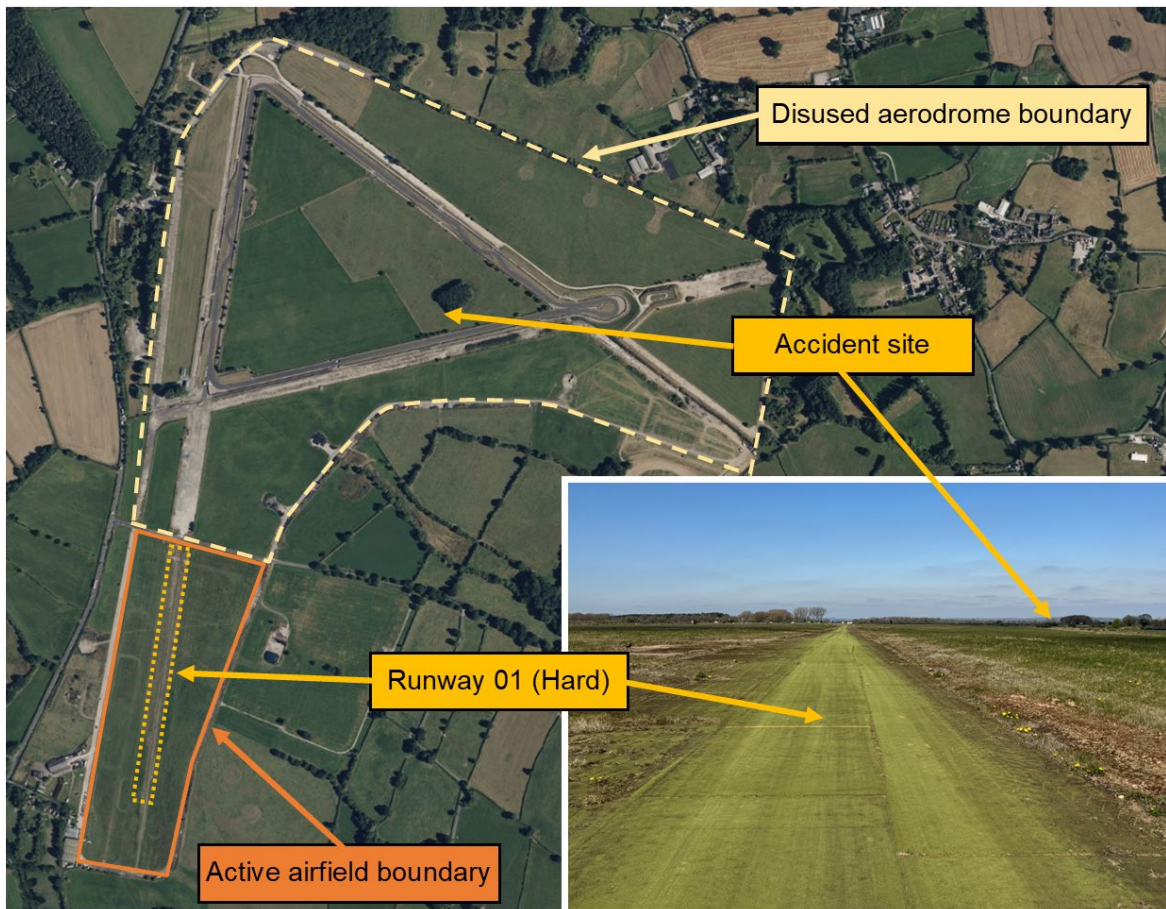
**Figure 8**

Overview of Darley Moor Airfield with inset view from threshold of Runway 01 (Hard)  
(Satellite imagery ©Vexcel Imaging)

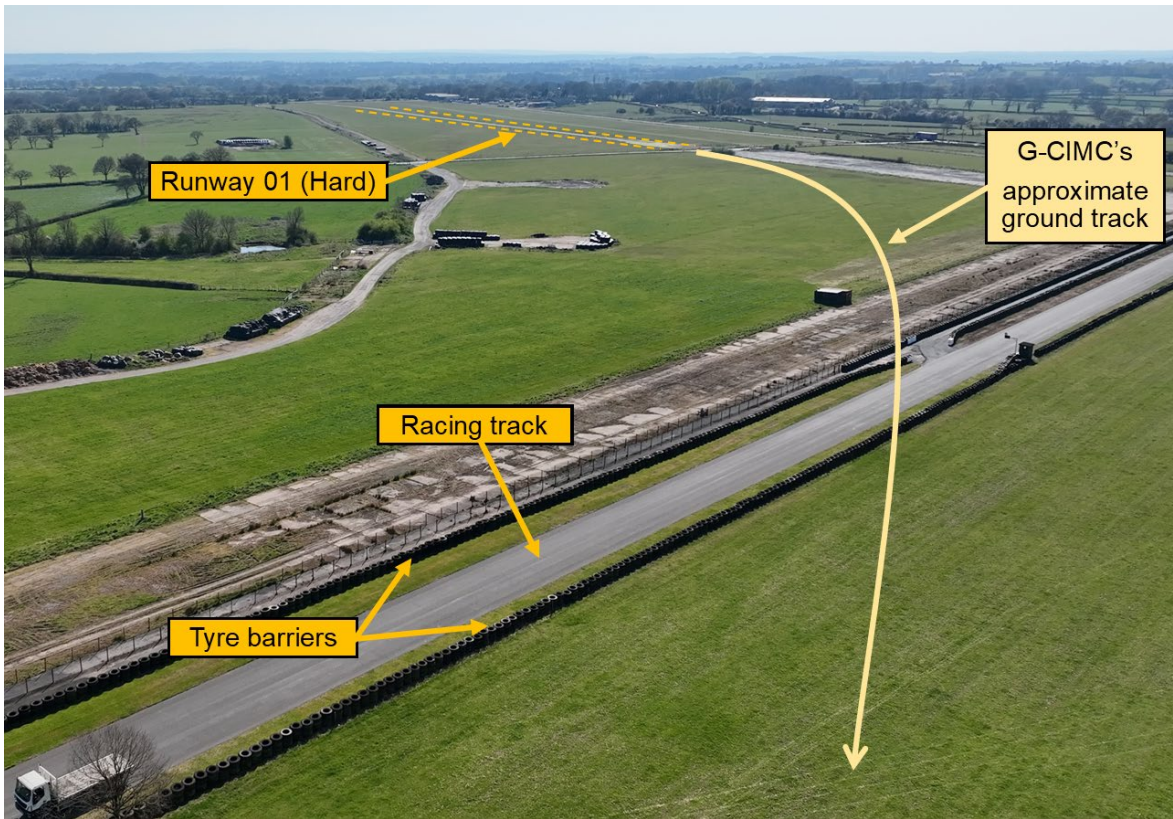
**Figure 9**

The active track of the racing circuit is bounded on both sides by barriers made from used vehicle tyres. These tyres form contiguous semi-solid structures which a pilot would ideally need to avoid during any forced landing attempt (Figure 9). Nonetheless, taking off in the Runway 01 direction there are several open grass areas within the bounds of the disused aerodrome suitable for emergency landings (Figure 10).

View towards airfield from above the accident site

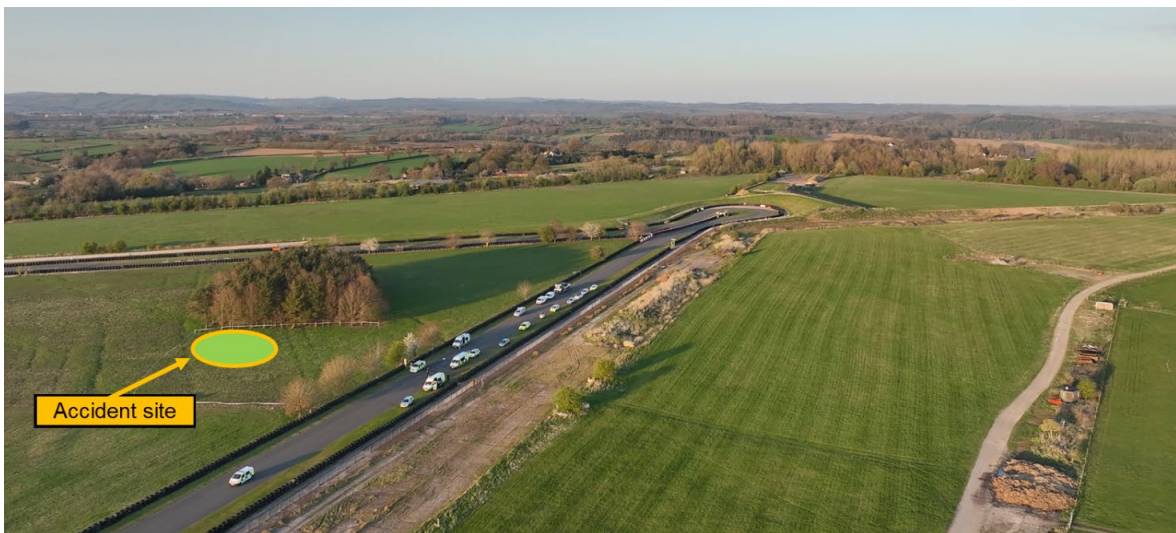
**Figure 10**

View looking north-east past the accident site

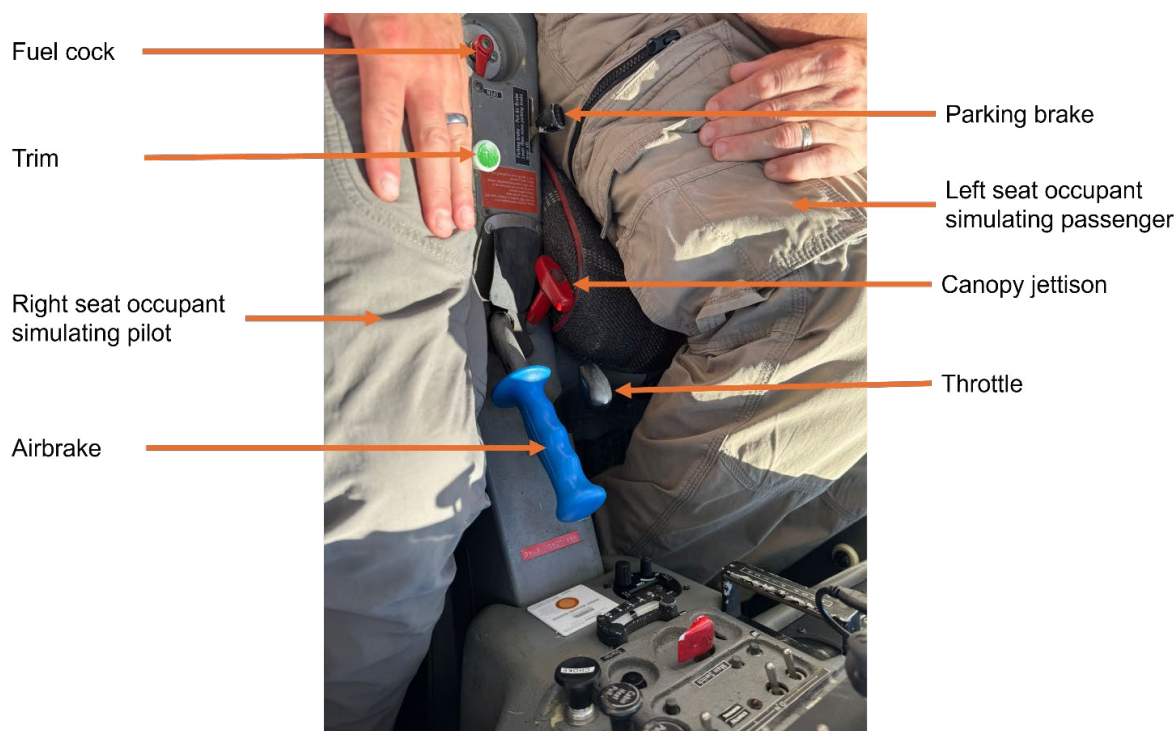
**Figure 12**

No instruments, switches or controls on the main cockpit panels were visually or physically obscured including the propeller pitch control, rpm indicator, air speed indicator and the choke (Figure 12).

Position of controls on the centre console (picture taken from above instrument panel looking towards the rear of the aircraft)

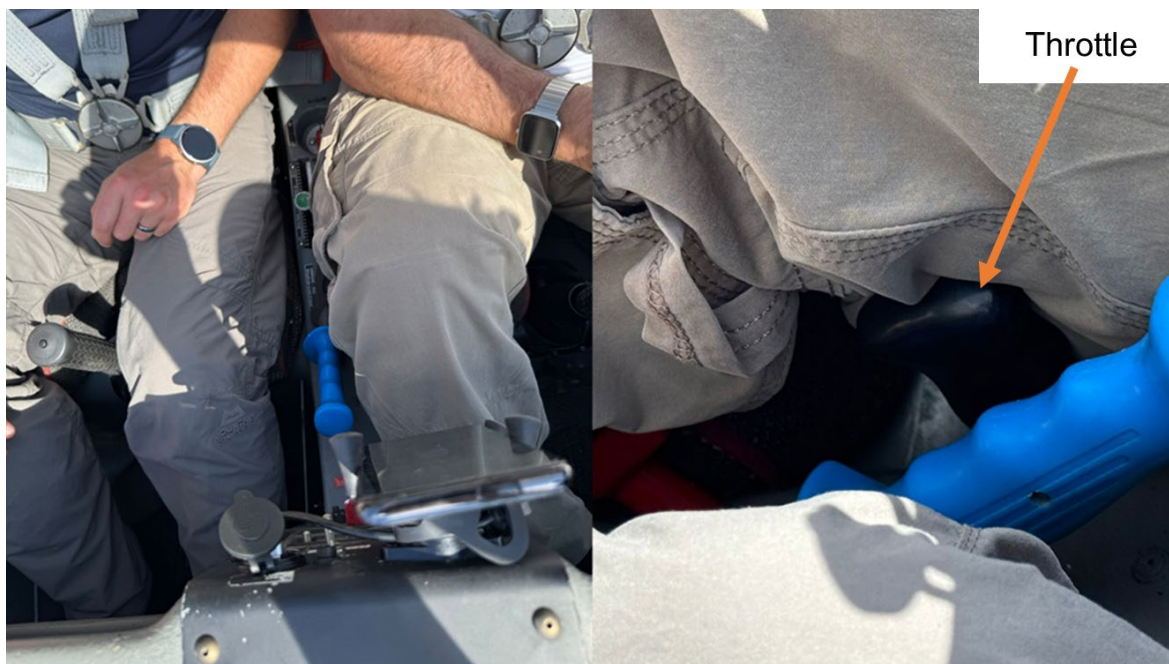
**Figure 13**

When the participants were seated in a relaxed posture, all controls on the lower centre console were fully or partially visually obscured and the controls on the left side of the centre console were partially physically obstructed by the right leg of the person in the left seat. Moving their right leg to the left to avoid obstructing these controls, resulted in fouling of the control column.

In particular, the throttle control was positioned in the crook of the left seat occupant's knee and inadvertent movement was possible, for example if moving the legs to avoid obstructing the rudder pedals (Figure 13). The airbrake control was not obstructed or at risk of inadvertent operation due to its length and direction of movement.

Obstruction of controls on the centre console
