**Serious Incident**

| <b>Aircraft Type and Registration:</b> | Piper PA-22-108, G-ARNE | |
| <b>Nature of Damage:</b> | Left aileron partly detached from the wing | |

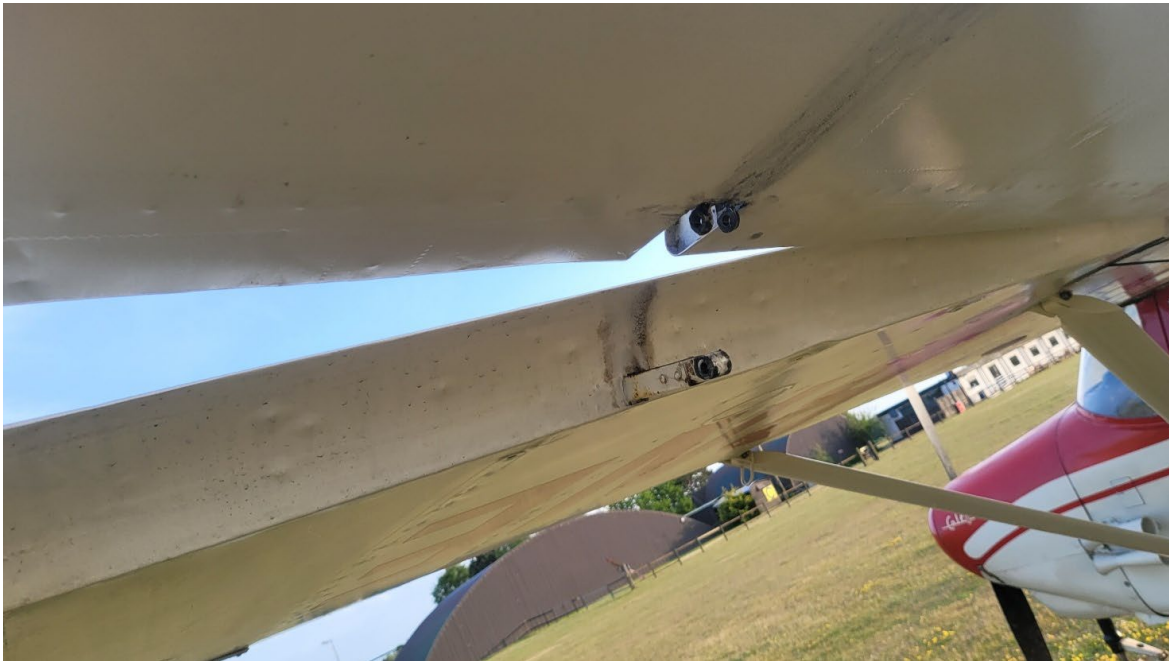
**Figure 1**

Subsequent assessment of the aircraft identified that the left outboard aileron hinge clevis pin was missing (Figure 1). It was also noted that the hinge bracket through which the clevis pin fitted was worn.

G-ARNE left aileron outboard hinge with missing clevis pin (reproduced with permission)

Although the left aileron outboard clevis pin was missing, the wear identified on both sets of hinge brackets and the presence of a non-standard clevis pin fitted to the right outboard aileron hinge suggests that the left outboard aileron clevis pin had been replaced. With the hinge brackets showing signs of wear, it is likely that oversized replacement clevis pins were manufactured, or non-standard pins found, to fit the worn hinge holes and negate the need to replace the hinge brackets.

Given the absence of the clevis pin, it was not possible to determine whether it was missing because the split pin had been lost, allowing the clevis pin to migrate out of the hinge, or if the clevis pin itself had failed. However, the fitment of non-standard parts in place of those specified by the aircraft manufacturer may have led to the loss of the clevis pin.

This event serves as a reminder to ensure that when maintaining aircraft the correct parts are used.

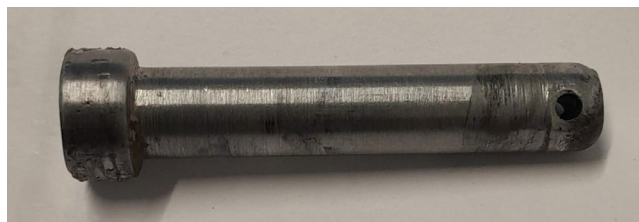
**Figure 2**

Assessment by the aircraft repair organisation identified that the equivalent clevis pin on the right aileron was a non-standard part (Figure 2) and had a larger diameter than the part specified by the aircraft manufacturer (Figure 3), and that the hinge bracket was also worn.

Non-standard part fitted to the right outboard aileron hinge on G-ARNE

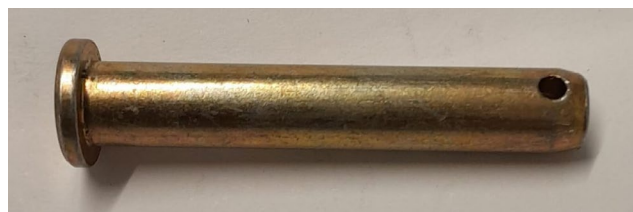
**Figure 3**

Unused clevis pin, part number AN394-41 that should be fitted to PA-22-108 aileron hinges
