# ***AAIB Bulletin***

***4/2026***

<b>Aircraft Type and Registration:</b>	Bristell NG5 Speed Wing, G-STEL	
<b>No &amp; Type of Engines:</b>	1 Jabiru 3300A piston engine	
<b>Year of Manufacture:</b>	2013 (Serial no: LAA 385-15235)	
<b>Date &amp; Time (UTC):</b>	20 May 2025 at 0842 hrs	
<b>Location:</b>	Near Gordon, Berwickshire	
<b>Type of Flight:</b>	Private	
<b>Persons on Board:</b>	Crew - 1	Passengers - None
<b>Injuries:</b>	Crew - 1 (Fatal)	Passengers - N/A
<b>Nature of Damage:</b>	Aircraft destroyed	
<b>Commander's Licence:</b>	Private Pilot's Licence (Aeroplanes) (Microlights Only)	
<b>Commander's Age:</b>	59 Years	
<b>Commander's Flying Experience:</b>	795 hours (of which 32 were on type) Last 90 days - 17 hours Last 28 days - 6 hours	
<b>Information Source:</b>	AAIB Field Investigation

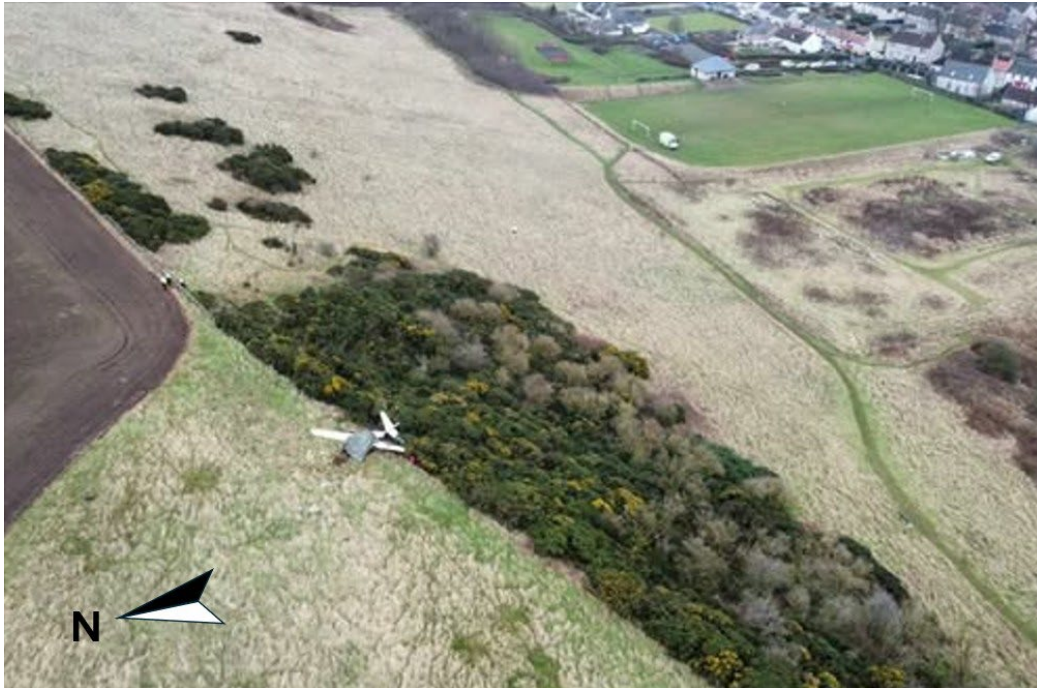
**Figure 1**  
Accident site

N4698W struck an area of rising ground to the north of Kinglassie (Figure 1) with low forward speed and a high rate of descent. The left wing was more damaged than the right wing, indicating that the aircraft was in a shallow left roll attitude at impact. The landing gear was in the UP position. The propeller was in fine pitch and had stopped with one blade folded rearwards, beneath the nose, with the other two blades intact without any impact marks, consistent with the propeller windmilling whilst not being driven under power by the engine at impact. No fire had occurred. It was not possible to reliably determine the pre-accident positions of the magneto switch and fuel selector valve.

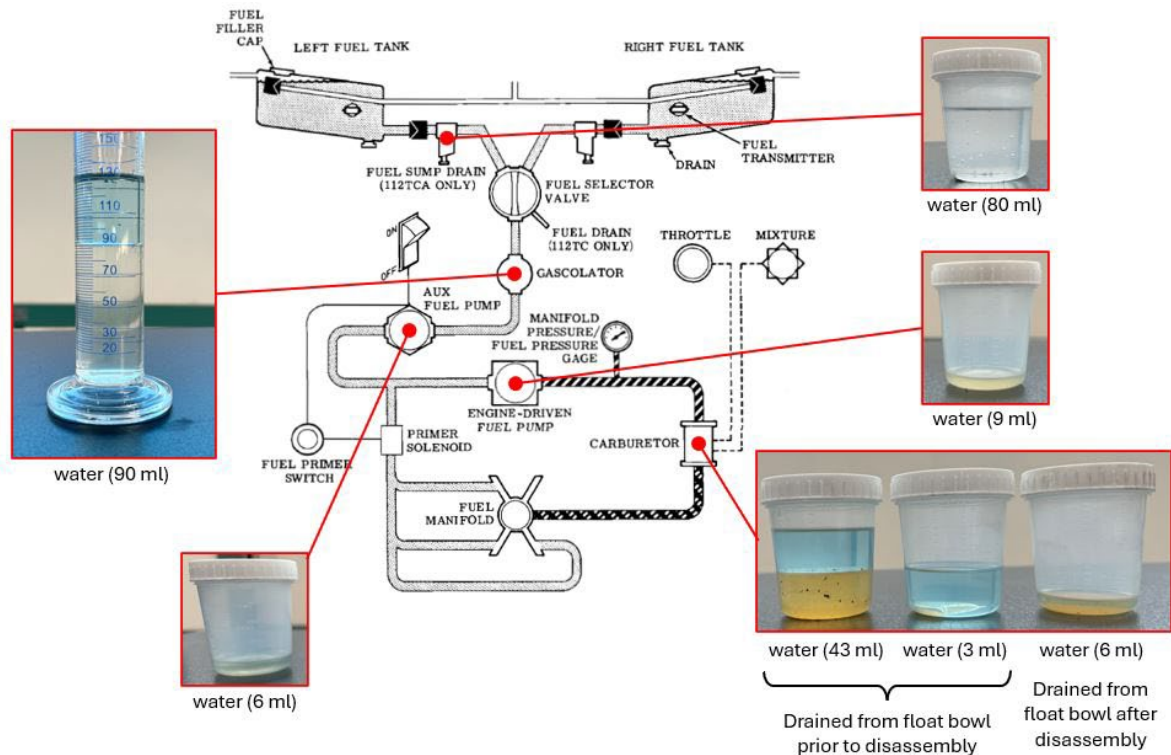
**Figure 5**

Water recovered from the aircraft's fuel system (fuel system diagram courtesy of Commander Aircraft Corp)

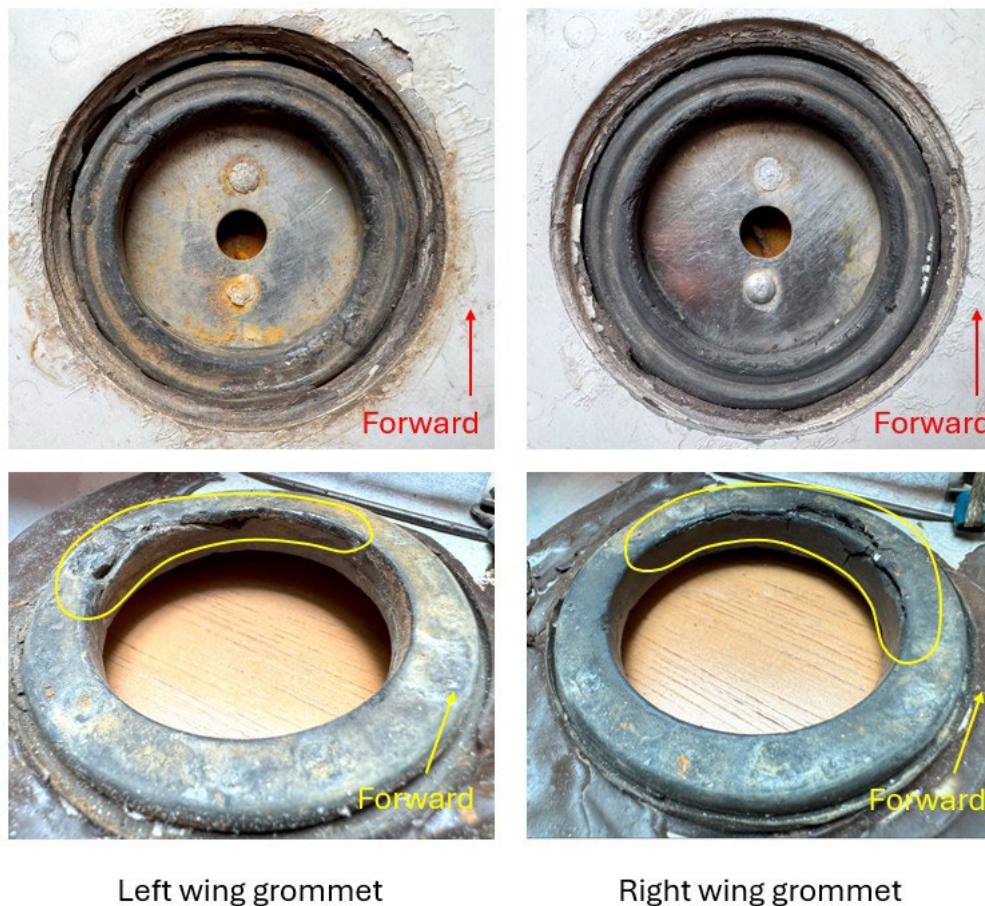
**Figure 6**

The wing fuel filler rubber grommets were visually examined. When viewed from above the wing, both grommets had visible surface cracking (Figure 6). The grommets had also taken on a permanent deformation where a raised section on the lower side of the filler cap had been pressed into the grommet when the caps were in the locked down position. This permanent deformation was caused by age-related hardening of the grommet's rubber material. As the section of wing skin around the filler aperture was cut away for access after the accident, it was possible to also view the lower surface of the grommets. The lower surfaces of both grommets had large cracks present, outlined in yellow in Figure 6, and some of the grommet material was missing.

Visual condition of the fuel filler rubber grommets (upper surface of grommet shown above, lower surface shown below)

Further, one Safety Recommendation is made to Commander Aircraft Corporation to amend the aircraft maintenance manuals to provide specific inspection criteria for the acceptable condition of fuel tank rubber grommet seals.

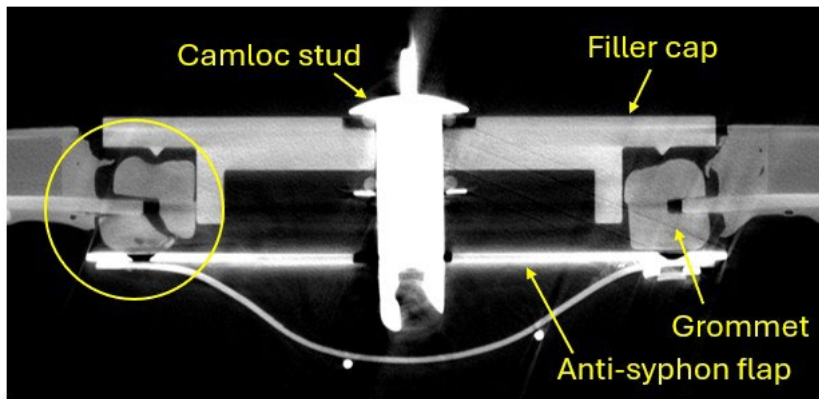
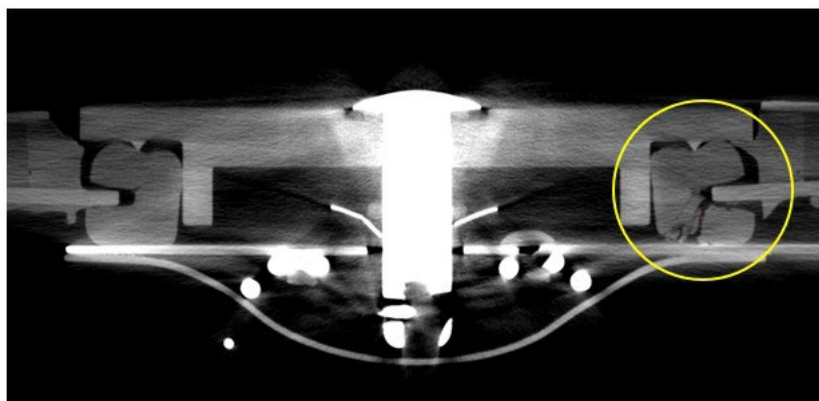
**Figure 7**

Left wing filler cap – loosely inserted

Right wing filler cap – locked position

CT X-ray images of the left and right fuel filler cap assemblies, showing through-thickness cracking (circled yellow) of the rubber grommet seals

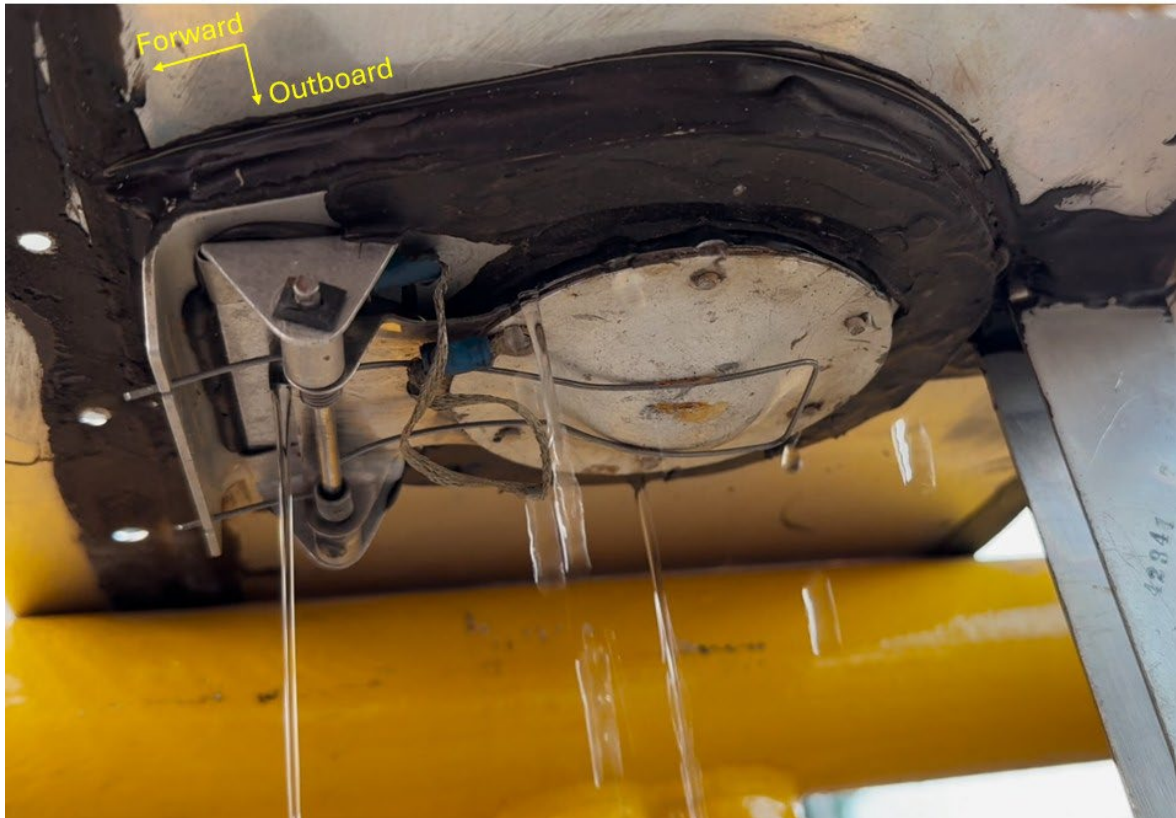
**Figure 8**

The right filler cap assembly was locked down and checked for leakage when water was applied to the upper wing skin. No leakage occurred when water was applied locally to the Camloc stud, showing that the O-rings replaced in July 2024 created an effective seal between the stud and the filler cap. When water was applied to the whole filler cap assembly, significant leakage past the filler cap was observed (Figure 8). It was not possible to conduct a similar leakage test on the left filler cap assembly due to the broken Camloc stud retaining wire.

Water leaking past the right filler cap seal when exposed to water, supported on trestles and viewed from below

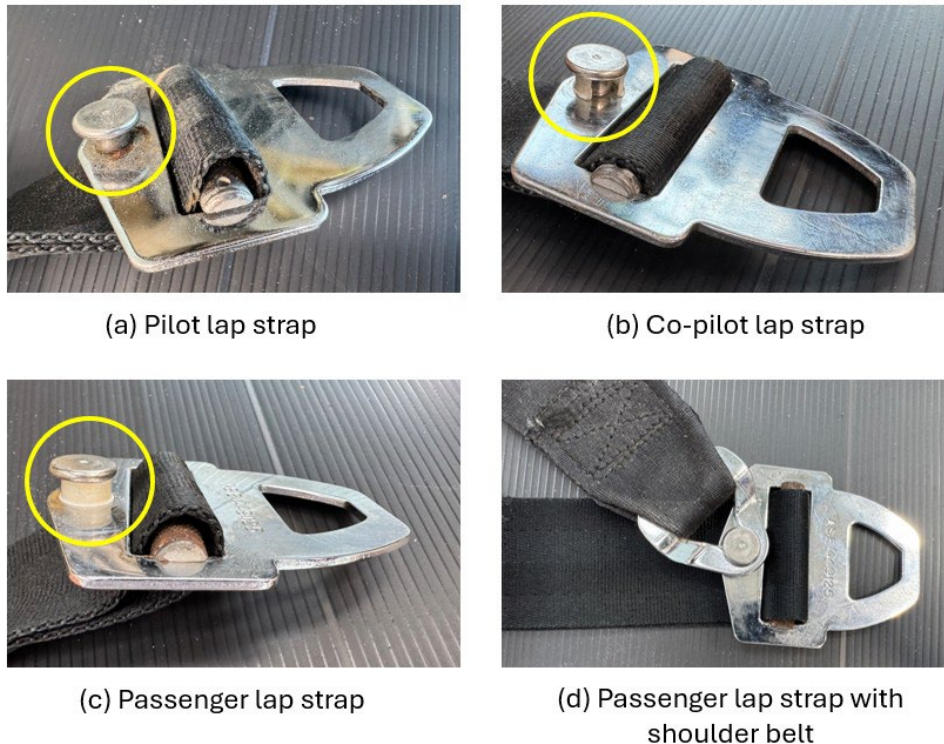
**Figure 9**

The aircraft was fitted with AmSafe three-point seat belts for all occupants. It was noted that the plastic collar on the pilot's lap strap buckle pin was missing (Figure 9 (a)). This collar is designed to provide a positive 'snap' location of the single shoulder strap where it attaches to the lap strap buckle pin, to prevent the shoulder strap from becoming inadvertently detached from the lap strap. Despite the missing collar, the pilot's shoulder strap had

remained attached to the lap belt during the accident. The co-pilot lap strap buckle had a plastic collar fitted, but this was cracked and loose on the pin (Figure 9 (b)). The passenger lap belts had plastic collars fitted and these were in good condition (Figure 9 (c) and (d)).

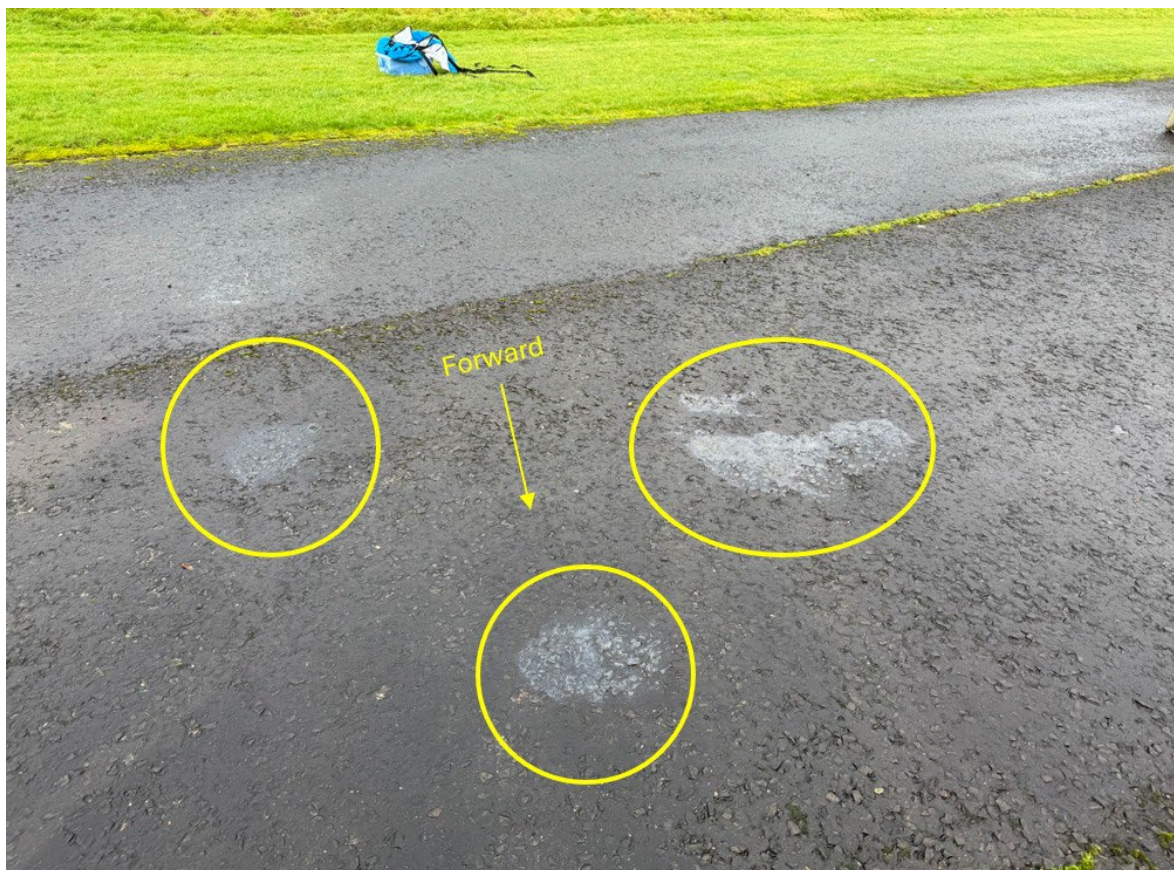
**Figure 13**

A photograph of the apron area where N4698W had been parked was taken in the morning of the day after the accident by the AAIB (Figure 13). This photograph showed a triangular pattern of fuel staining at a similar spacing and orientation to the aircraft's wheel well fuel drains and firewall-mounted fuel gascolator. No similar fuel staining was present outboard of the three fuel stain marks. Fife Airport had remained closed since the accident had occurred and no other aircraft had occupied this area of the apron since N4698W departed.

Fuel stain marks, circled in yellow, on the Fife Airport apron where N4698W had been parked

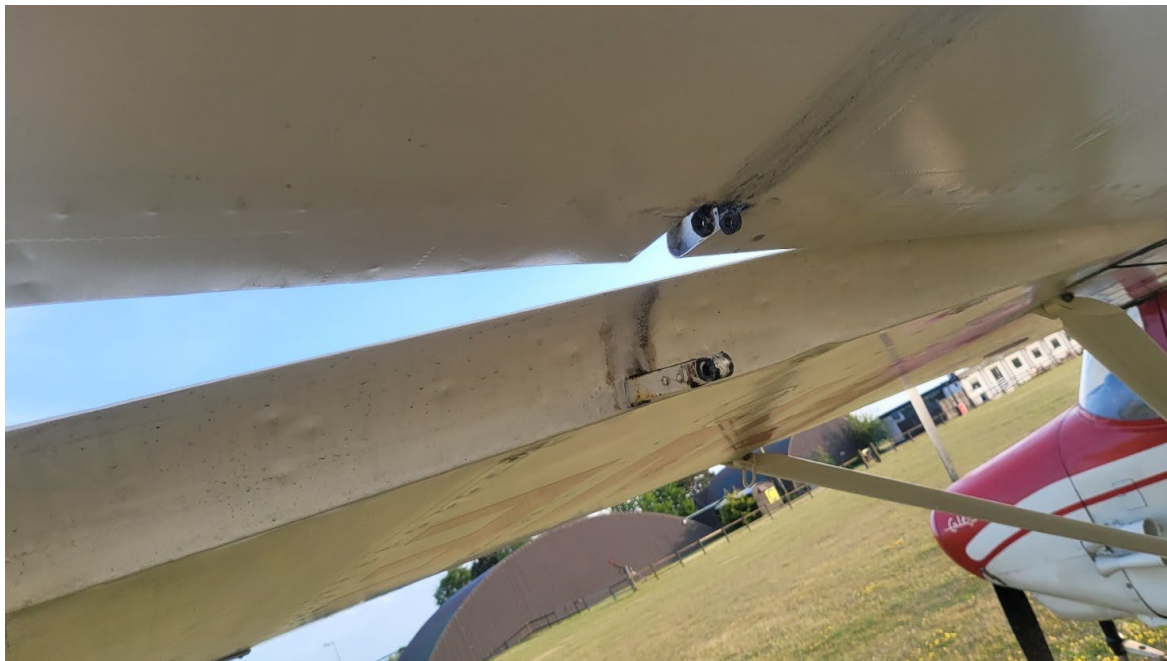
**Figure 1**

Subsequent assessment of the aircraft identified that the left outboard aileron hinge clevis pin was missing (Figure 1). It was also noted that the hinge bracket through which the clevis pin fitted was worn.

G-ARNE left aileron outboard hinge with missing clevis pin (reproduced with permission)

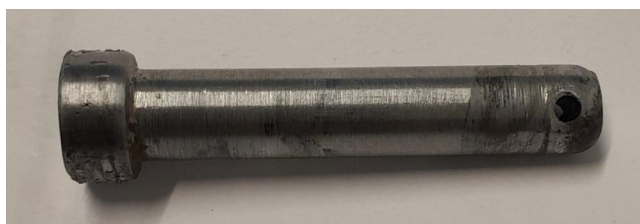
**Figure 2**

Assessment by the aircraft repair organisation identified that the equivalent clevis pin on the right aileron was a non-standard part (Figure 2) and had a larger diameter than the part specified by the aircraft manufacturer (Figure 3), and that the hinge bracket was also worn.

Non-standard part fitted to the right outboard aileron hinge on G-ARNE
