# Overspeed at Cambridge Junction, Hertfordshire, 11 December 2025

## Summary of the incident

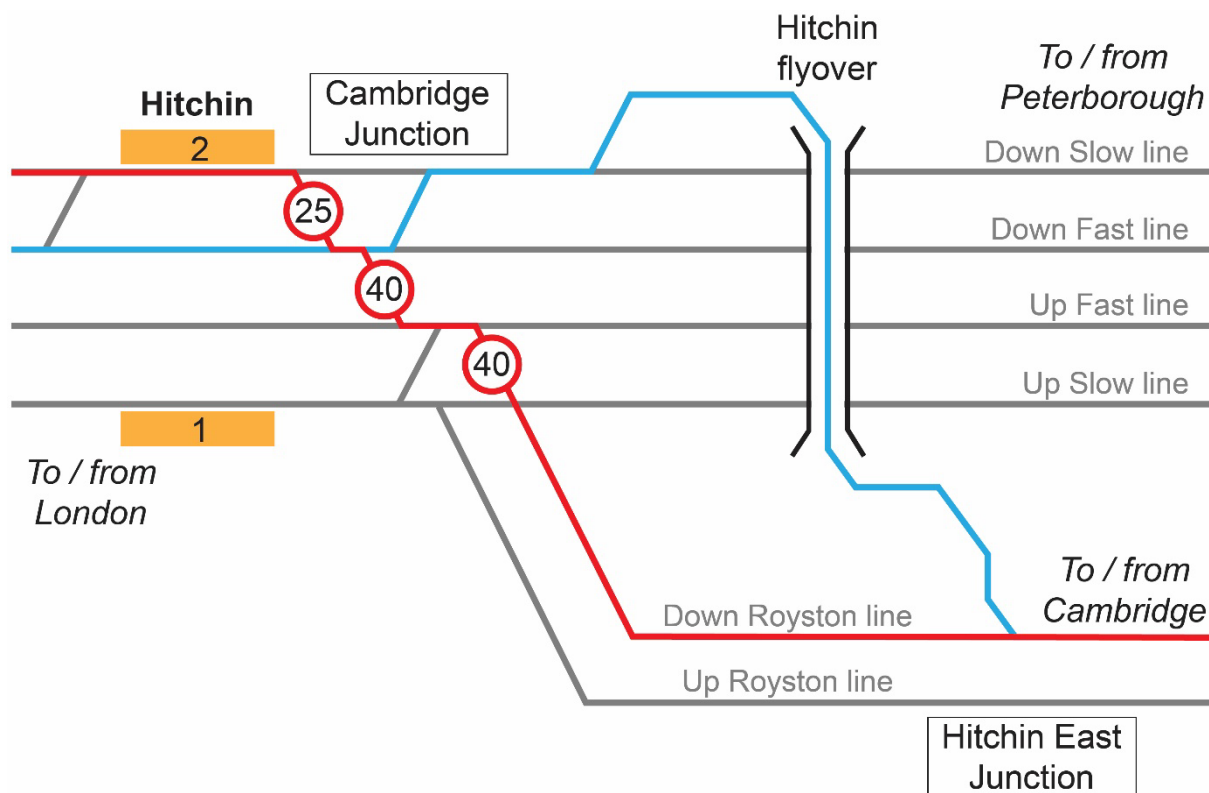
Train 1T20 was routed from the Down Slow line to take the diverging route over the junction towards Cambridge by passing over six sets of points and a switch diamond. For this route, the first two sets of points have a permanent speed restriction of 25 mph (40 km/h). The permanent speed restriction for the remainder of this route, over the other points and the switch diamond, is 40 mph (64 km/h). However, when the train began to traverse the first two sets of points it was travelling at 56 mph (90 km/h) instead of 25 mph (40 km/h).

Track layout at Cambridge Junction with path taken by train 1T20 shown in red and its timetabled path shown in blue.

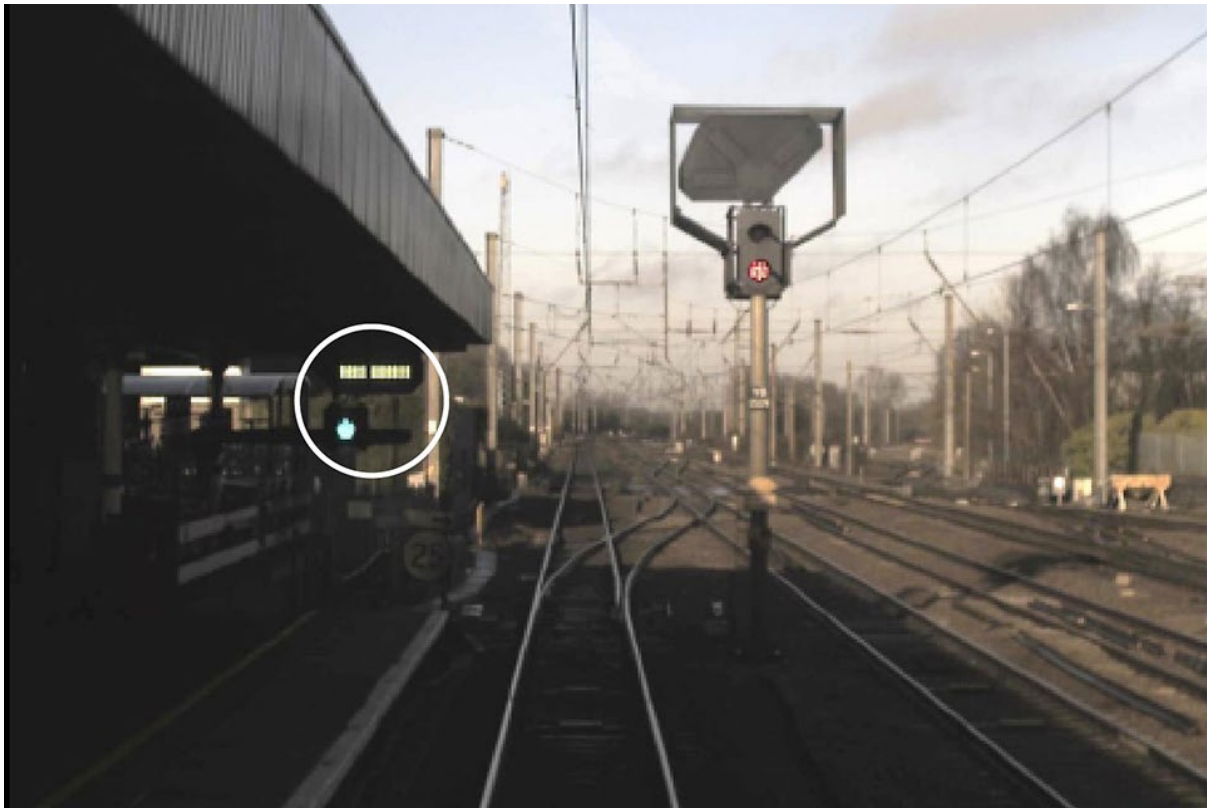
**Forward-facing CCTV image from the incident train showing YB1507 signal on the left displaying a green aspect and its junction indicator with a position 5 indication (circled in white). YB1509 signal next to the track on the right is displaying a red aspect and applies to the adjacent Down Fast line (courtesy of Great Northern).**

The location of YB1507 signal and its junction indicator under the station canopy means they are positioned lower down than normal (as can be seen when compared to YB1509 signal). The sighting assessment noted that the top part of the position 1 and 4 indications might not be visible to drivers on the approach to the signal, when between 280 and 180 metres from it. This was due to the station canopy support being in the way. However, the assessment concluded that more than the minimum viewable proportion of these position 1 and 4 indications, as required by railway group standards, would remain visible throughout. During this incident, the position 5 indication was lit, so was fully visible to the driver throughout.

At 10:43, the driver called the signaller again to report that they had crossed the junction at too high a speed. The driver explained that they had misread the junction indicator and thought it had been displaying a position 1 indication instead of a position 5 indication. The signaller instructed the driver to bring their train to a stand at Royston station while they spoke to control to decide what to do next. After speaking to control staff, the driver was authorised to continue to Cambridge station where they were relieved by another driver.

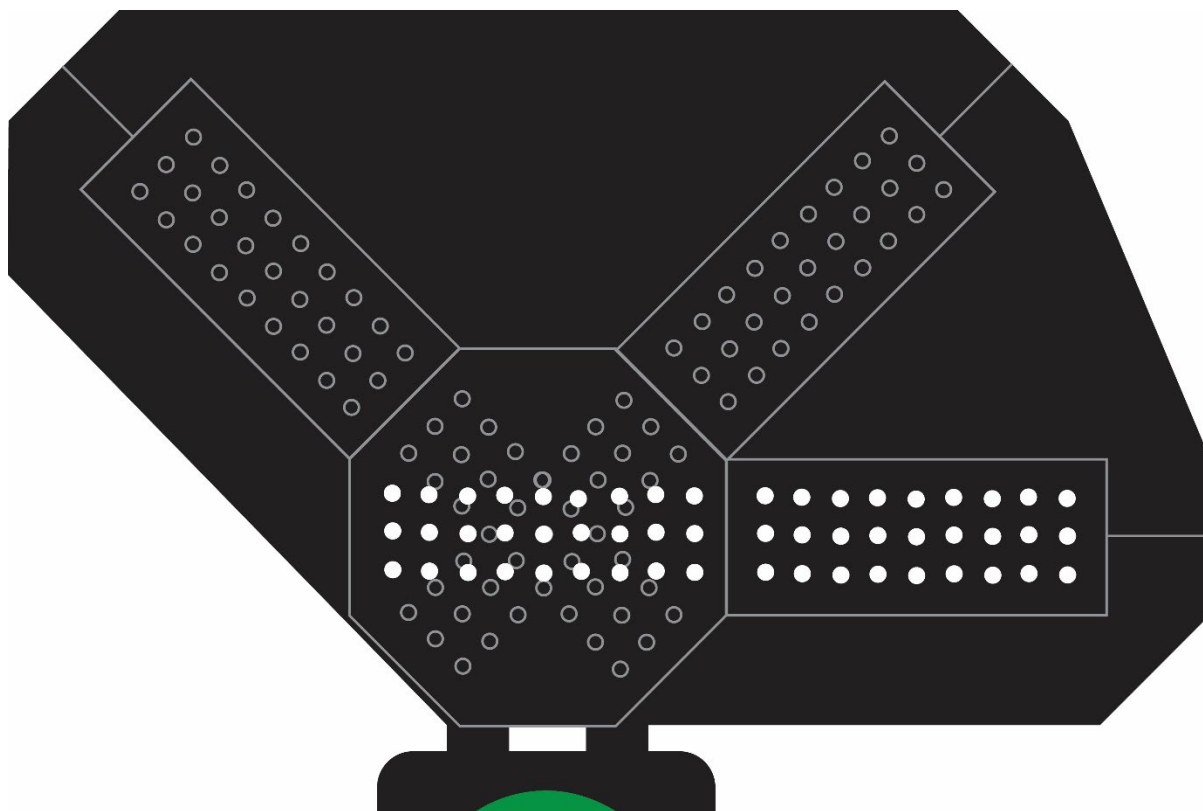
At junctions where there is more than one line for a train to take, the signalling system provides drivers with information about which route the train will be taking. At Cambridge Junction, relevant signals are fitted with junction indicators to provide this information. The type fitted to YB1507 signal is an LED style junction indicator, which can display position 1, 4 and 5 indications using a matrix of white LEDs. The position 1 indication is for the route to go over the Hitchin flyover towards Cambridge, position 4 is to join the Down Fast line and go straight on towards Peterborough, and position 5 is to cross the junction to go towards Cambridge. When the junction indicator is unlit, this informs the driver that their train is routed to continue along the Down Slow line towards Peterborough.

**An LED style junction indicator displaying a position 5 indication.**
