# Derailment at Hopetown Junction, Darlington, 31 January 2026

## Summary of the accident

At around 13:19, a passenger train derailed, and then rerailed, at Hopetown Junction, near to Darlington North Road station. The train involved was a passenger charter service from Derby to Shildon. This was formed of a High Speed Train (HST) set owned by ROMIC Group and operated by Rail Adventure UK.

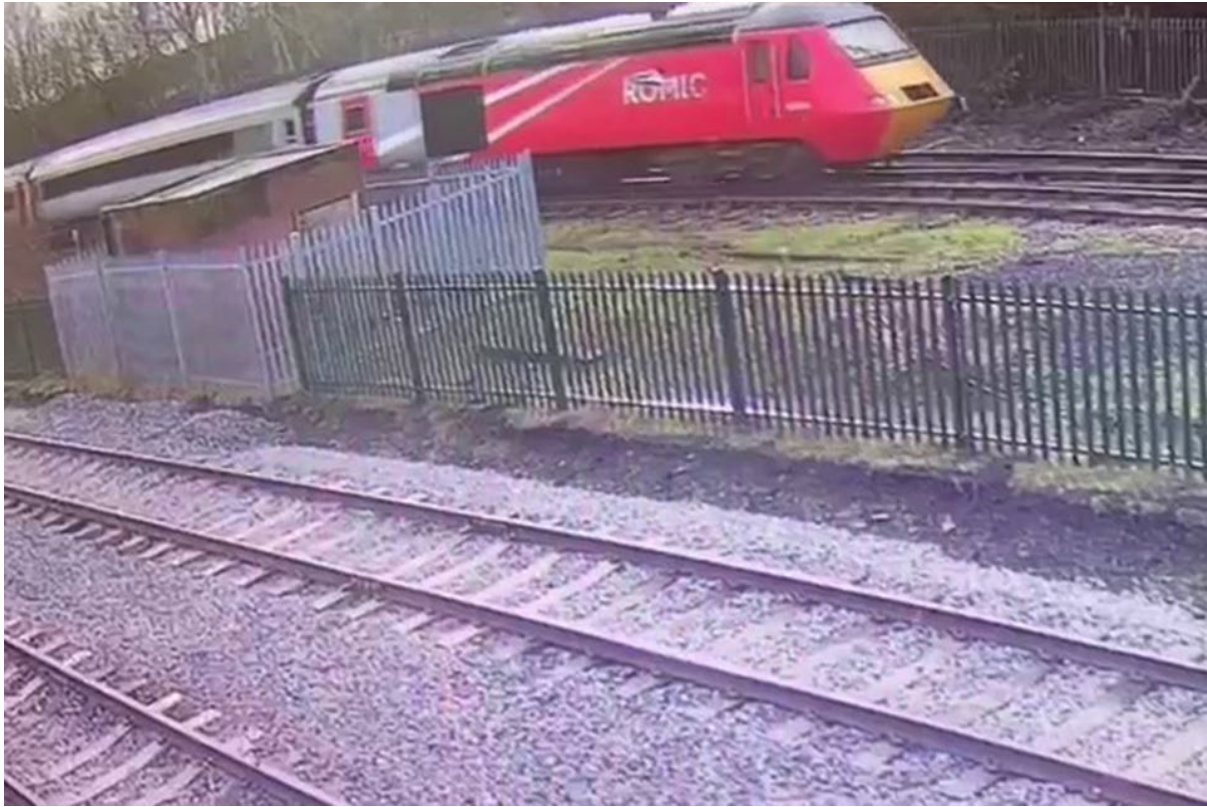
A subsequent examination of the train and track found evidence that several wheels had derailed, and then rerailed, within the length of the crossover at Hopetown Junction.

The train at the derailment location (courtesy of Darlington Railway Preservation Society).

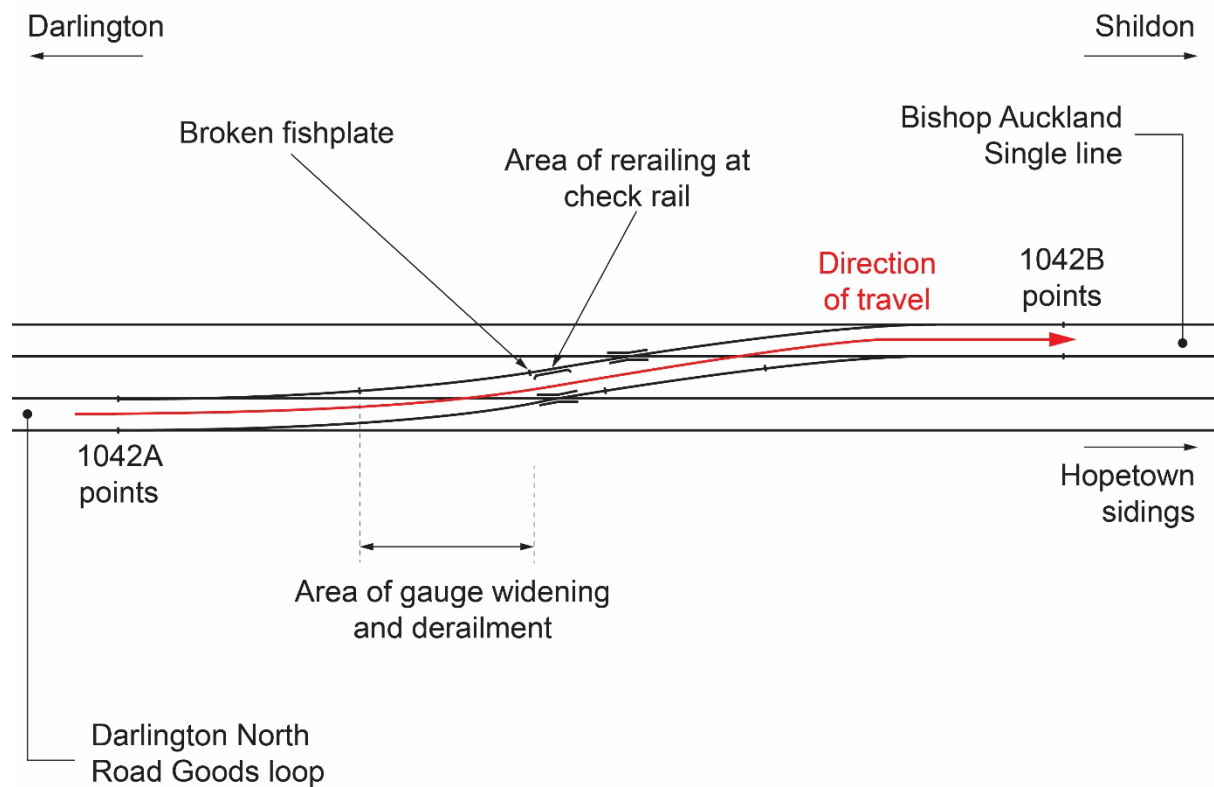
The track layout at Hopetown Junction.

When the derailment occurred, the train was moving from the Darlington North Road Goods Loop line, over crossover points 1042A and 1042B, onto the Bishop Auckland Single line. The subsequent examination by RAIB of the track showed that the sleepers through the points, in the immediate vicinity of the derailment, were in a poor condition.

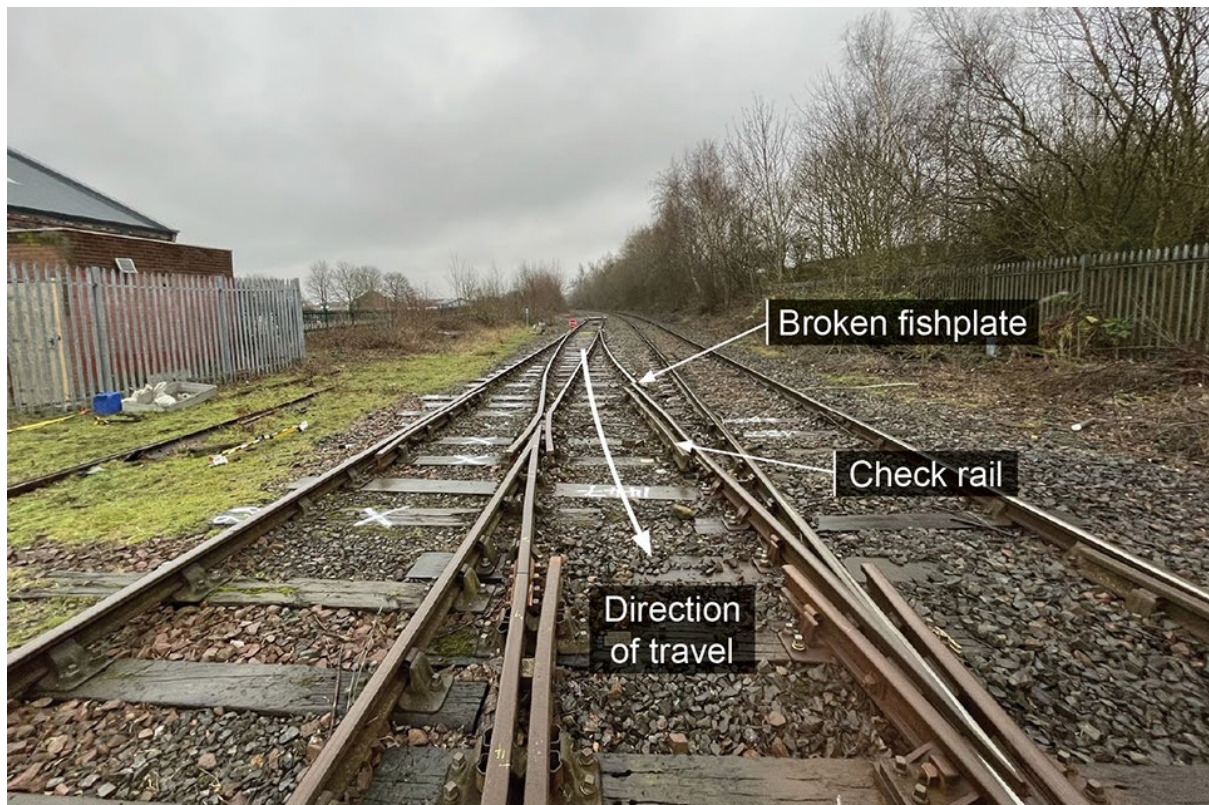
The derailment occurred because the track under the train failed, resulting in the rails spreading apart. This allowed several wheels to drop into the space between them, known as the 'four-foot'. A number of these derailed wheels then struck rail fastenings and a 'fishplate'. Fishplates are used to join two sections of rail together using bolts. The fishplate bolts failed in shear due to the derailed wheels striking the fishplate. The derailed wheels then struck rail fastenings adjacent to a length of check rail, and climbed back onto the railhead, allowing the train to continue running.

**Damage to the crossover after the derailment.**

RAIB examined the train after it had returned to the depot. A number of marks were found on several wheels. These were consistent with wheels dropping between the rails due to wide gauge, making contact with rail fastenings and a fishplate, and then climbing back onto the railhead. The marks were therefore considered by RAIB to be a result of the derailment. There was no evidence to indicate that the condition of the train contributed to the accident.

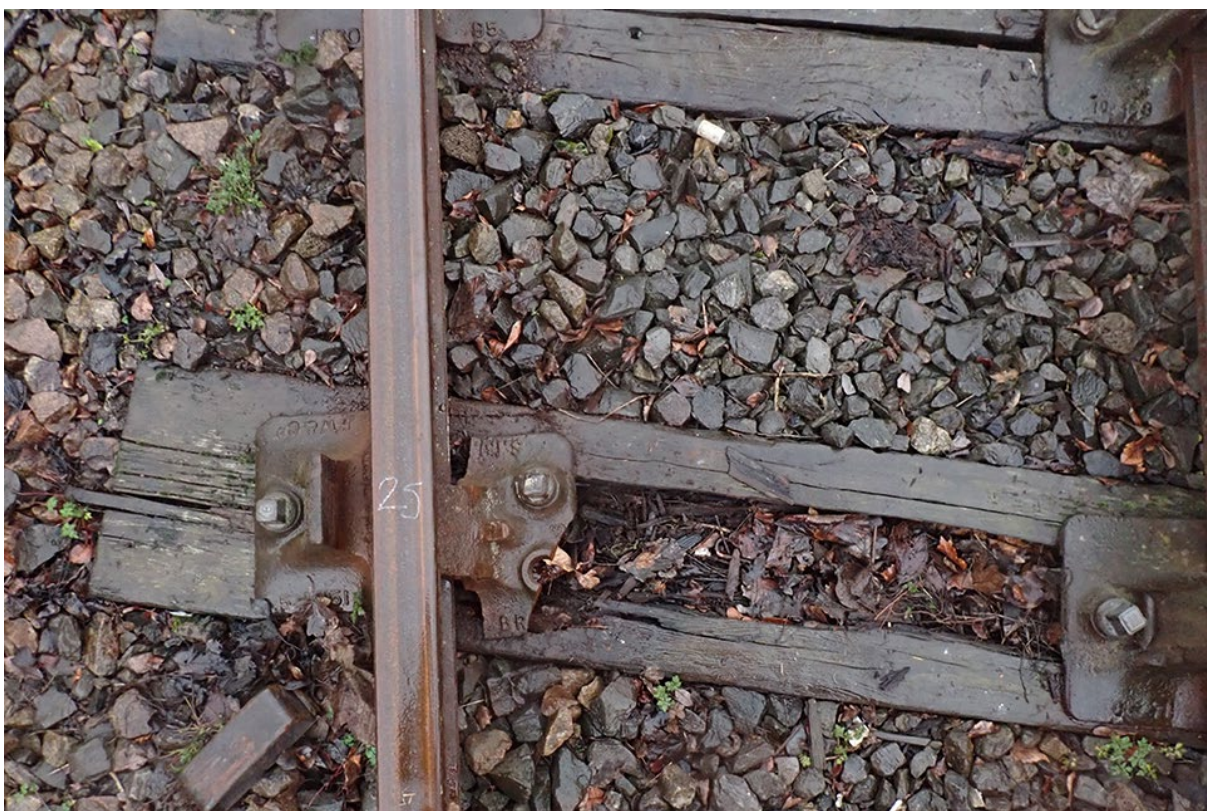
**A timber sleeper inside the crossover after the derailment, showing rotten wood and insecure rail fastenings.**

Several sleepers were split and decaying, with little solid timber into which the rail fastenings were secured. Some of the sleepers showed wear marks where the chairs, in which the rail was secured, had been experiencing lateral movement, known as 'shuffle'. This showed that the screws that secured them into the sleeper were insecure, probably because of the state of the timber.

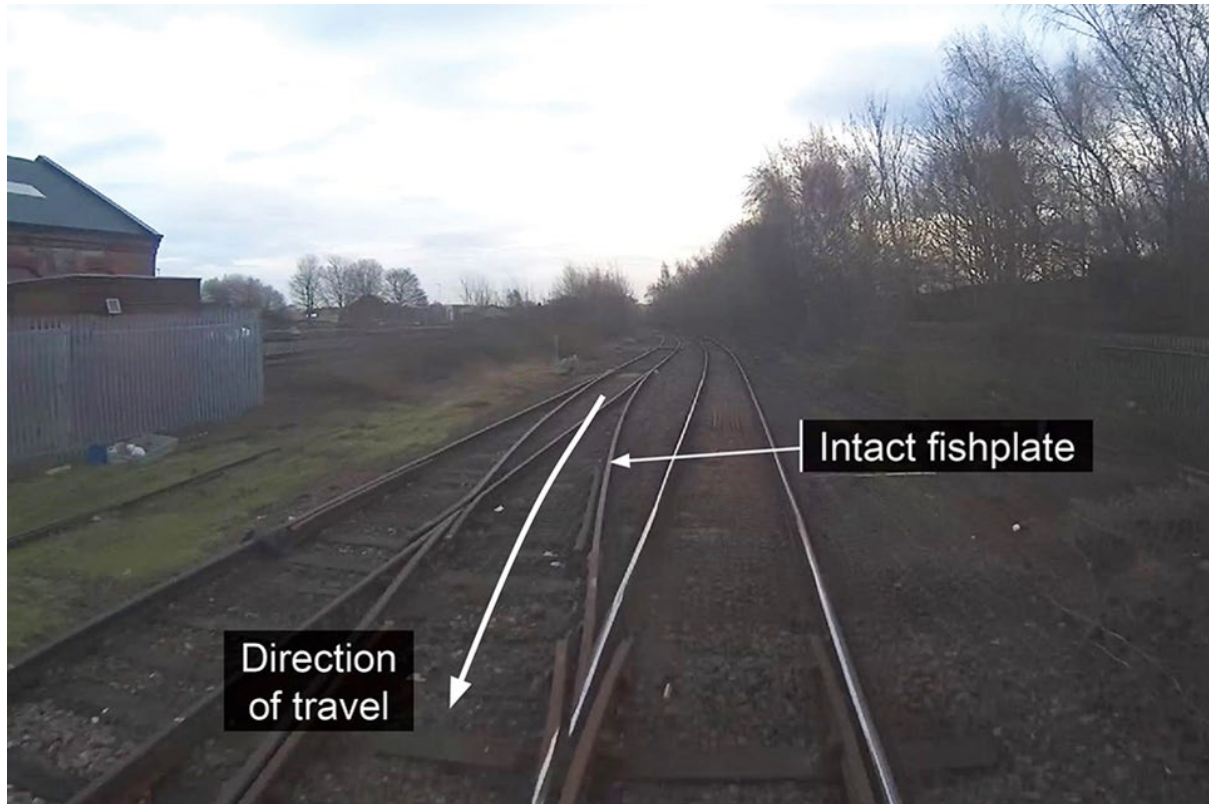
Footage from the video inspection vehicle on 14 January 2026 shows that the fishplate joint (the bolts from which were found to be broken after the derailment) was intact at that time. This strongly suggests that the fishplate bolts broke under the charter train, which was the next one to traverse the crossover.

**The crossover on 14 January 2026, showing fishplate joint still intact (courtesy of Network Rail).**
