Overspeed at Cambridge Junction, Hertfordshire, 11 December 2025

Rail Accident Investigation Branch

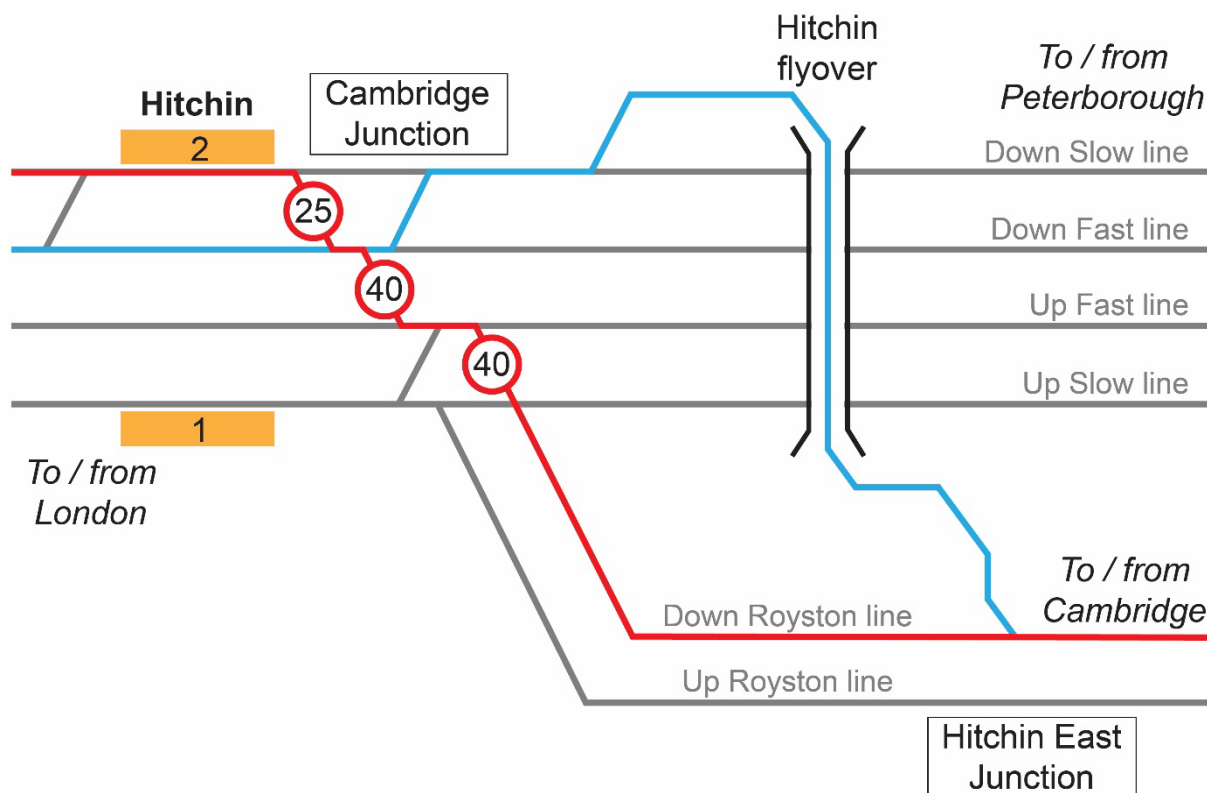
Train 1T20 was routed from the Down Slow line to take the diverging route over the junction towards Cambridge by passing over six sets of points and a switch diamond. For this route, the first two sets of points have a permanent speed restriction of 25 mph (40 km/h). The permanent speed restriction for the remainder of this route, over the other points and the switch diamond, is 40 mph (64 km/h). However, when the train began to traverse the first two sets of points it was travelling at 56 mph (90 km/h) instead of 25 mph (40 km/h).

Track layout at Cambridge Junction with path taken by train 1T20 shown in red and its timetabled path shown in blue.

The driver realised the train was traversing the junction and applied the train's brakes causing it to slow. By the time the train's rear carriage crossed the first two sets of points, the train was still travelling at 44 mph (71 km/h). When the front of the train had started to traverse the rest of the junction, it was travelling at 55 mph (89 km/h) although it had slowed to 42 mph (68 km/h) by the time the rear of the train reached this point.
