Rail Accident Investigation Branch

Rail Accident Report

Derailment at Denbigh Hall South Junction, near Bletchley, Buckinghamshire 26 June 2025

Report 04/2026
April 2026

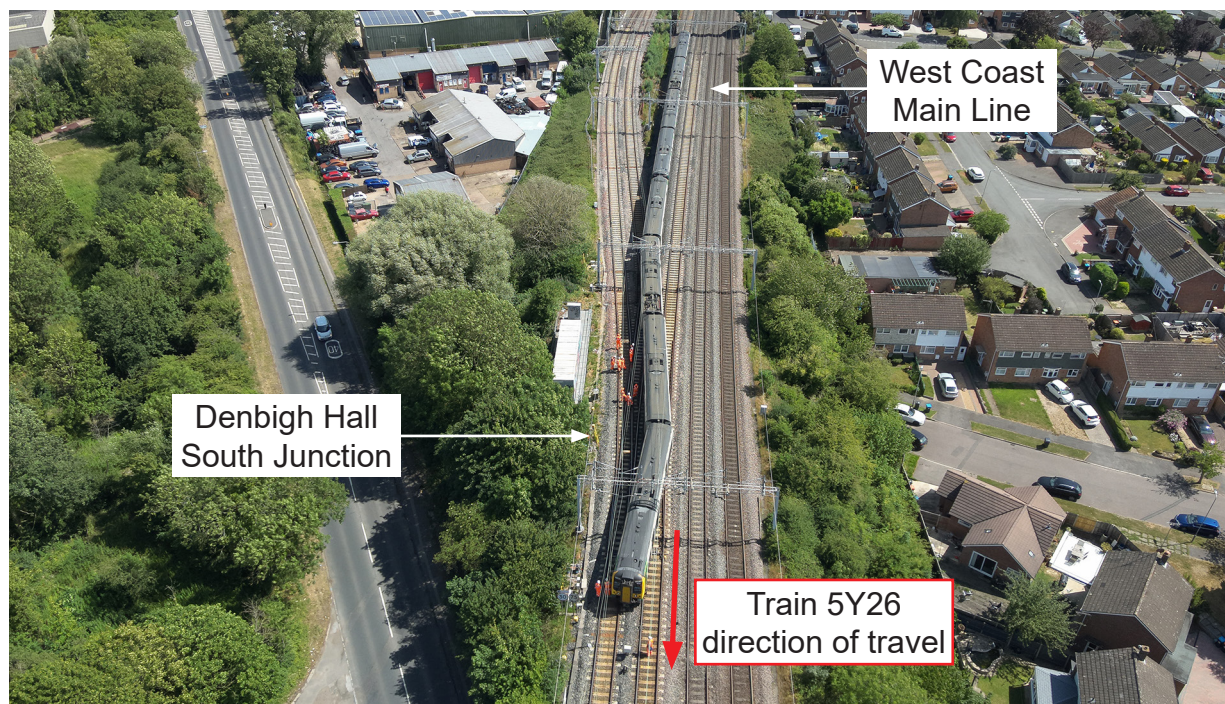
- 3 At about 12:27 on 26 June 2025, an out-of-service passenger train travelling at 15 mph (24 km/h) derailed as it passed over Denbigh Hall South Junction, on the West Coast Main Line (WCML), between Bletchley and Milton Keynes Central stations (figures 1 and 2).

Figure 2: The derailed train (courtesy of Network Rail with RAIB annotations).

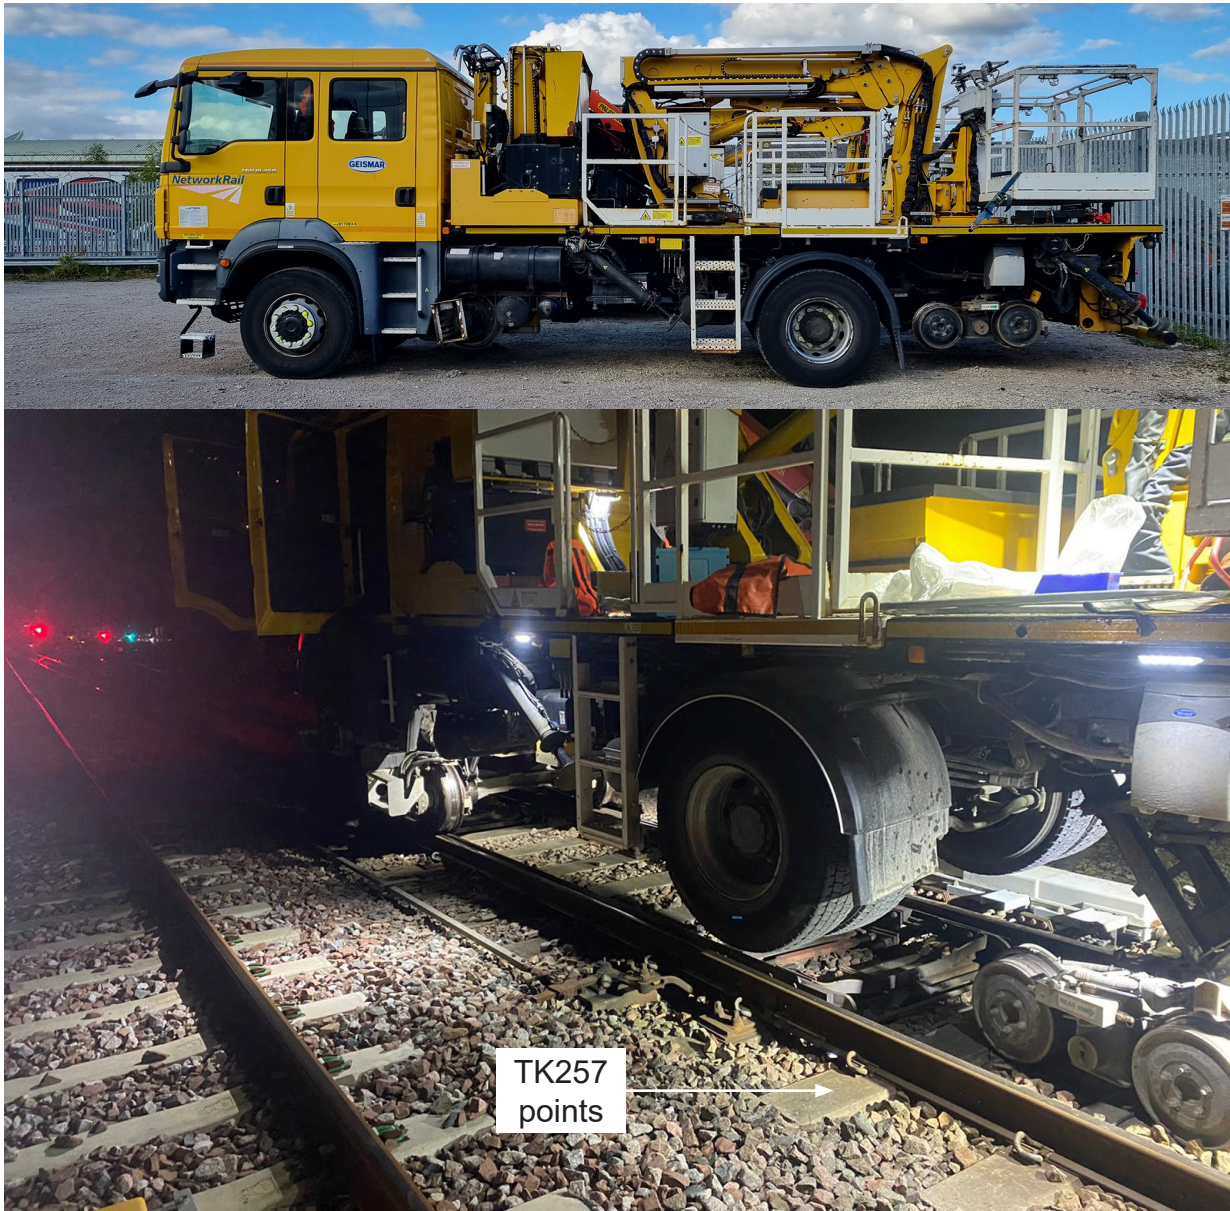
Figure 9: The road-rail vehicle type that ran through TK257 points and derailed (lower image courtesy of Network Rail with RAIB annotations).

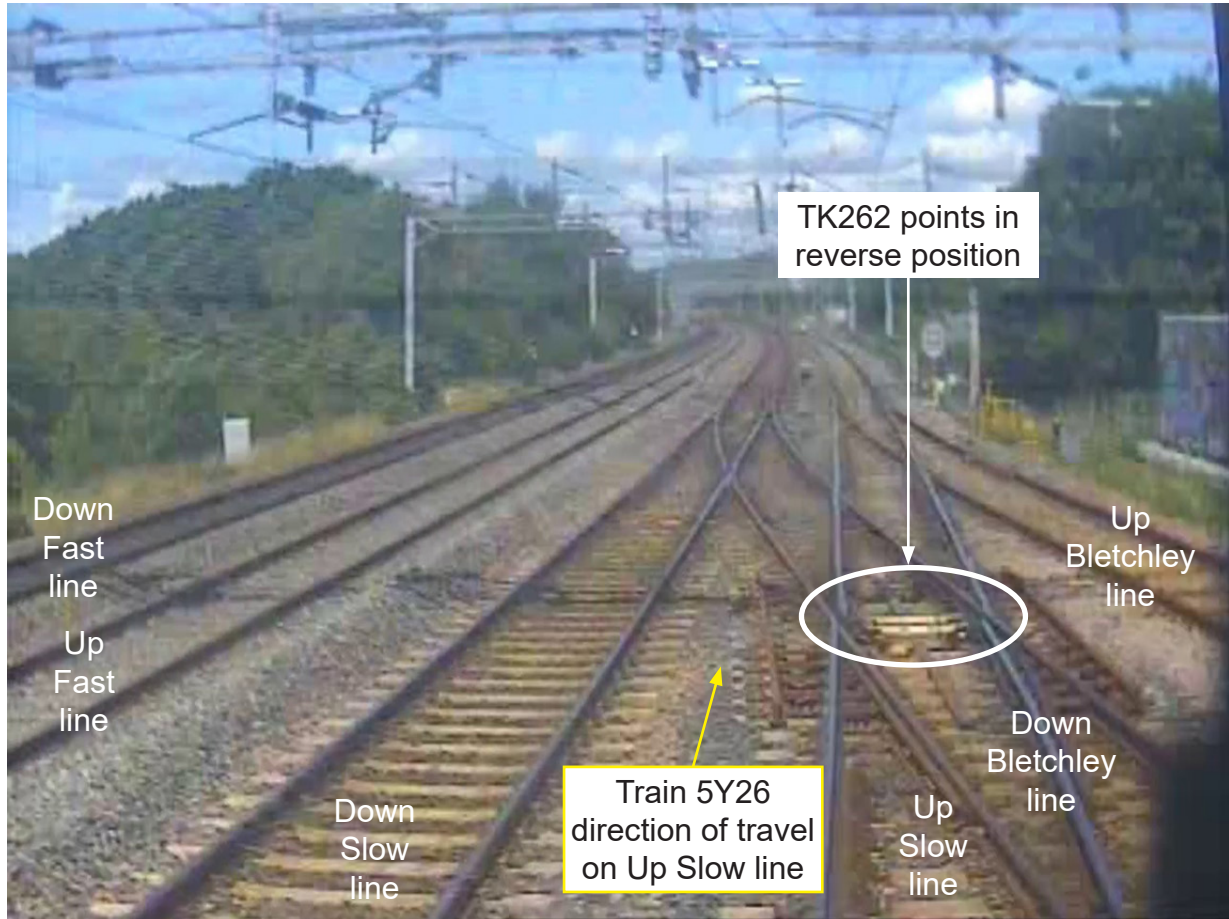
- 48 Train 5Y26 continued at about 15 mph (24 km/h) towards Denbigh Hall South Junction. At 12:27:01, the train arrived at TK262 points which were set in their reverse position (figure 11).

Figure 11: Forward-facing CCTV image from train 5Y26 showing the position of TK262 points (courtesy of West Midlands Trains with RAIB annotations).

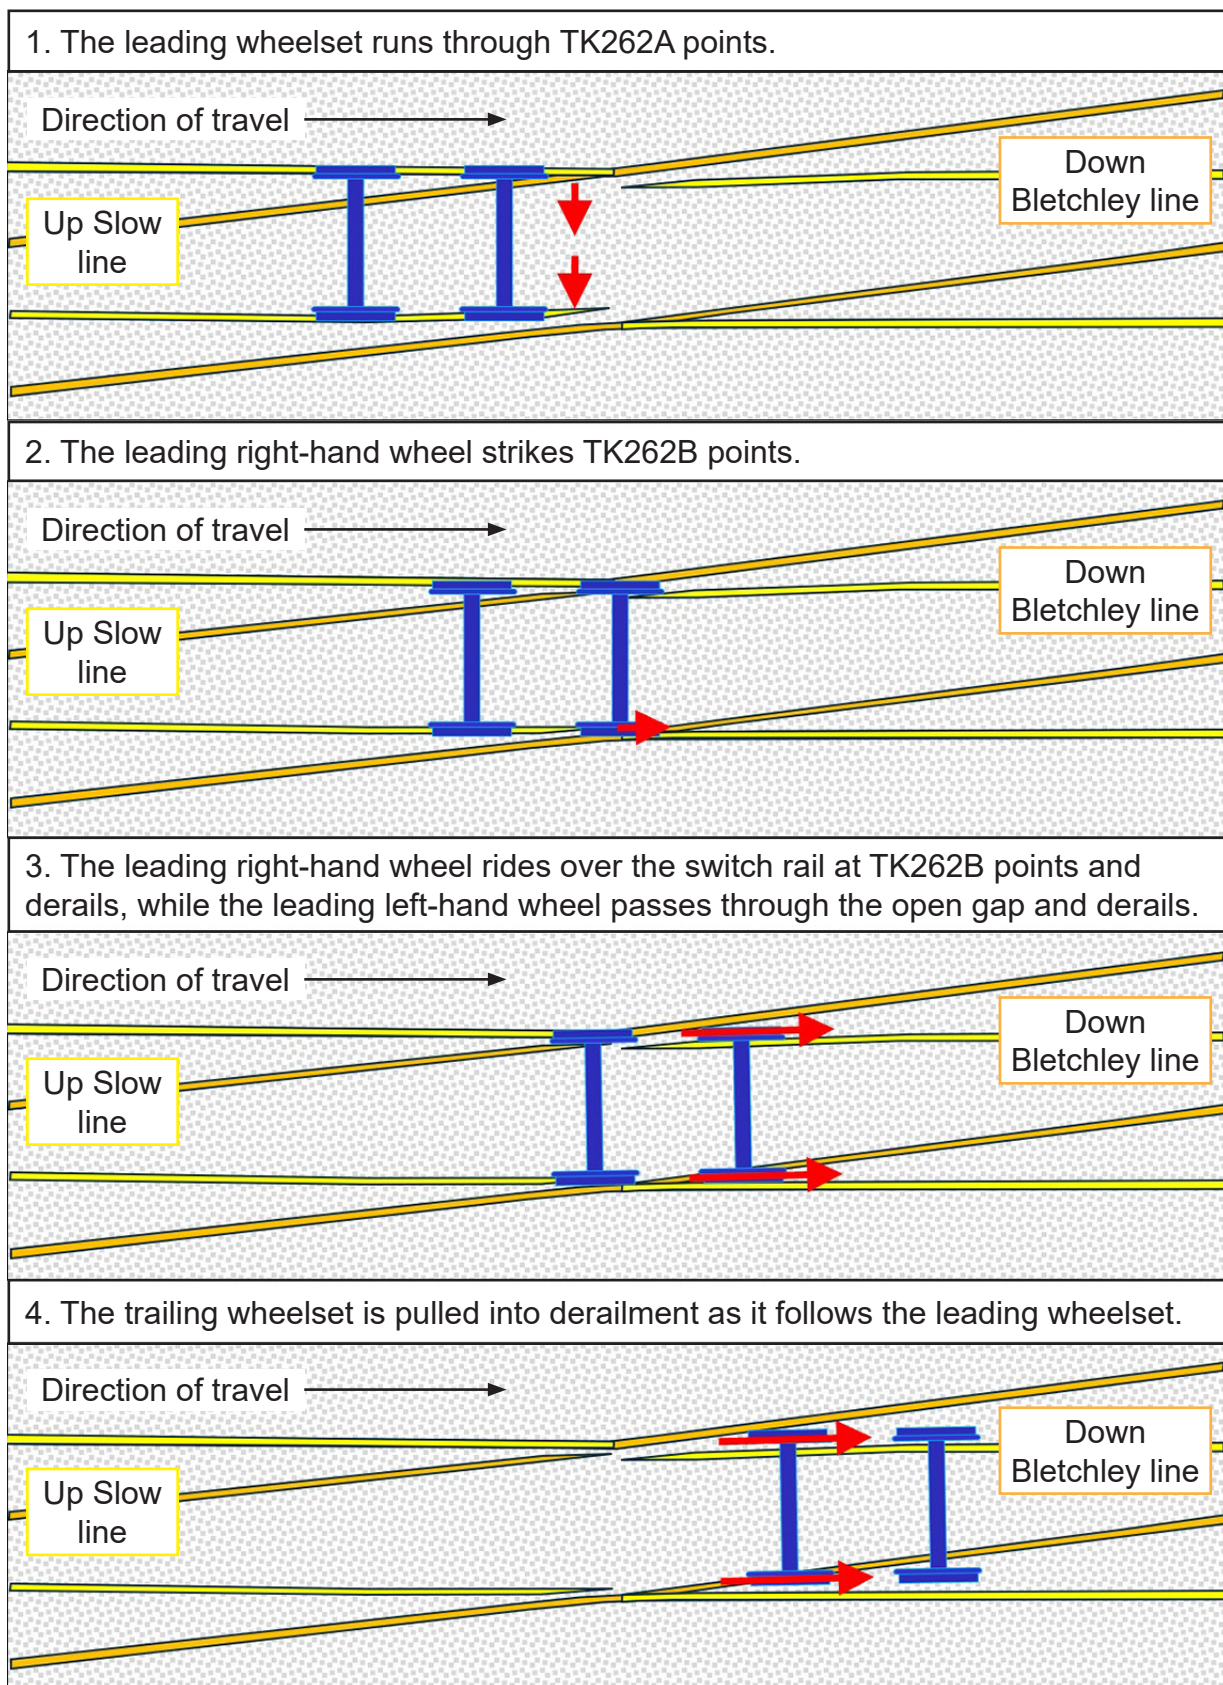
- 49 The train's leading wheelset first ran through the trailing TK262A points. The left-hand wheel forced the closed switch rail open, while the right-hand wheel pushed the open switch rail towards its closed position (figure 12). This caused the signalling system to report a loss of reverse detection for TK262A points at 12:27:01. Immediately after, the leading right-hand wheel struck the closed switch rail of facing TK262B points (figure 12). This caused the signalling system to record a loss of reverse detection for TK262B points at the same time.

- 50 The leading right-hand wheel was unable to negotiate the sharp divergence to the left to travel along the right-hand switch rail. Instead, this wheel climbed over the switch rail and into derailment (figure 12). This initially lifted the front of the train before the leading wheelset then dropped down onto the ballast. At the same time, the leading left-hand wheel passed through the gap at the open switch rail on its side and into derailment on the ballast. The trailing wheelset of the leading bogie was then pulled into derailment as it followed the path of the derailed leading wheelset (figure 12).

Figure 12: The path of the train's wheels through TK262A and TK262B points.

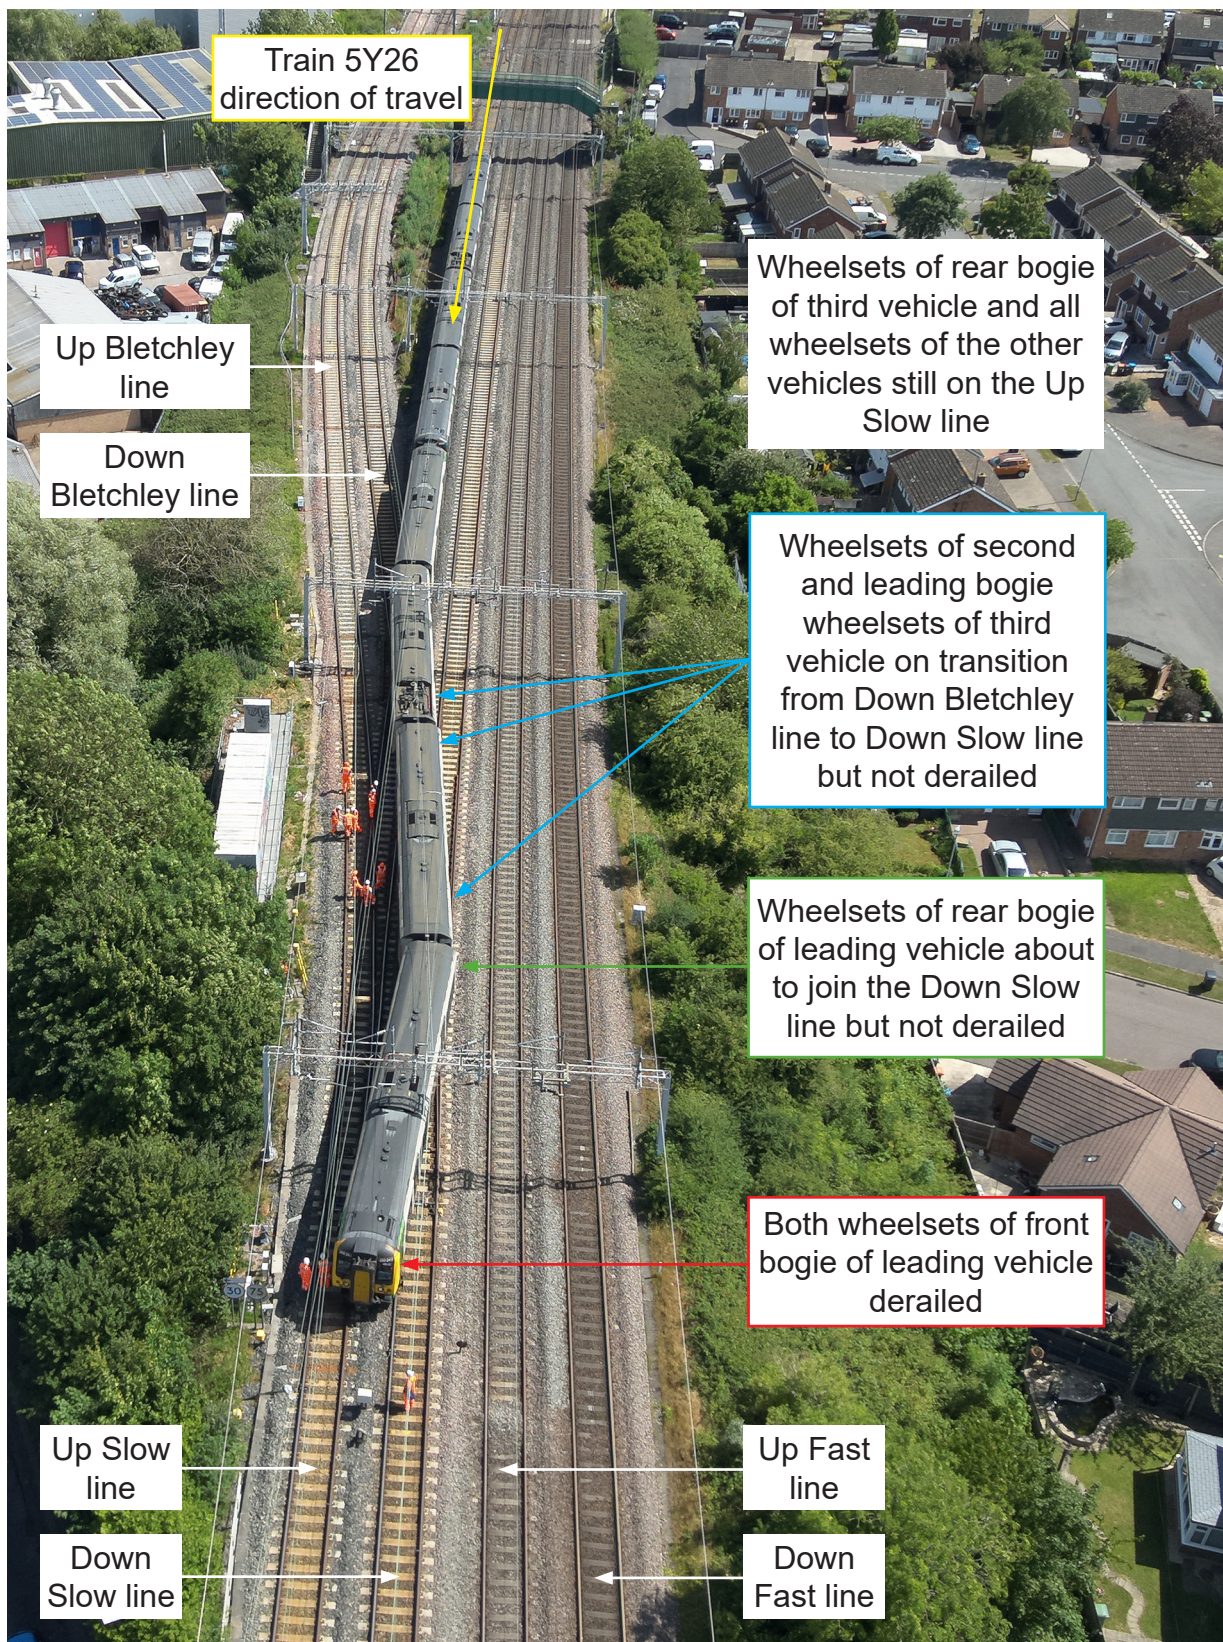
- 51 At 12:27:02, after feeling the front of the train lift and drop back down, the driver applied the train's brakes. As the train continued forward, the wheelsets of the rear bogie of the leading vehicle passed over TK262A and TK262B points. These wheelsets did not derail. Instead, they were able to negotiate the sharp turn to the left and were diverted from the Up Slow line onto the Down Bletchley line, and towards the Down Slow line (figure 13). Similarly, all the wheelsets for the second vehicle and the wheelsets of the leading bogie for the third vehicle did not derail as they passed over TK262A and TK262B points. They too were diverted onto the Down Bletchley line (figure 13).

Figure 13: Positions of the train's wheelsets after passing over TK262A and TK262B points (courtesy of Network Rail with RAIB annotations).

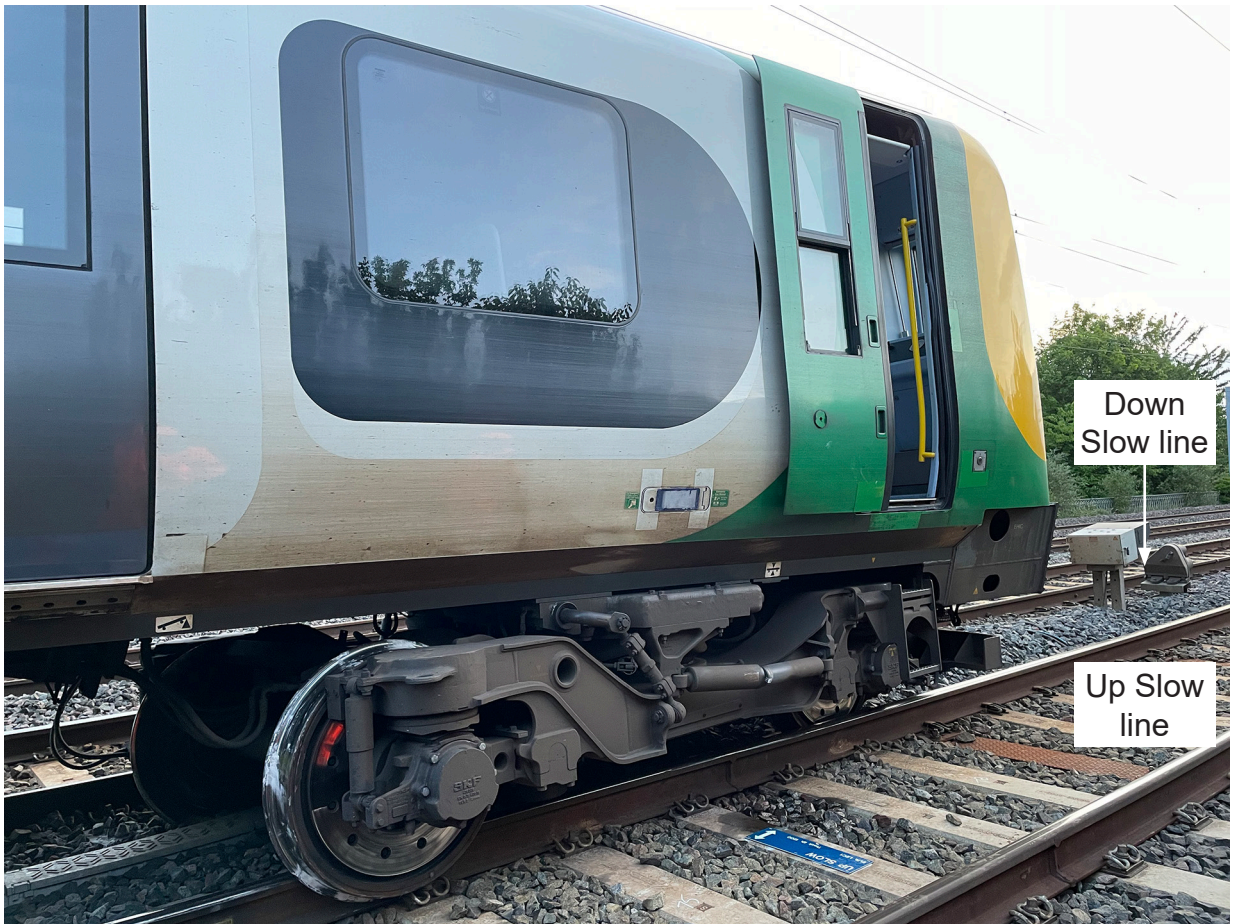
Figure 14: The front of the derailed train.

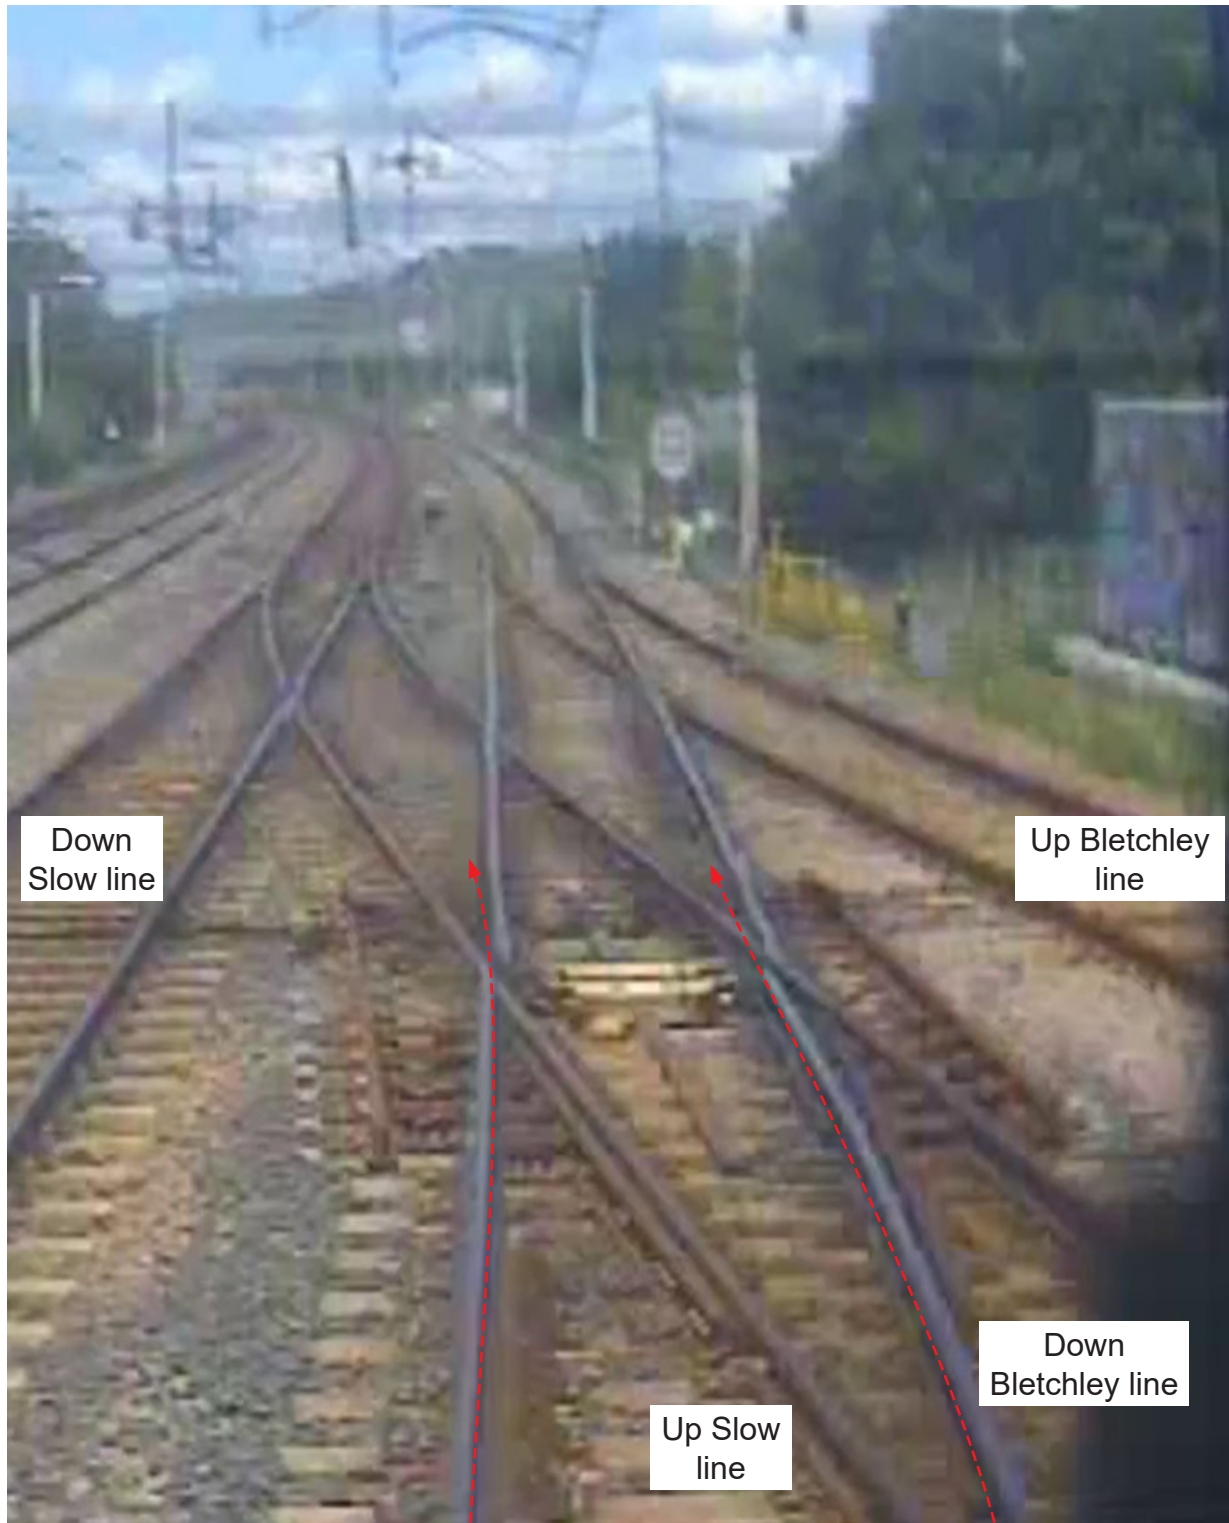
Figure 17: Path taken by the leading wheelset of train 5Y26 after approaching on the Up Slow line and then travelling through TK262A points and over TK262B points in their reverse position (courtesy of West Midlands Trains with RAIB annotations).

- 61 Instead of diverting to the left, all the wheels of the leading bogie derailed (paragraph 50). The path these wheels took is shown in figure 17. The right-hand wheels of the leading bogie derailed due a combination of the train's speed and the angle of the right-hand switch blade being too acute for these wheels to be directed onto the Down Bletchley line. The following wheels were able to negotiate the sharp turn to the left due to a combination of the train slowing down and its leading end moving over to the left as it ran derailed between the two slow lines (figure 17).

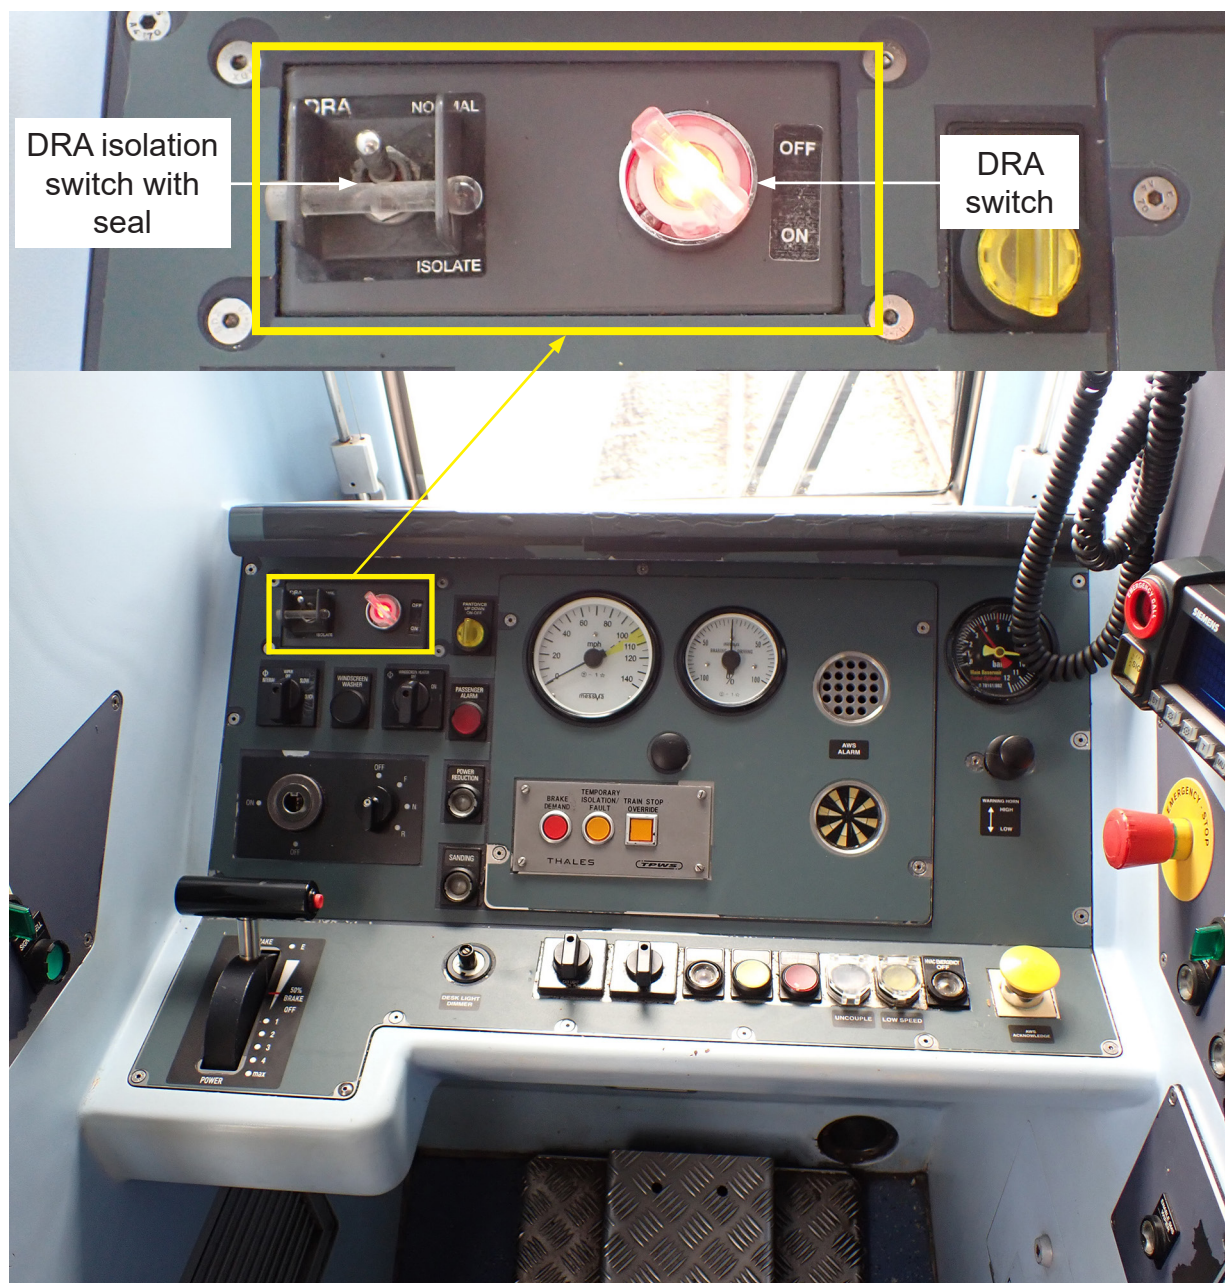
Figure 18: The DRA switch in the cab of a class 350 unit.

- 75 Although the driver had moved the DRA switch to its off position, the failed open circuit switch contact meant an input to the traction control unit was not energised. This was despite all other conditions for allowing traction being met, such as the leading cab being occupied, all the doors being detected as closed, and there being no emergency brake application due to a safety system. As far as the driver and driver manager could tell, there was nothing in the cab that indicated to them what the problem with the train was.

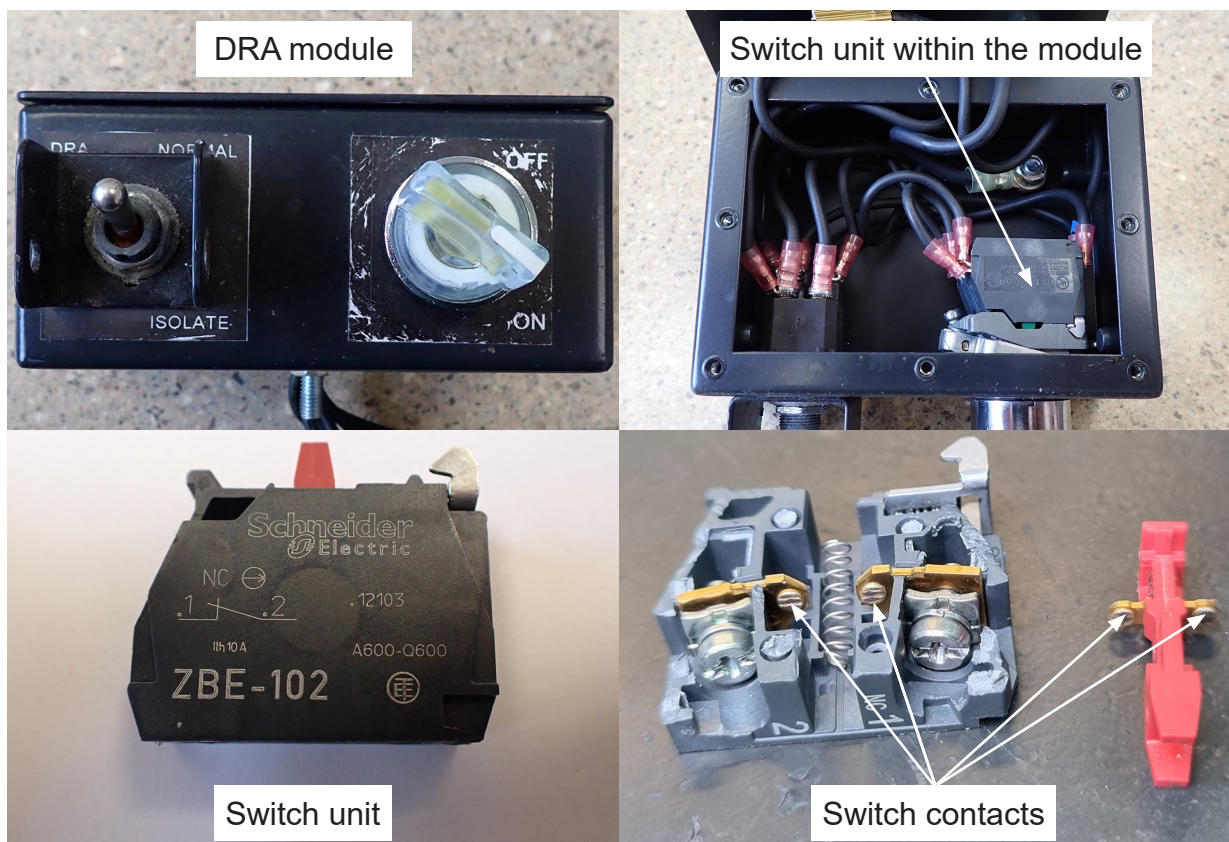
- 76 The DRA switch module was removed for inspection and testing (figure 19). When the DRA switch contact was first tested while in situ within the DRA module, it remained open circuit. However, when the switch unit was disturbed to remove it from the DRA module, the switch contact began working correctly (figure 19). The switch unit was then taken apart. Under close examination, this showed there was some pitting on the contact faces and a very small amount of black residue. It is likely that these issues had caused the switch contact to fail open circuit, but it began conducting again when it was disturbed.

Figure 19: The DRA module, switch unit and switch contacts.

- 77 This DRA module had been installed into this cab of unit 350370 in 2018. It was to be replaced as part of a campaign change due to issues with the DRA switch failing on some class 350 units (the class 350/3 and 350/4 variants). However, Siemens reported no previous history of contact failures within DRA switches on class 350 units that had prevented traction from being taken by drivers.

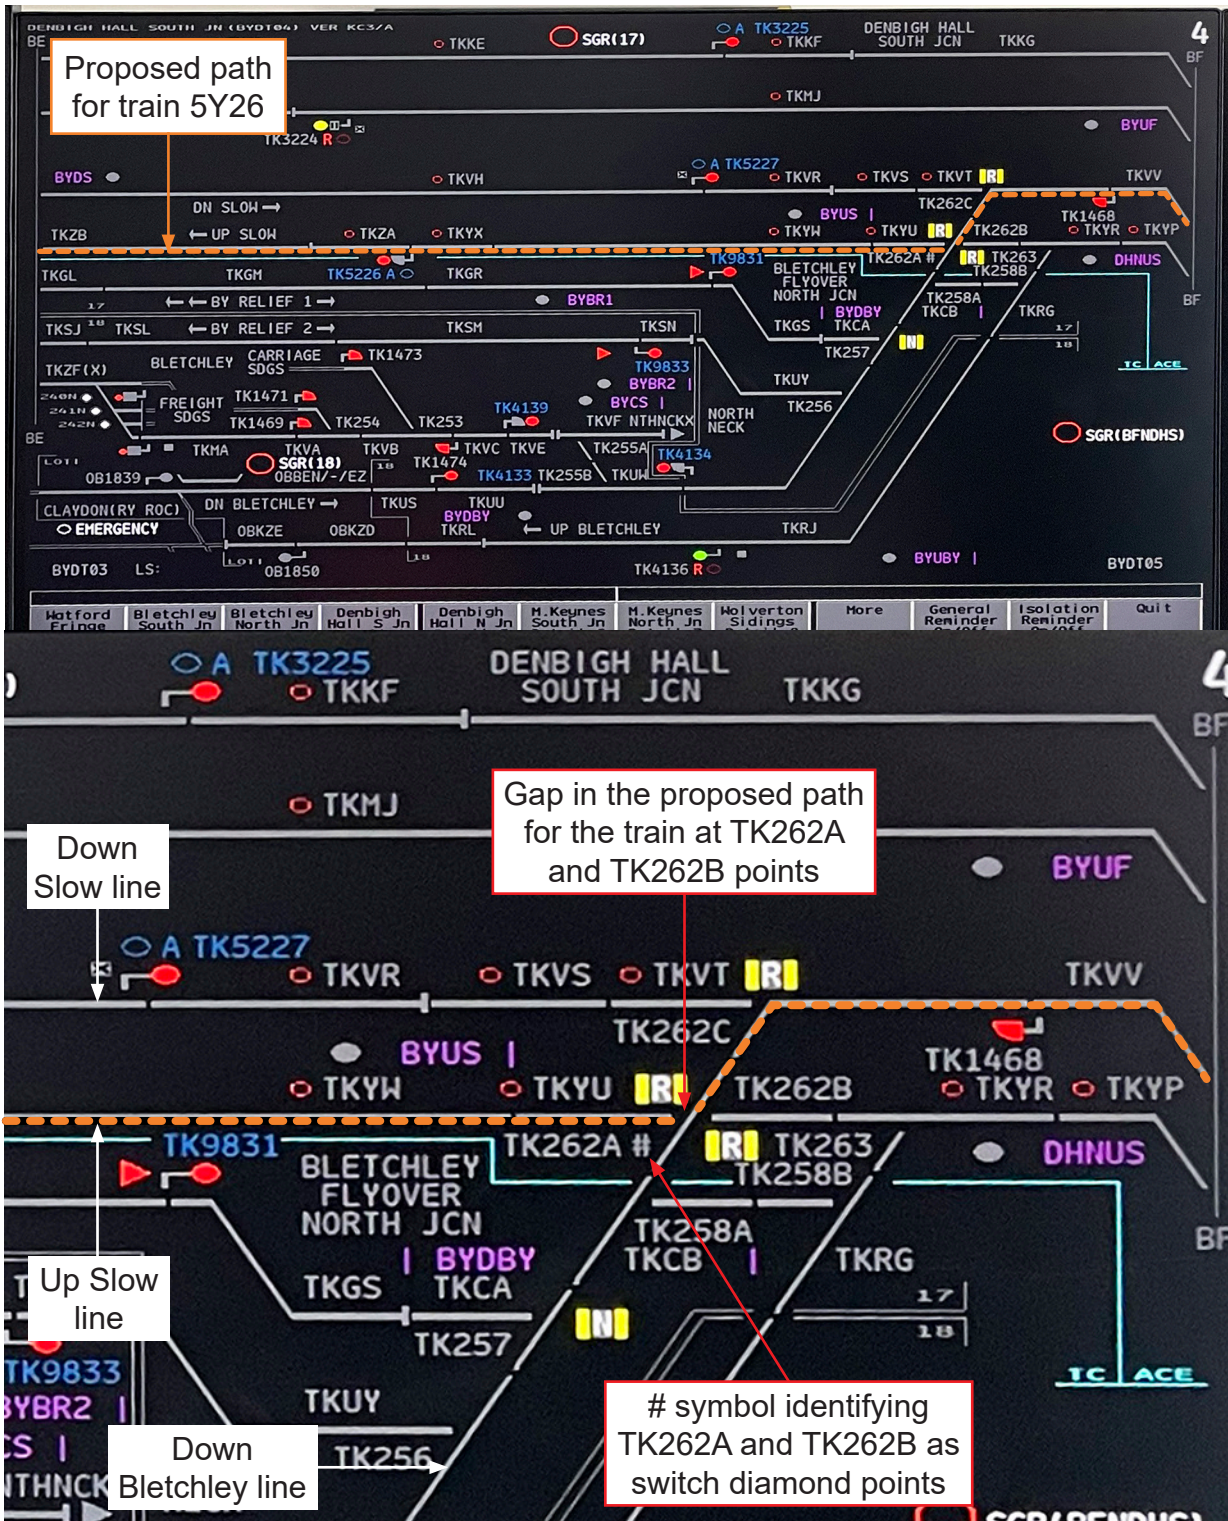
102 Signallers should also look for any gaps in the line along the train's proposed path when carrying out this check. A continuous line through all the points along the proposed path for a train indicates that the path has been set up correctly for the safe passage of the train. Conversely, a gap in the line at a set of points shows that the path is not set up correctly at those points. However, none of the checks by anyone on the day of the accident identified that there was a gap in the line at TK262A and TK262B points (figure 21).

Figure 21: The gap at TK262A and TK262B points in the train's proposed path and # symbol identifying these points as switch diamond points.

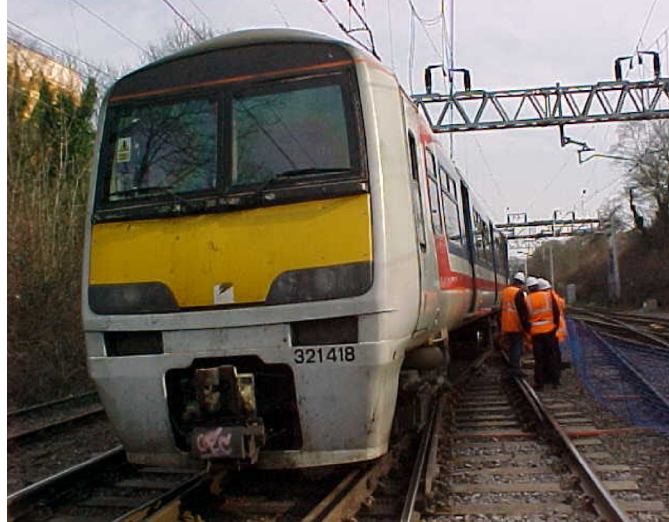
Figure 22: Derailed train on switch diamond points at Hemel Hempstead South Junction (courtesy of Network Rail).
