Near miss between a passenger train and a van near Millbrook, Bedfordshire, 25 September 2025

Summary of the incident

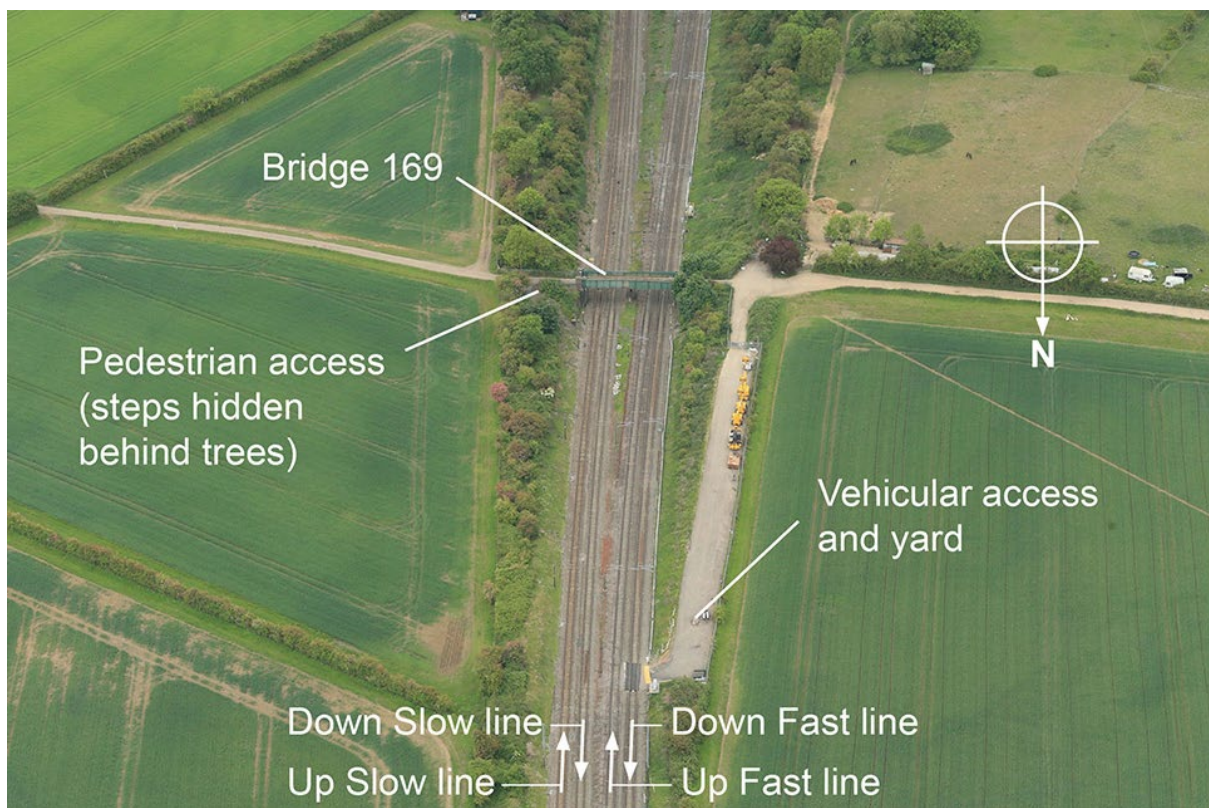
The incident occurred because the van was driven onto the incorrect side of the railway and parked on lines which remained open to traffic.

The site of the incident (courtesy of Network Rail with RAIB annotations).

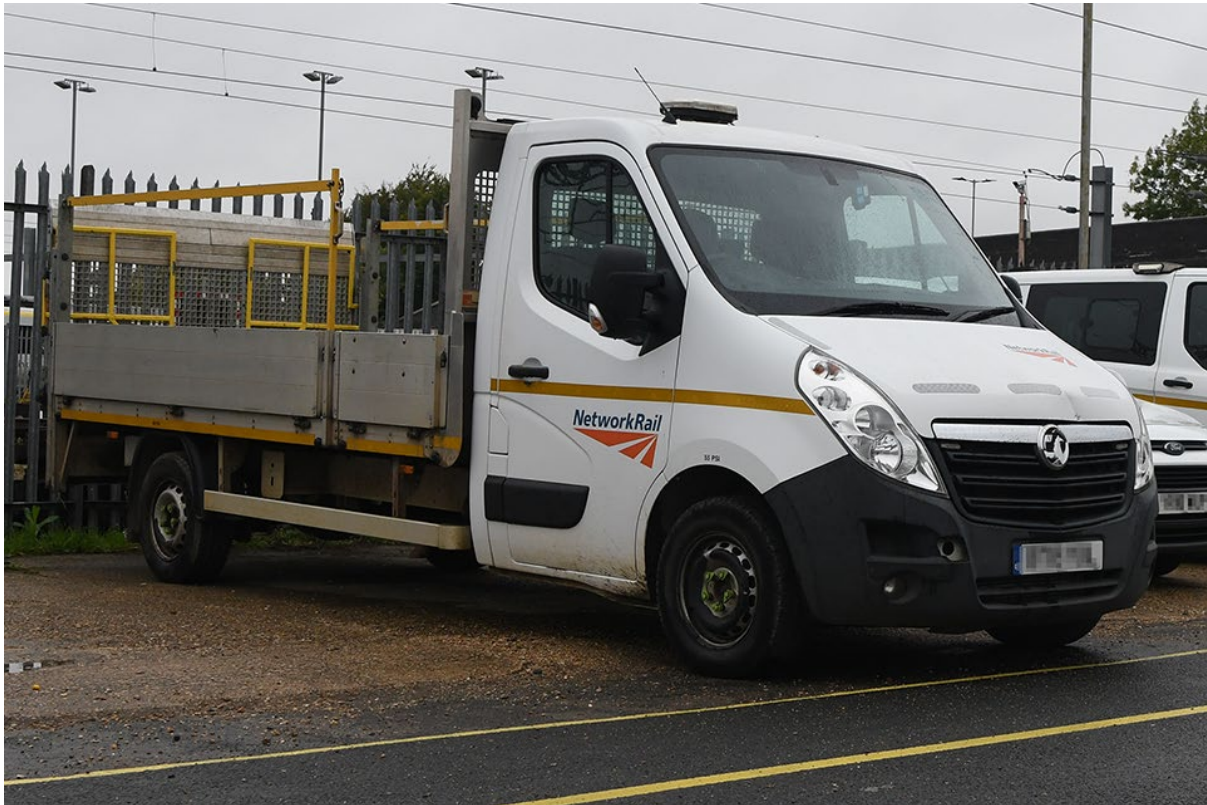
The van involved in the near miss.

At around 23:34, a passenger train travelling at 108 mph (174 km/h) passed the site on the Up Fast line, heading towards London. Forward-facing CCTV from the train shows that the van was stationary on the RRAP, and that the rear of the van was very close to the passing train. The train driver was unaware of the van and so did not sound the train's horn as it approached the RRAP. Witness evidence suggests that the train was "between 1 and 2 feet" from the van. The site warden, who was still in the van, stated that they did not see or hear the passing train. Witness evidence is that the contractor's staff told the site warden to move the van clear, after seeing the near miss.

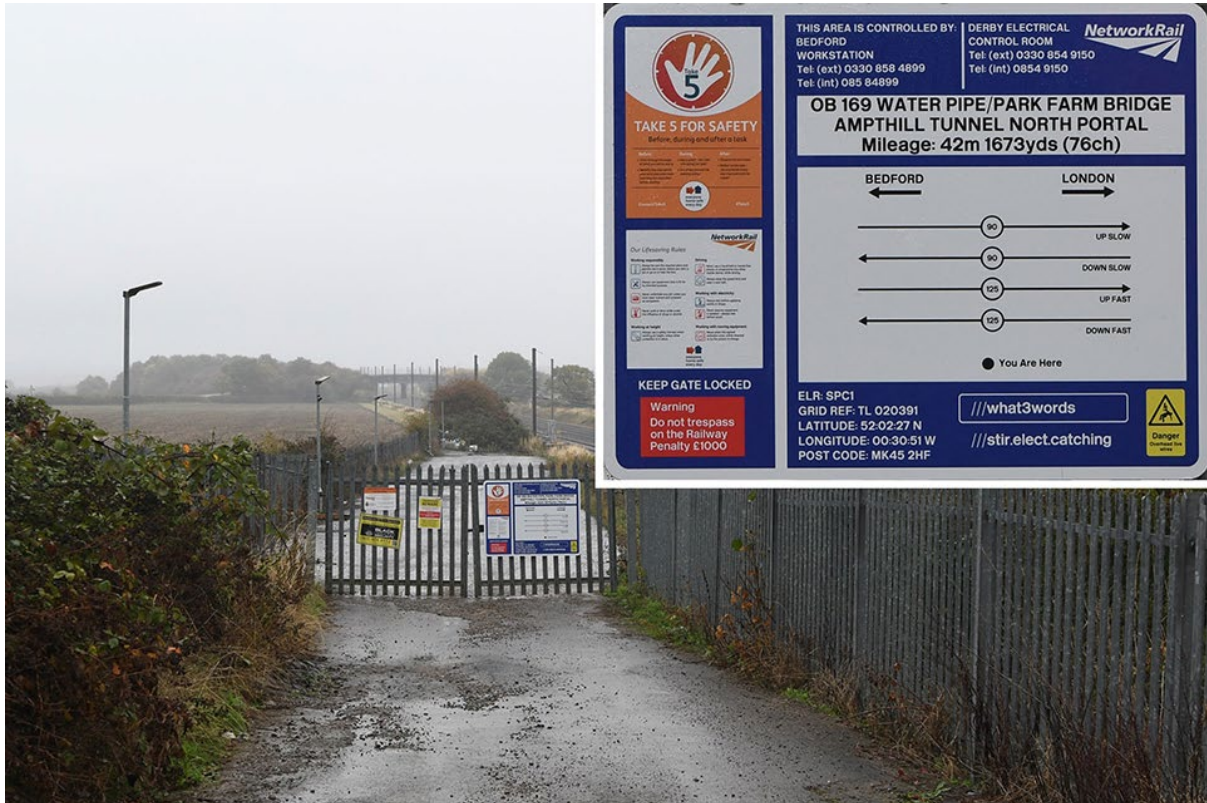
RAIB has not been able to determine exactly what led to the site warden confusing the two access points on the night of the incident.

The vehicular access point and (inset) close up of the sign detailing the access point arrangements.
