## Accident

<b>Aircraft Type and Registration:</b>	Cessna FRA150L, G-PPFS
<b>No &amp; Type of Engines:</b>	1 Continental Motors Corp O-240-A piston engine
<b>Year of Manufacture:</b>	1972 (Serial no: 0126)
<b>Date &amp; Time (UTC):</b>	28 July 2024 at 0845 hrs
<b>Location:</b>	Near Thorganby, North Yorkshire
<b>Type of Flight:</b>	Private
<b>Persons on Board:</b>	Crew - 1                      Passengers - 1
<b>Injuries:</b>	Crew - 1 (Fatal)              Passengers - 1 (Fatal)
<b>Nature of Damage:</b>	Aircraft destroyed
<b>Commander's Licence:</b>	Private Pilot's Licence
<b>Commander's Age:</b>	21 years
<b>Commander's Flying Experience:</b>	153 hours (of which 131 were on type) Last 90 days - 53 hours Last 28 days - 13 hours
<b>Information Source:</b>	AAIB Field Investigation

## Synopsis

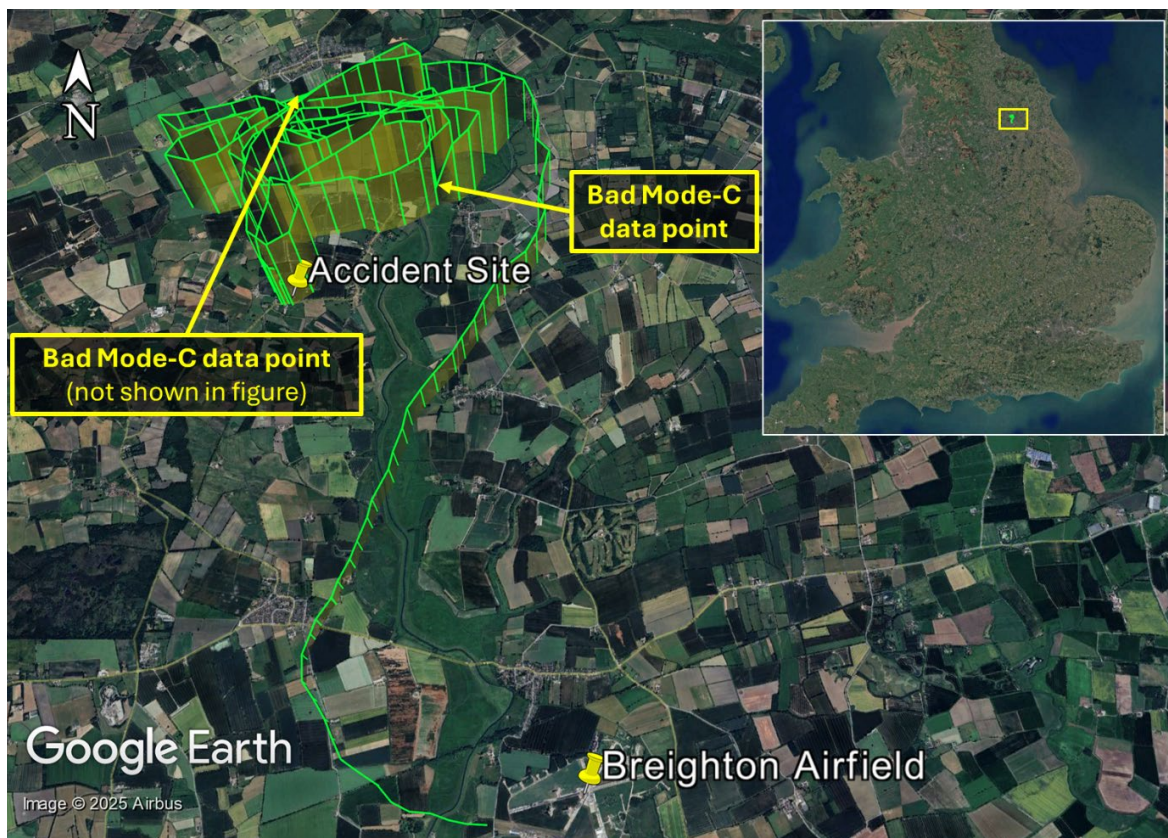
**Figure 1**

Aircraft's flight path from Claxby radar data

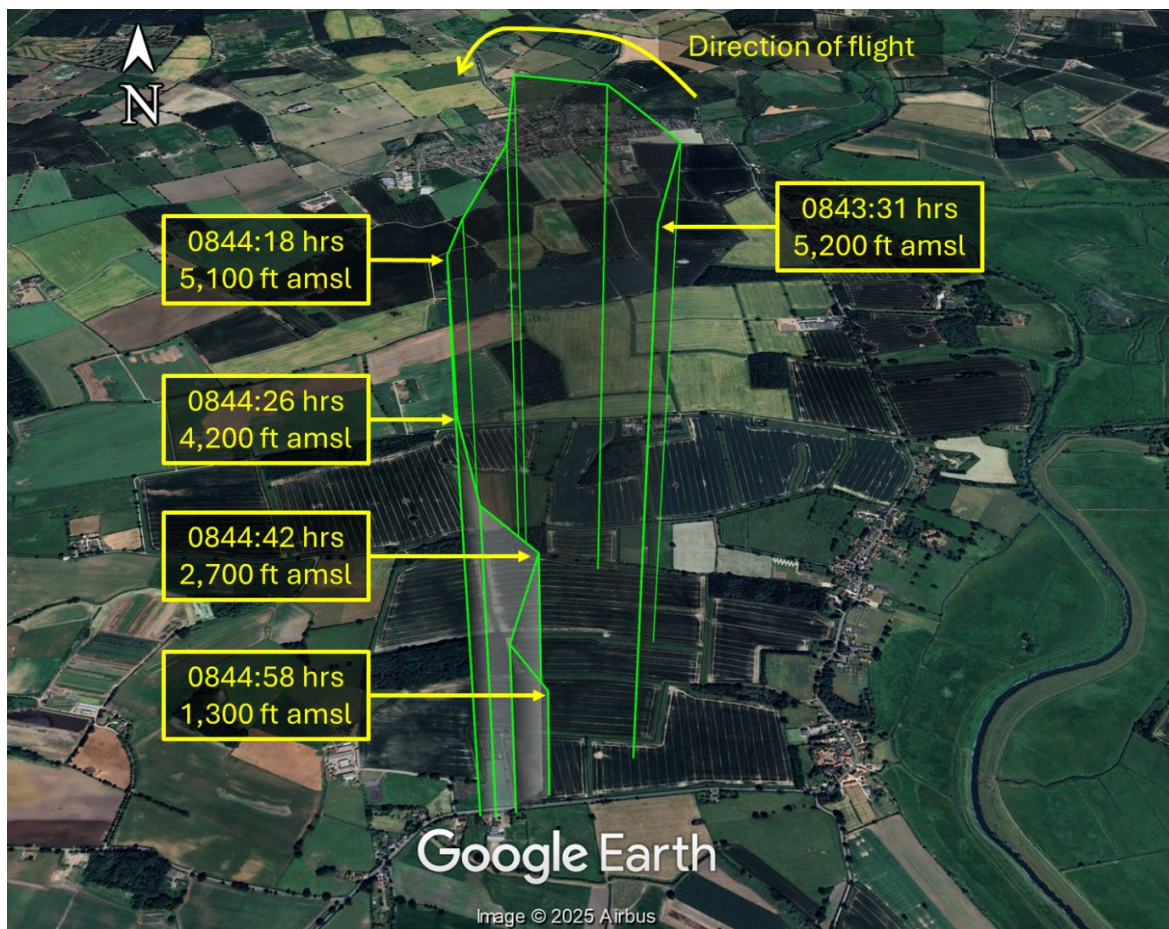
**Figure 2**

At 0844 hrs, the pilot entered the aircraft into a power off stall then a spin to the left<sup>3</sup>. While descending below 1,300 ft amsl (Figure 2), according to radar data, he transmitted a MAYDAY call saying the aircraft was "IN AN UNCONTROLLED SPIN". The ATCO replied but there were no further transmissions from the aircraft. The aircraft's average descent rate was about 5,700 ft/min. It disappeared from radar when it was below 600 ft amsl and struck the ground in a field near Thorganby at 0845 hrs. The ATCO alerted the emergency services.

Aircraft's flight path during the descent
