Abbreviated Dust Monitoring Report

Project: Grenfell Tower

Document Ref: EEMC-DMR-201/107 – Grenfell Tower Rev 01

Period: 02 March 2026 to 29 March 2026

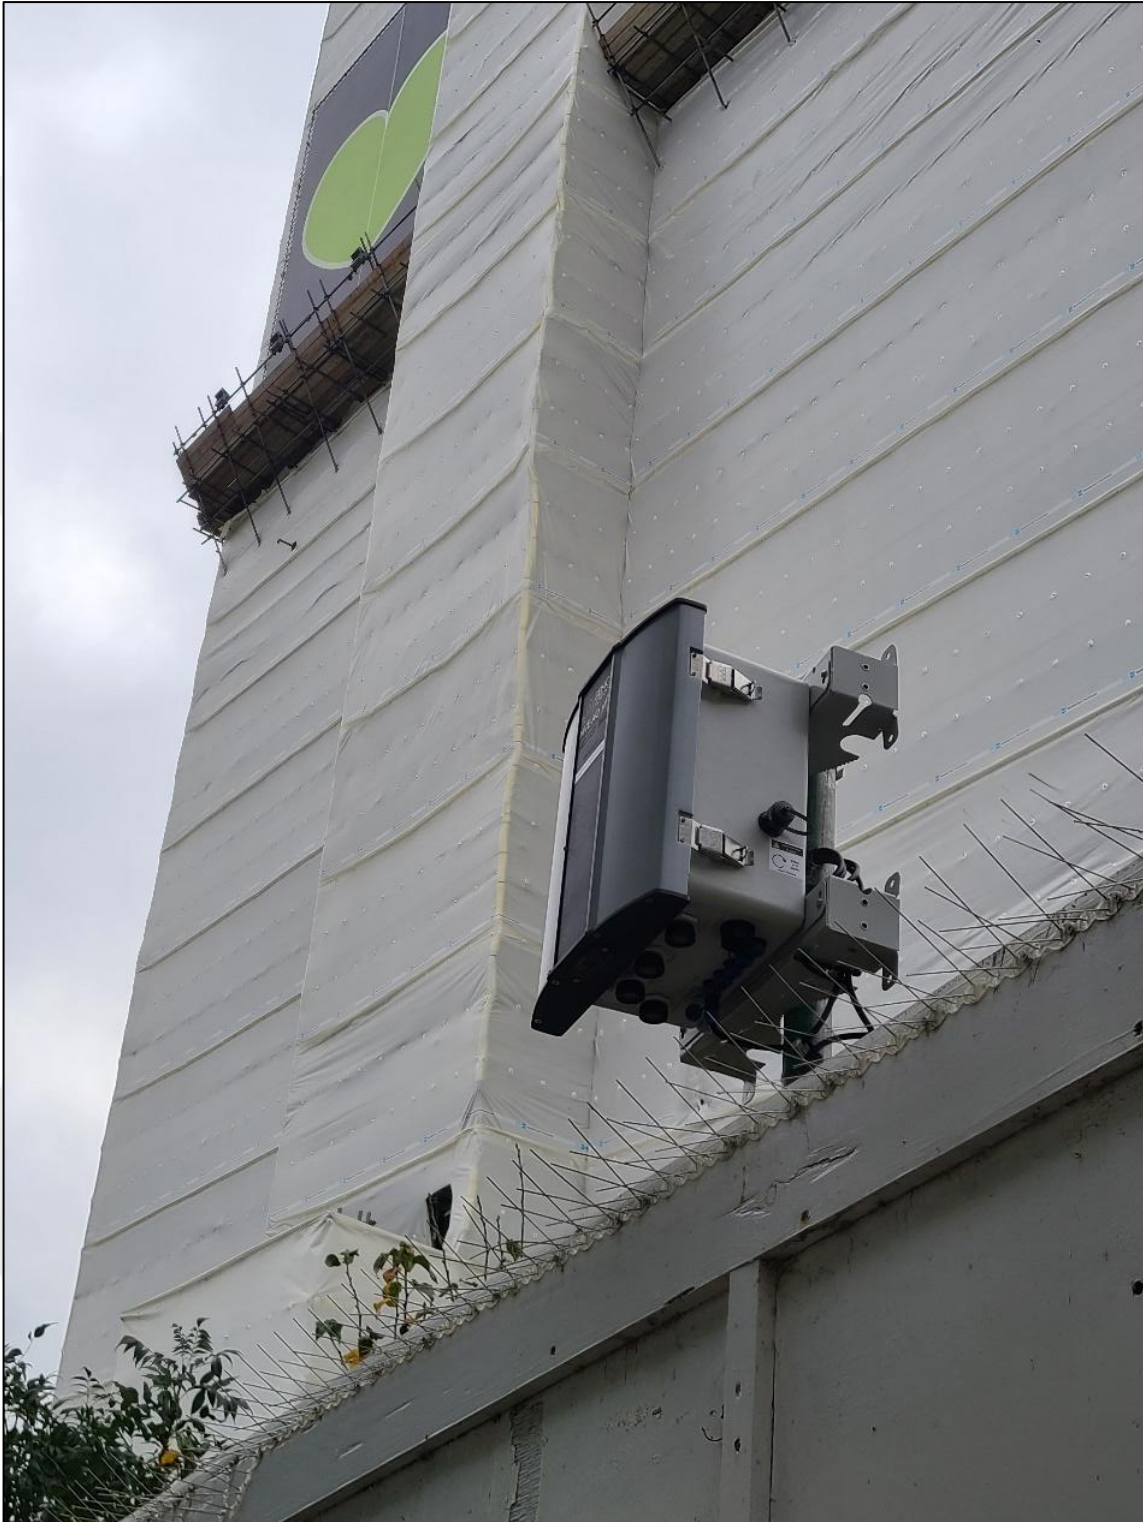
Images 1 – DMP1 Monitoring Location (photo taken on site on 19/5/2025).

There were nineteen (19) exceedances of the 15-minute PM_{2.5} 54 (µg/m³) and no exceedances of the 15-minute PM₁₀ 150 (µg/m³) Amber Trigger levels at DMP1.

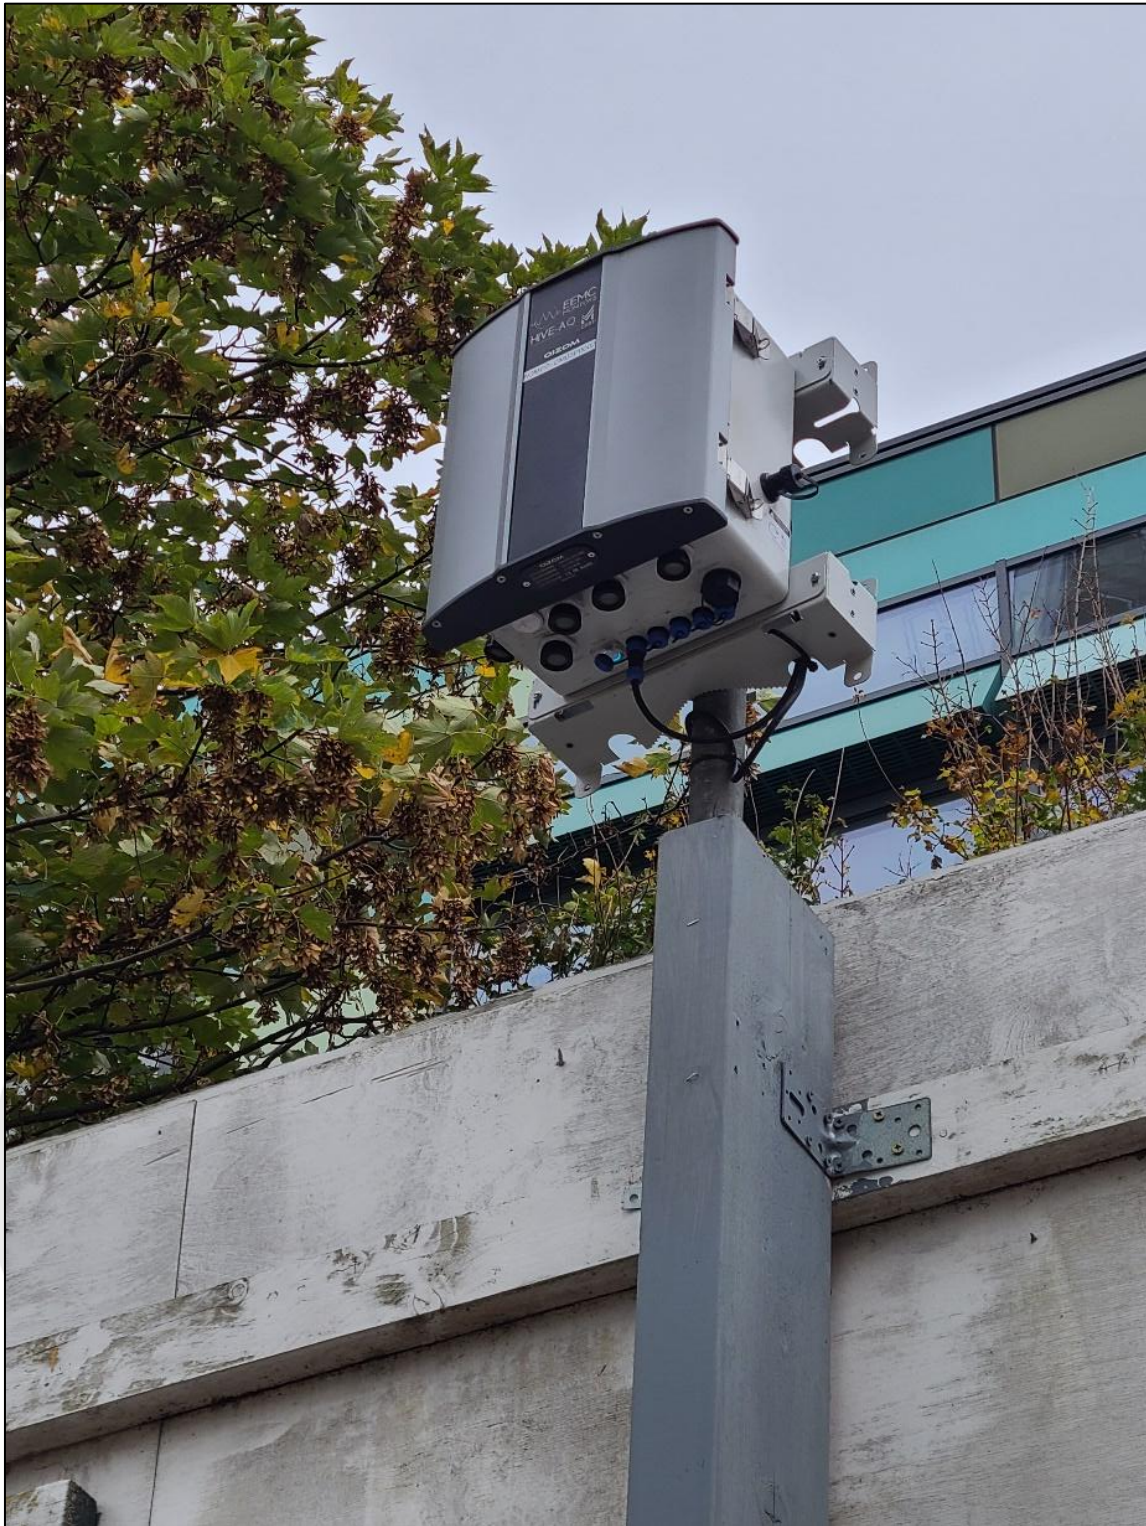
Images 3 – DMP2 Monitoring Location (photo taken on site on 19/5/2025).

There were seventeen (17) exceedances of the 15-minute PM_{2.5} 54 (µg/m³) and six (6) exceedances of the 15-minute PM₁₀ 150 (µg/m³) Amber Trigger levels at DMP2.

There was **one (1) exceedances** of the 1-hour PM₁₀ 190 (µg/m³) and **three (3) exceedances** of the 1-hour PM_{2.5} 70 (µg/m³) Red Action Alert levels at **DMP2**. There were **no exceedances** at any other monitoring locations.

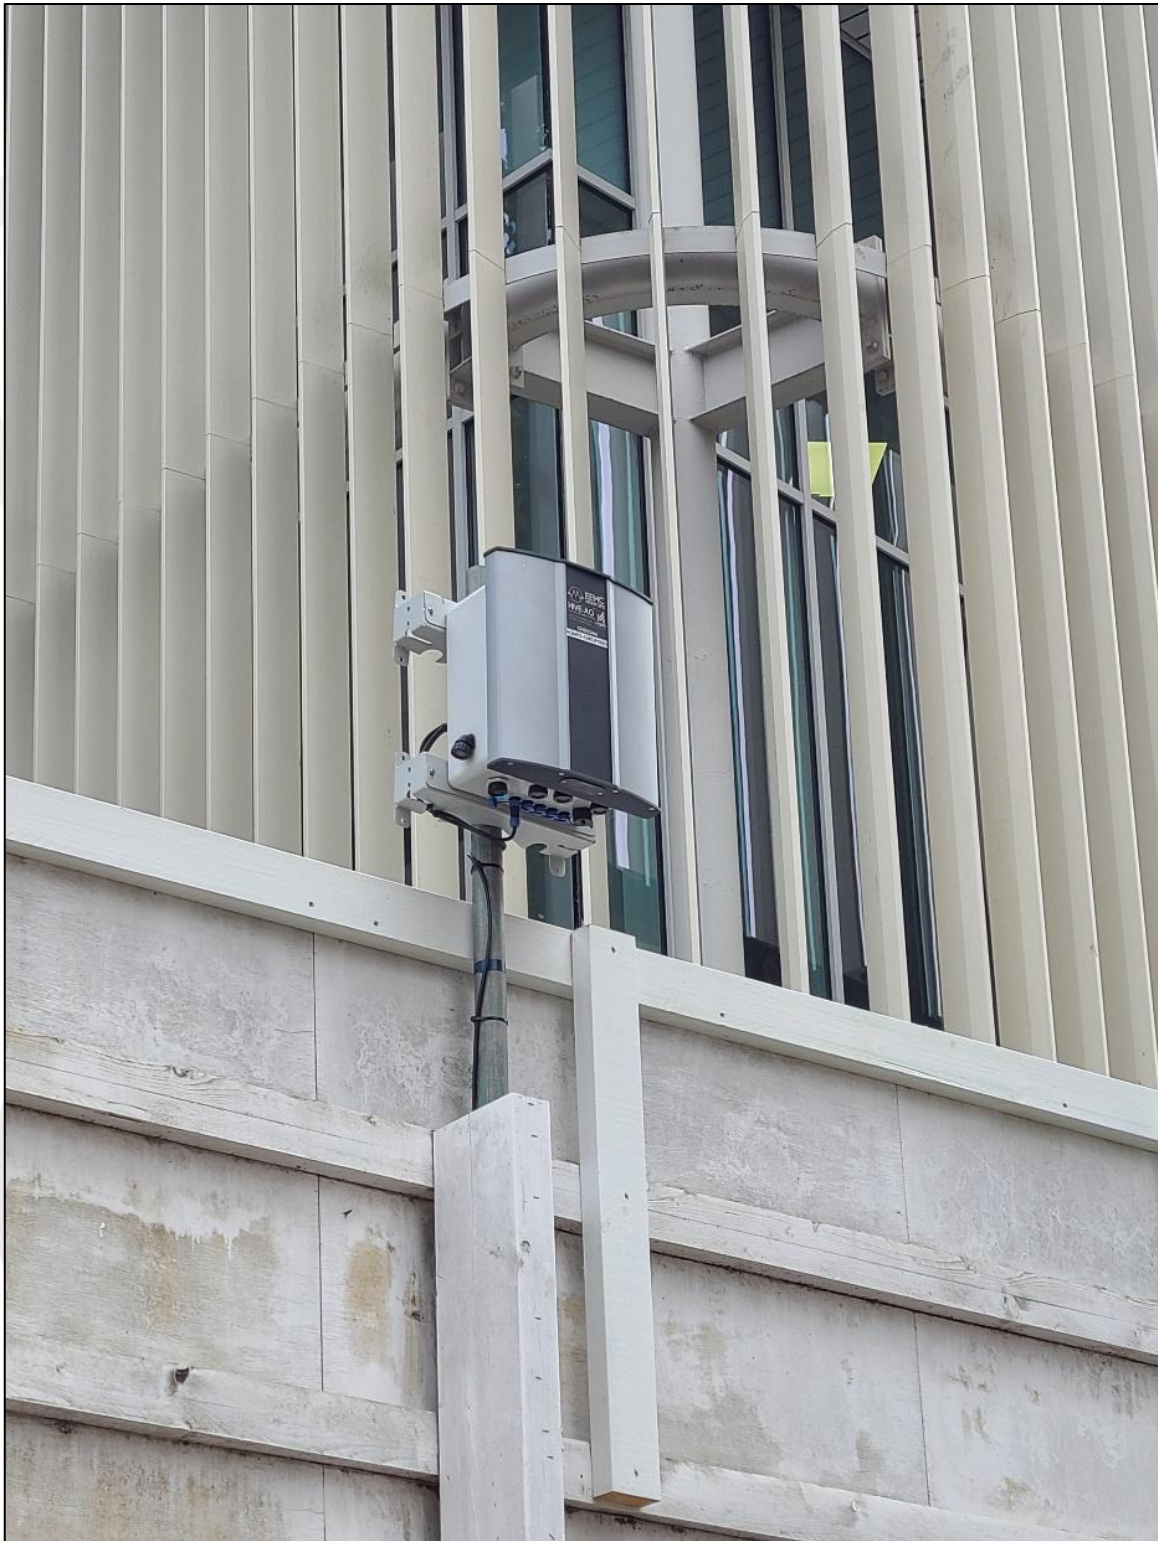
Images 5 – DMP3 Monitoring Location (photo taken on site on 19/5/2025).

There was also one (1) exceedance of the 15-minute PM_{2.5} 54 (µg/m³) and no exceedances of the 15-minute PM₁₀ 150 (µg/m³) Amber Trigger levels at DMP3 and DMP5.

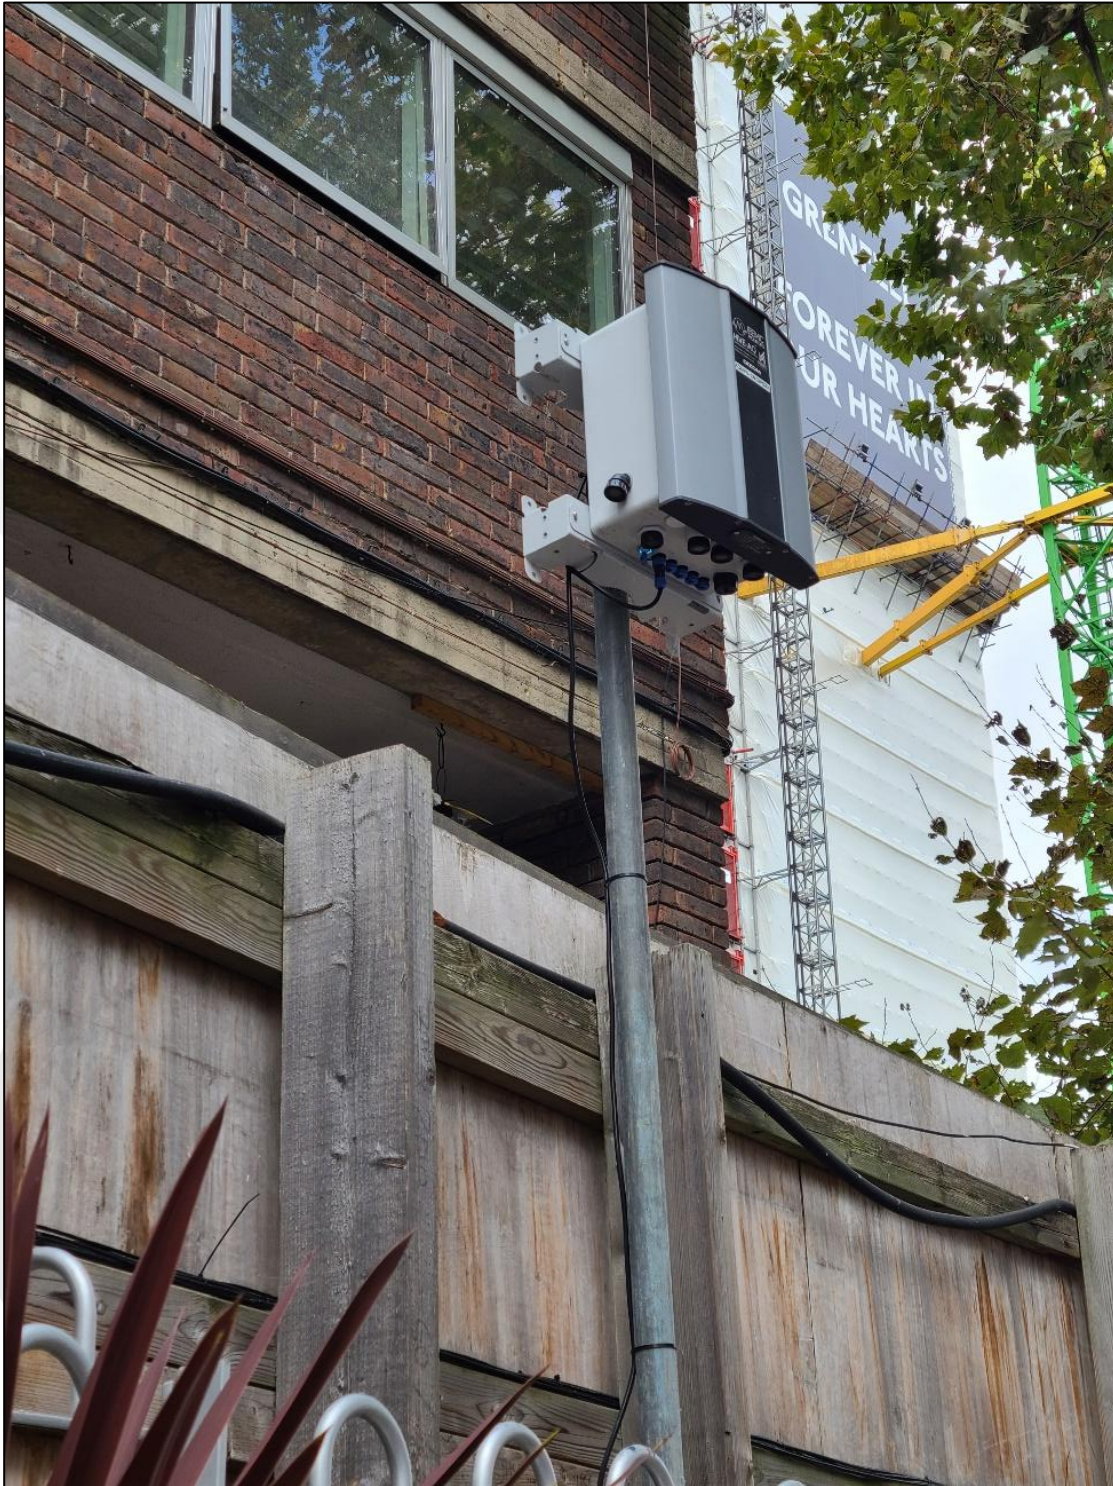
Images 7- DMP4 Monitoring Location (photo taken on site on 19/5/2025)

There were no other exceedances of either the 15-minute PM₁₀ 150 (µg/m³) or the 15-minute PM_{2.5} 54 (µg/m³) Amber Trigger levels at DMP4.
