Report on the investigation of
the double man overboard from the potter
Weston Bay (GY123)
resulting in one fatality
approximately 12 nautical miles south-east
of Spurn Head, England
on 22 May 2024

SYNOPSIS

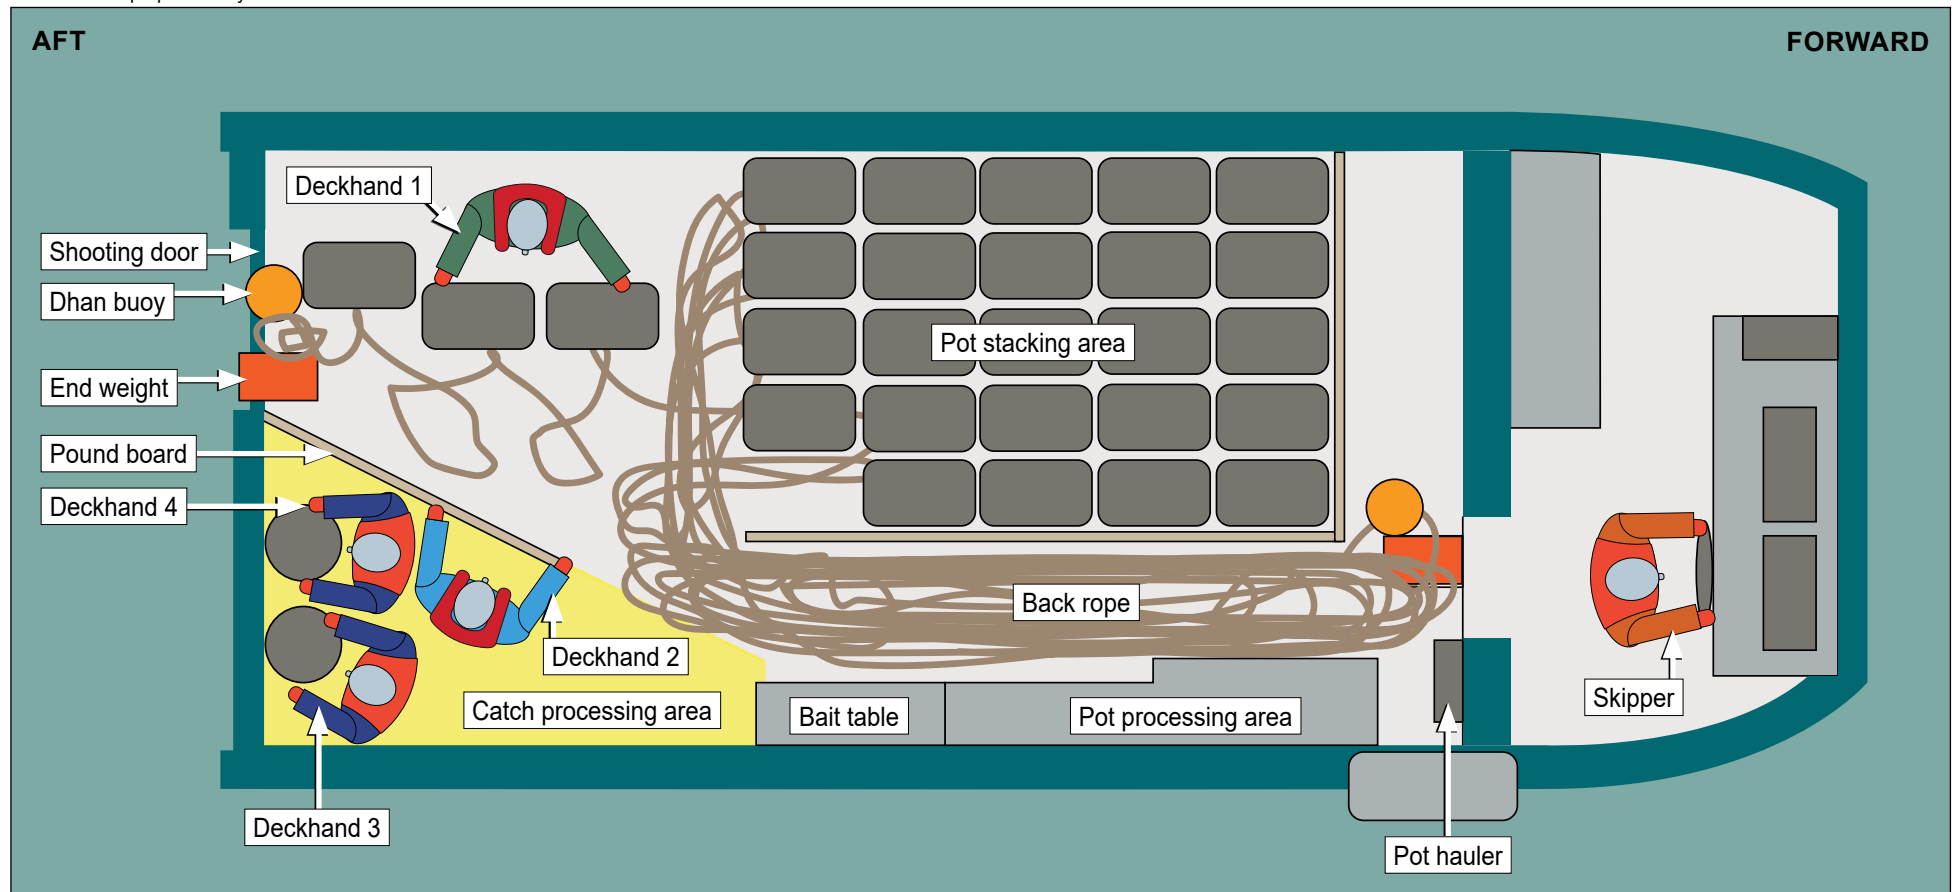
Figure 3: Crew positions at the shooting stations

3. The crew allocation had not considered the risks of inexperienced crew. This meant that deckhand 1 was faced with working on an unfamiliar task in the hazardous position in front of the pot stack as the pots were being deployed, which placed them at risk of injury and harm. [2.3.3]

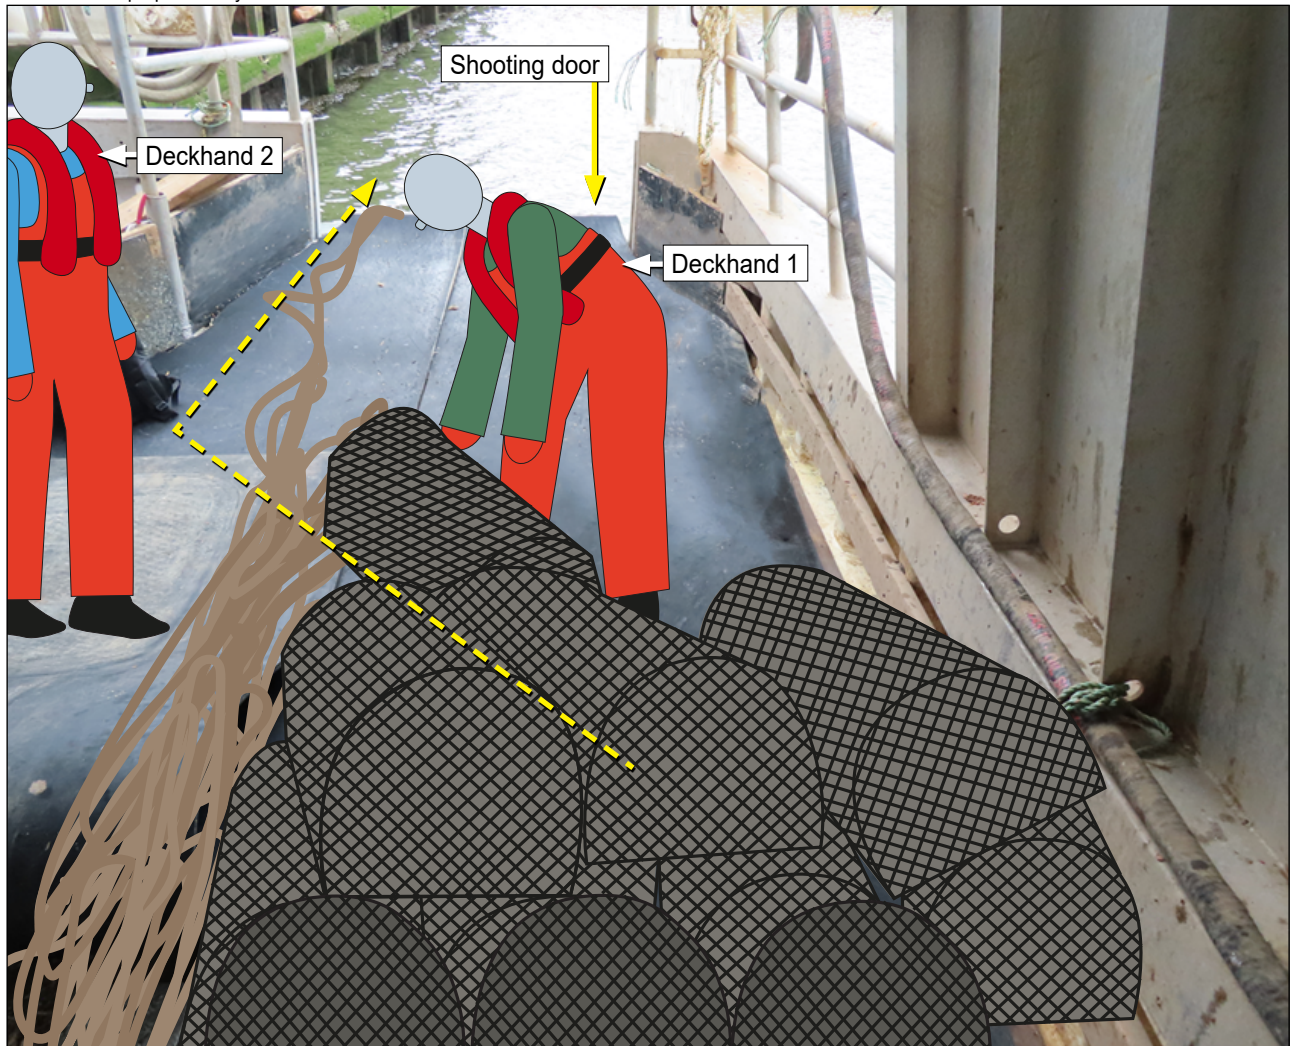
The investigation found that the two deckhands entered the water following an incident while manually downstacking a string of shooting pots. The first deckhand was struck, knocked onto the deck and taken overboard by the next pot in the sequence; a second deckhand entered the water as he went to assist.

Figure 4: Deckhand 1 downstacking shooting pots

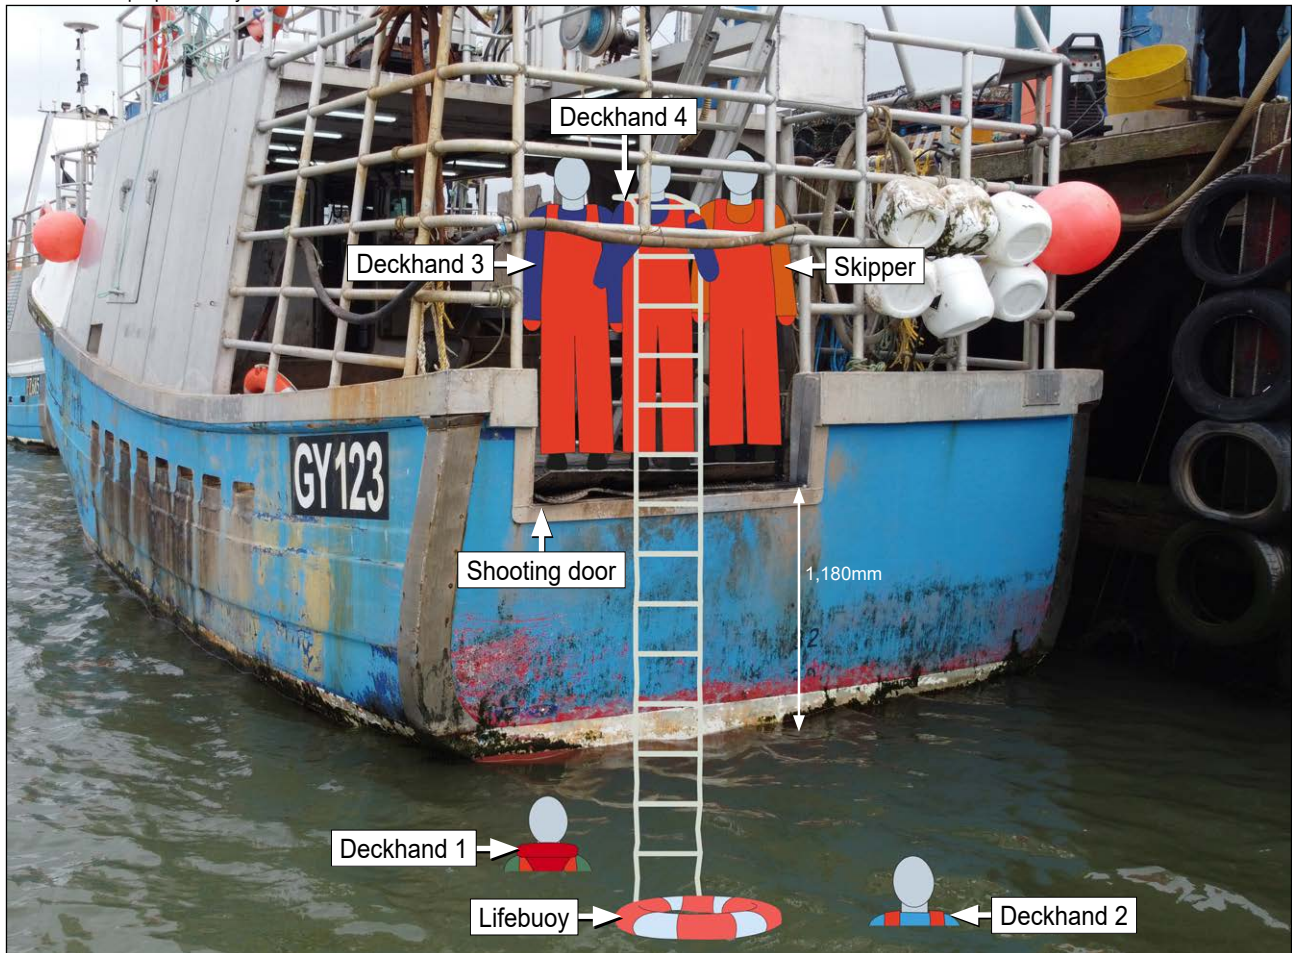
Figure 5: MOB recovery area (freeboard height)

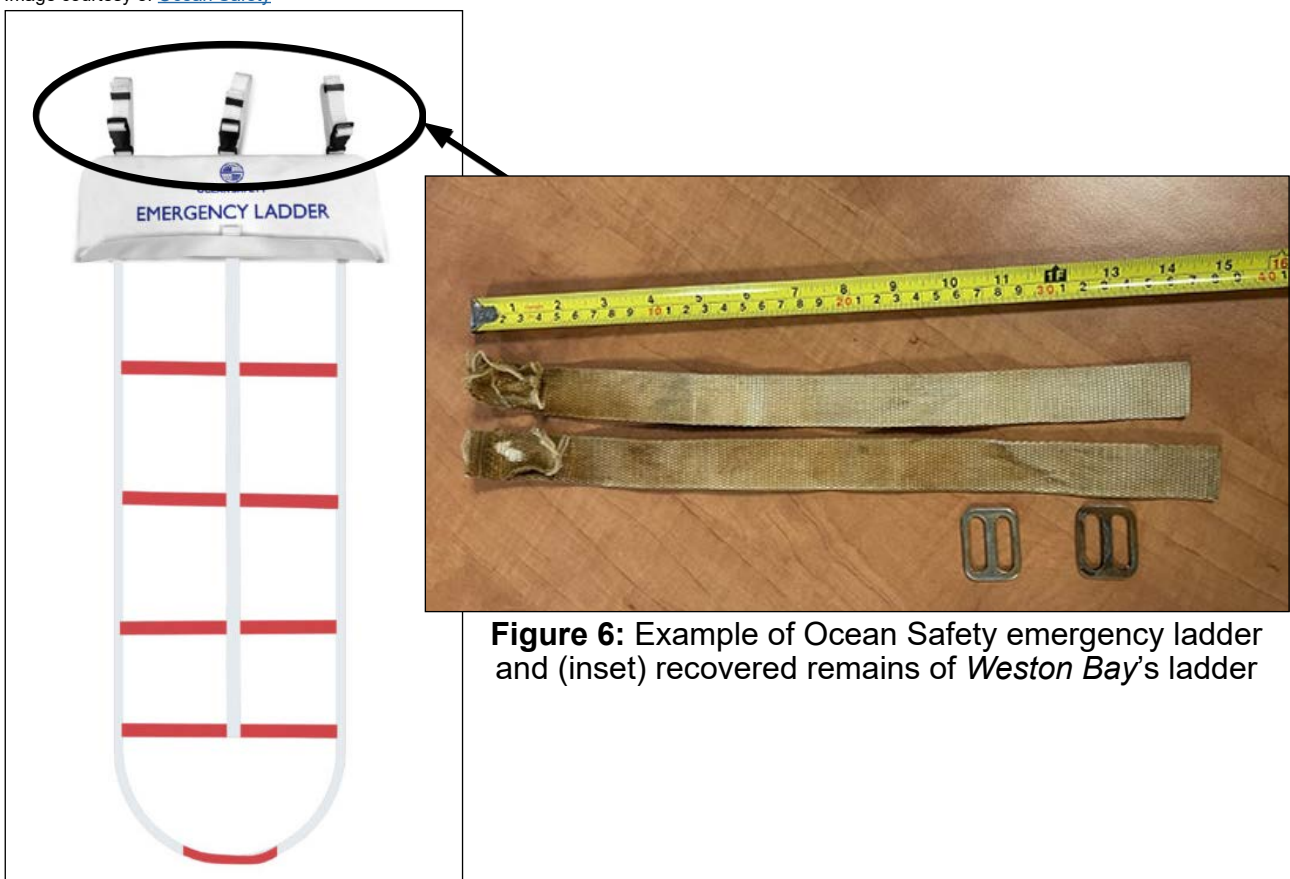
Weston Bay's emergency ladder was stored on the port side of the working deck. Post-accident examination of the ladder's two fastening straps found they were broken and displayed signs of corrosion (**Figure 6**). The rest of the ladder was unavailable for inspection as it was lost at sea during the accident.

Figure 6: Example of Ocean Safety emergency ladder and (inset) recovered remains of *Weston Bay*'s ladder

Weston Bay's Ocean Safety emergency ladder was in very poor condition and began to fail as soon as the crew attempted to use it. Although the crew were able to haul deckhand 1 on board using the ladder as an improvised scramble net, the ladder catastrophically failed and fell apart when deckhand 2, who was approximately 46kg heavier than deckhand 1, attempted to use it. The crew then had no available means to recover deckhand 2 on board.

It is evident that the emergency ladder provided on *Weston Bay* was not suitable for recovering an unconscious person from the water. This was contrary to updated requirements and placed the crew at risk in an MOB event. Additionally, *Weston Bay's* crew had not conducted regular inspections of the vessel's MOB recovery equipment, which resulted in the ladder's significant deterioration going

unnoticed and failing catastrophically when most needed. The ladder's degraded condition hampered the crew's ability to recover deckhand 1 and its failure meant the ladder was completely ineffective to recover deckhand 2.

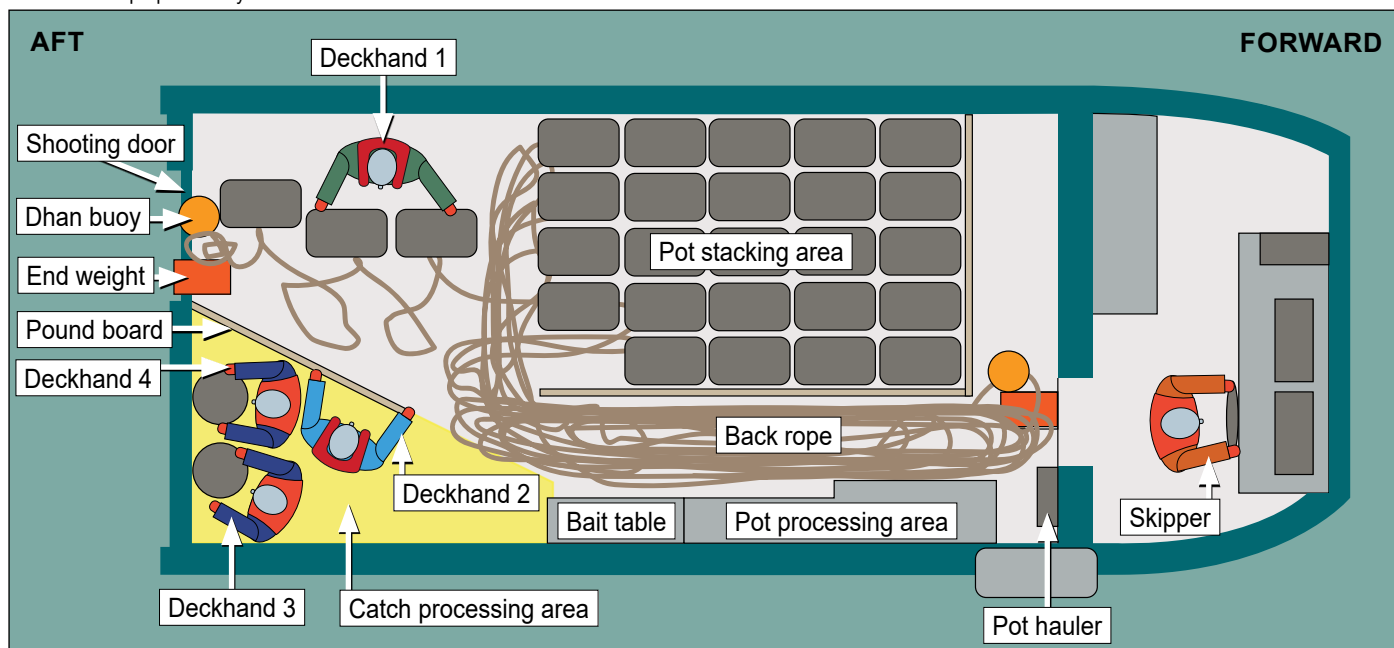
The accident happened when the inexperienced deckhand 1 was struck and knocked onto the deck (see **figure**) while downstacking a string of shooting pots and was taken overboard by the next pot in sequence. Deckhand 2 entered the water as he went to assist.

Figure: Crew positions at the shooting stations
