Grounding and subsequent loss of the fishing vessel *Crystal Stream* (LH 147) on Barmore Island, Loch Fyne, Scotland on 6 June 2025

SUMMARY

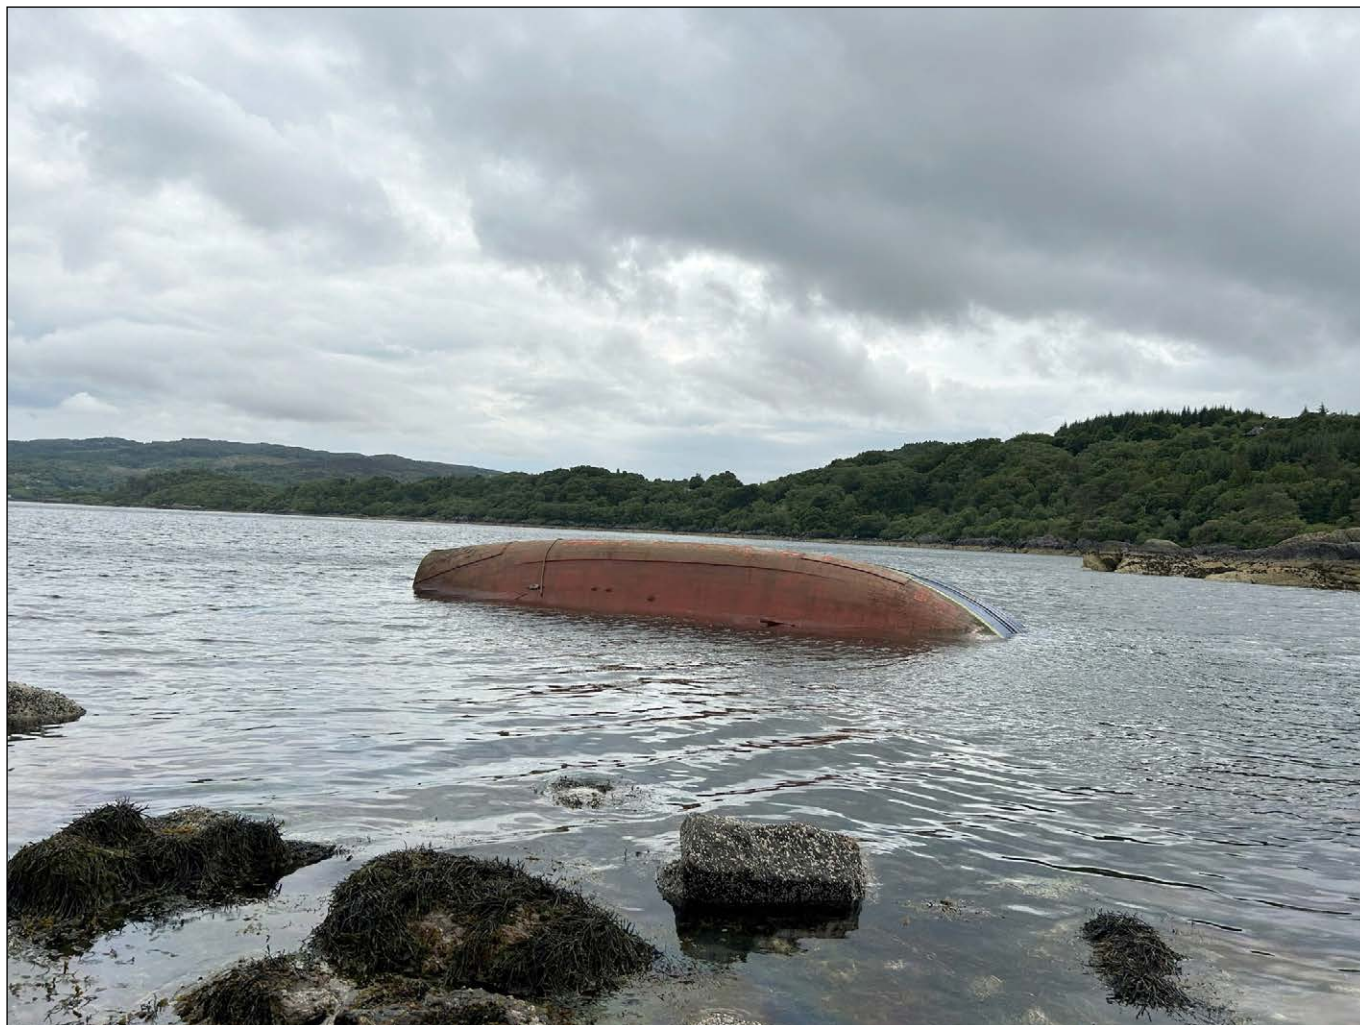
Figure 2: *Crystal Stream* lying on its port side, partially submerged

After an initial attempt was made to pump out the water entering *Crystal Stream*, the skipper deliberately grounded the vessel on Barmore Island and the crew abandoned to a liferaft. Once aground, the damage to *Crystal Stream* caused its fish hold to flood. As the tide fell further, the vessel rolled onto its port side and was partially submerged.

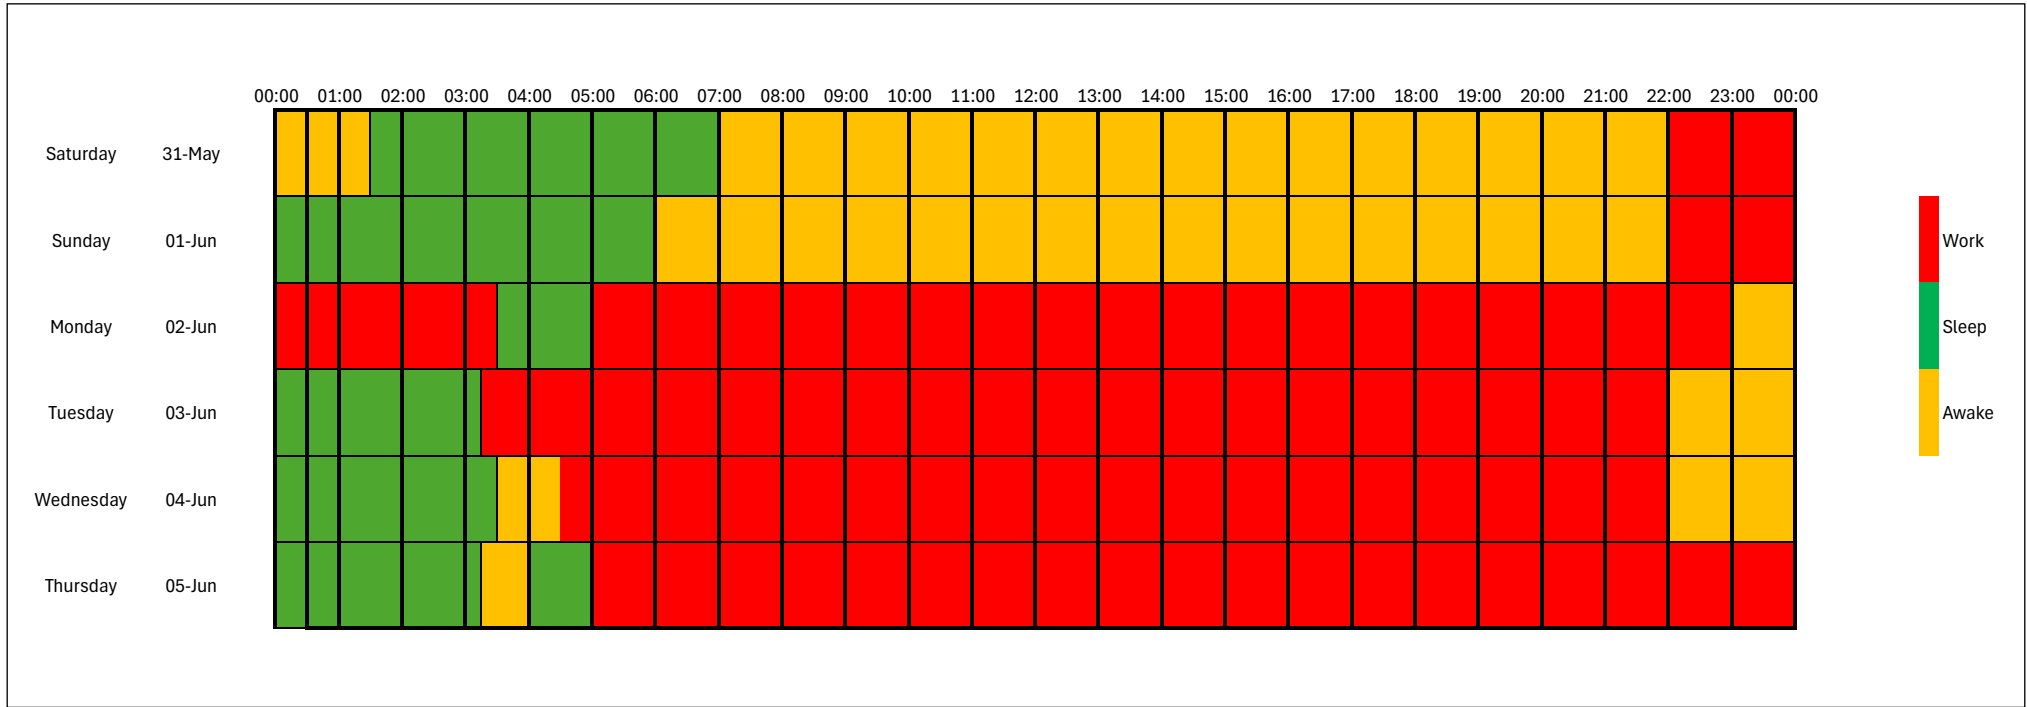
Figure 3: Skipper's hours of work and rest

The skipper of *Crystal Stream* was managing their own rest periods at the time of the accident. However, their rest schedule did not meet the minimum requirements set out in MSN 1884 (F) Amendment 1 to reduce the risk of fatigue.

In the 24 hours before the grounding the skipper had a little over 4 hours rest, divided between two separate periods. In the six days leading up to the accident, the skipper's rest totalled just over 24 hours (**Figure 3**). The skipper's rest fell far short of that required by the legislation. Analysis of the skipper's sleep patterns indicated a significant sleep debt had accumulated in the week leading up to the accident, making it highly likely they were severely fatigued.

- The adoption of a safety management system aligned with the Fishing Safety Management Code.
- The implementation of watchkeeping procedures aligned with the guidance in MGN 313 (F) and the Fishermen's Safety Guide.
- The implementation of a fleetwide fatigue management system to ensure that crew on board its vessels are provided with adequate rest in line with MSN 1884 (F) Amendment 1.
