# Overspeeding at Grantham South Junction, 26 September 2025

## Summary of the incident

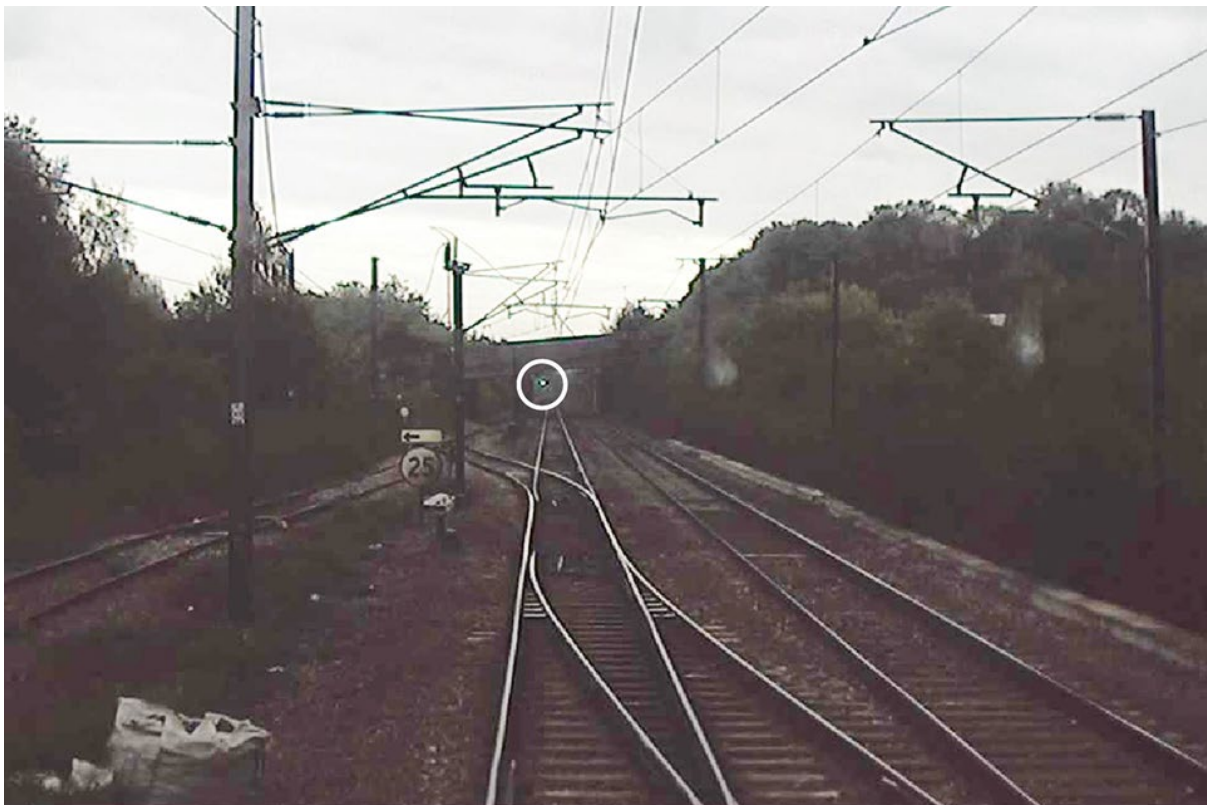
A comparison of data obtained from the OTDR on train 1Y80 and FFCCTV images shows that, around the location the train began to increase speed, the next signal ahead on the Up Fast line, signal D12, had come into view and was displaying a green (proceed) aspect. This signal is located beyond Grantham South Junction and so did not apply to train 1Y80, which was being routed onto the Up Slow line.

RAIB considers it likely that the driver reacted to this green signal (known as 'reading through') causing them to accelerate towards the higher permitted speed of the straight-ahead route. This is supported by the fact that the driver continued to apply traction power until the train was deflected towards the Up Slow line at the junction points. This response to the signal on the Up Fast line beyond the junction was either as a consequence of the driver not correctly observing the route information provided by signal D22 or forgetting this information after passing it.

FFCCTV image from train 1Y80 showing the Up Fast line signal displaying a green aspect (in white circle) which did not apply to train 1Y80 (courtesy of LNER).
