Rail Accident Investigation Branch

Rail Accident Report

**Pedestrian struck by a train at Pewsey footpath crossing, Pewsey, Wiltshire
26 February 2025**

Report 05/2026
May 2026

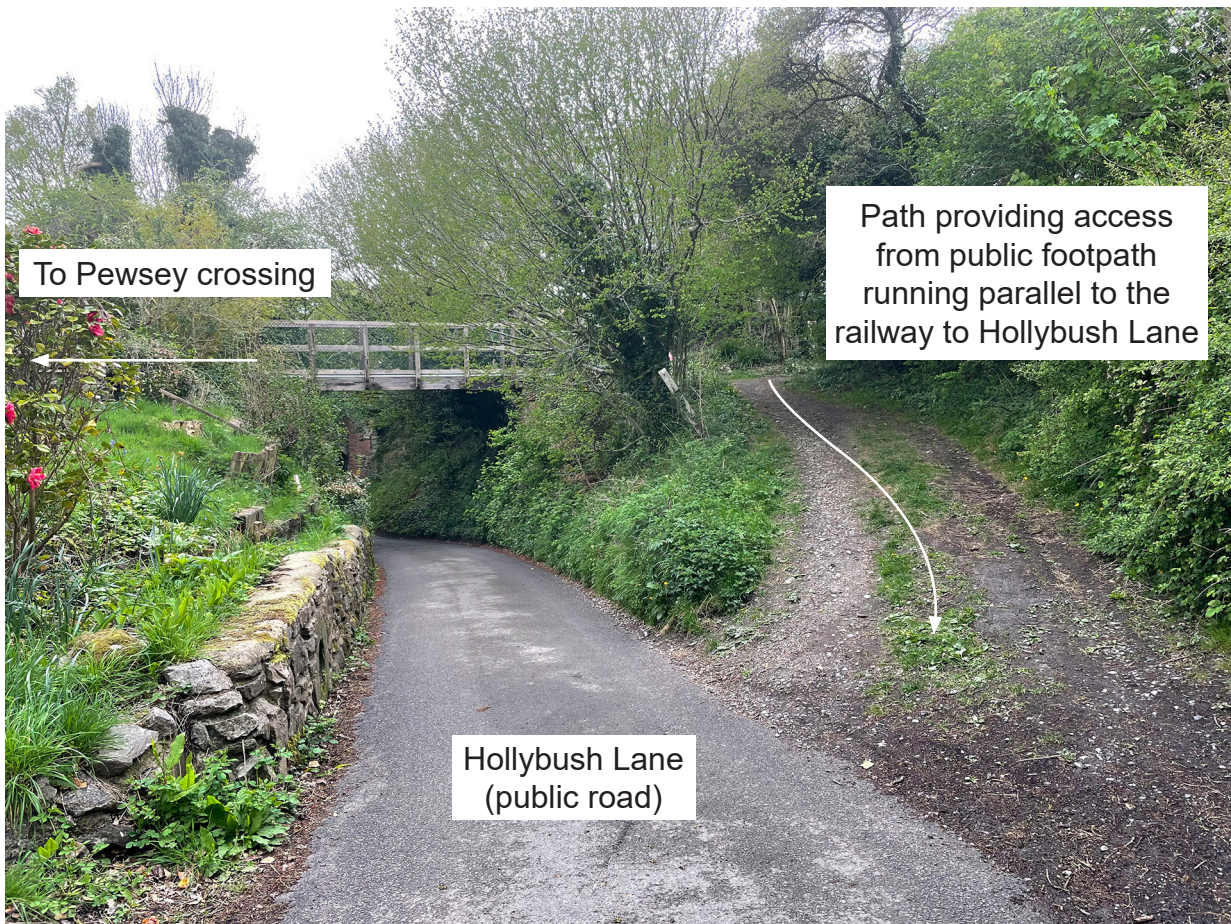
Figure 3: Hollybush Lane side bridge.

- 172 Network Rail records show that detailed examinations of Hollybush Lane side bridge had been conducted annually since at least 2018 due to the bridge's timber construction. Condition reports from 2018 to 2021 show consideration of decay of the timber structure and in 2022 Network Rail decided to replace the bridge with a new structure. This replacement was expected to be completed in 2023 or 2024. However with insufficient funding being available, and other locations being deemed a higher priority, Network Rail delayed the replacement of the bridge.

- 173 A further detailed examination of the bridge in 2023 showed no further deterioration of the structure. In September 2024, a detailed examination noted worsening deterioration and recommended the bridge for immediate closure. Initially, in September 2024, Network Rail decided not to replace the bridge but to progress a repair of the timber elements which was planned for January 2025. However, in October 2024 the repair of the bridge was delayed until beyond 2028 due to budget constraints.

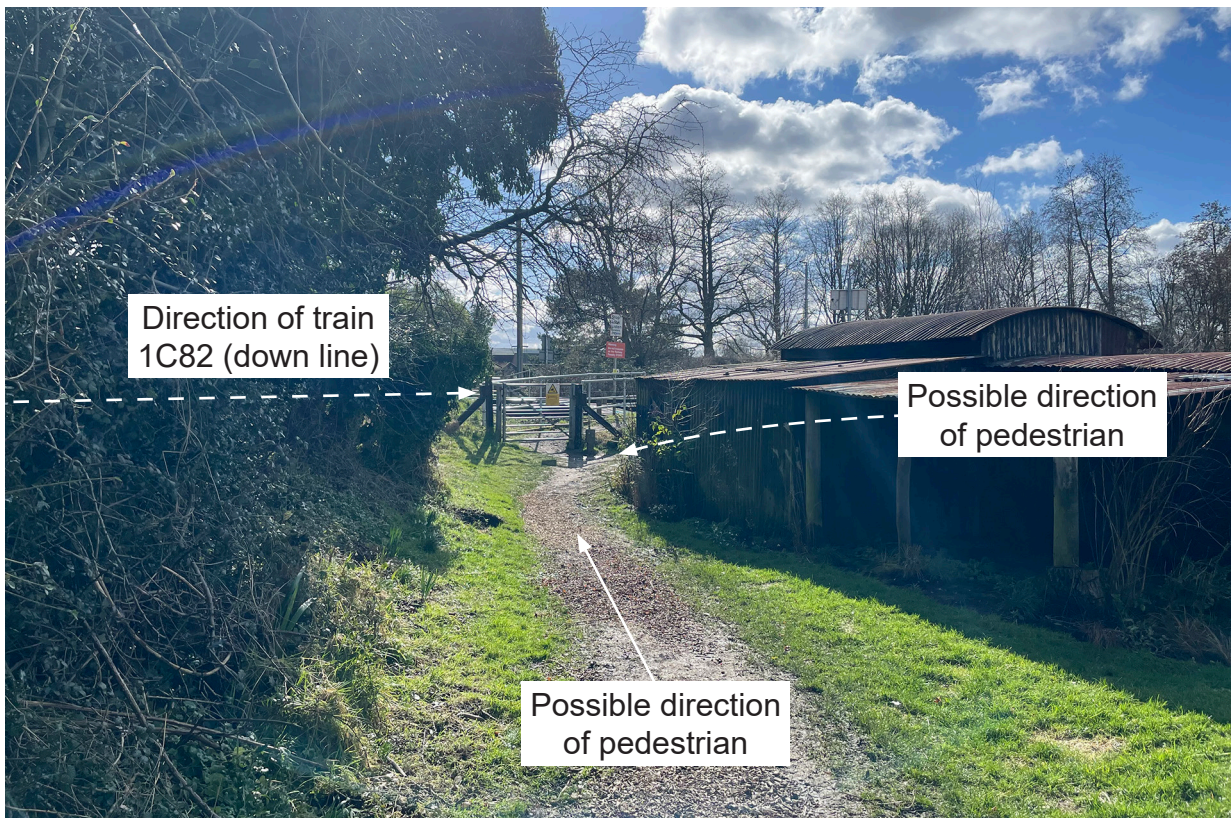
Figure 4: Possible approaches used by the pedestrian to reach the north side of the crossing. The approach parallel to the railway is obscured by a building.

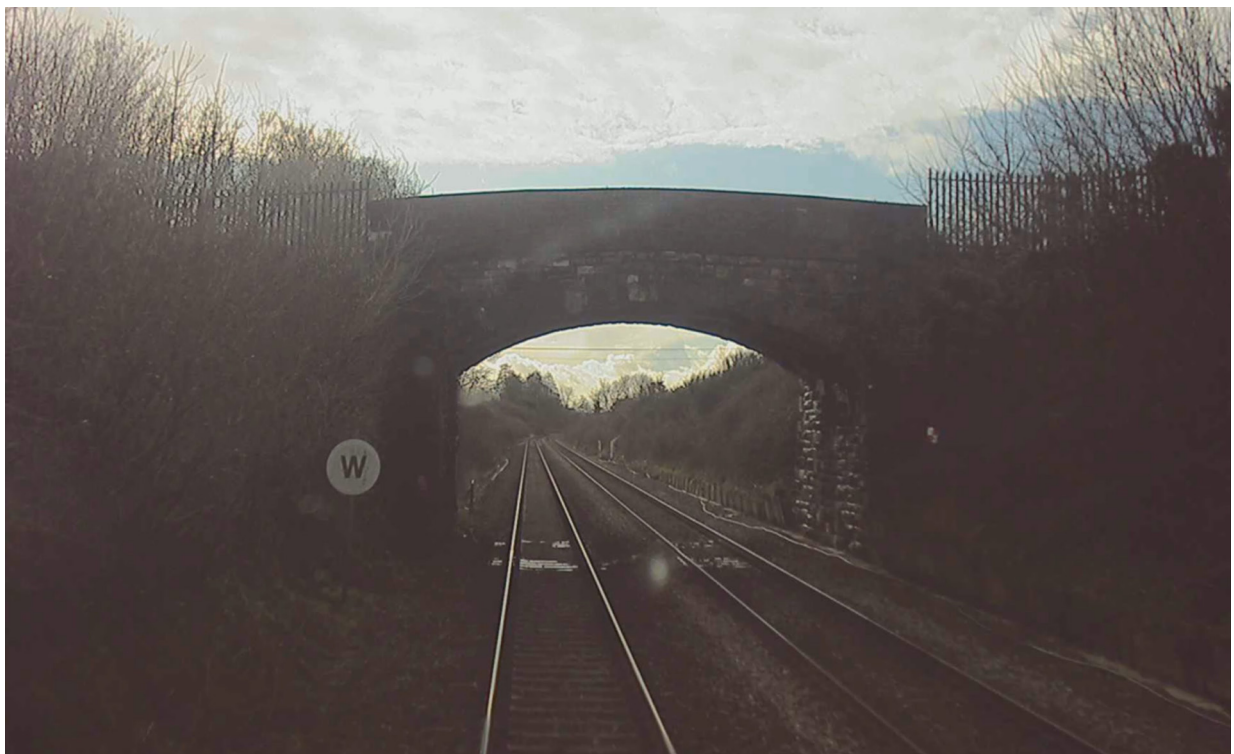
- 7 A whistle board sign is provided lineside at around 580 metres north-east of the crossing (figure 7). The sign indicates to train drivers that they must sound their train's warning horn as they pass. The purpose of trains sounding their horn at this location is to warn pedestrians using the crossing of trains approaching on the down line. A further whistle board is provided lineside around 400 metres south-west of the crossing to warn pedestrians of trains approaching on the up line.
- 8 The pedestrian approached the crossing from the north side (figures 4 and 6). When inspected by RAIB on the day after the accident, the path at this location was uneven in places and muddy. Woodchips had been placed on parts of the surface, likely to improve underfoot conditions.

Figure 7: Forward-facing CCTV showing whistle board sign adjacent to down line near Dursden Lane bridge (courtesy of Great Western Railway).

- 121 Witness evidence shows neither the LCM nor the RLCM considered relocating the Down Westbury line whistle board, which was 580 metres from the crossing, to improve the audibility of horn warning. Witness evidence shows a relocation would only be considered if there was an issue identified, for example with audibility at the crossing, or with train driver visibility (sighting) of the whistle board itself. Neither issue was found during the assessments. The LCM also stated that, on a previous occasion, enquiries they made about relocating a whistle board at another crossing had been rejected because of the associated time and cost implications.

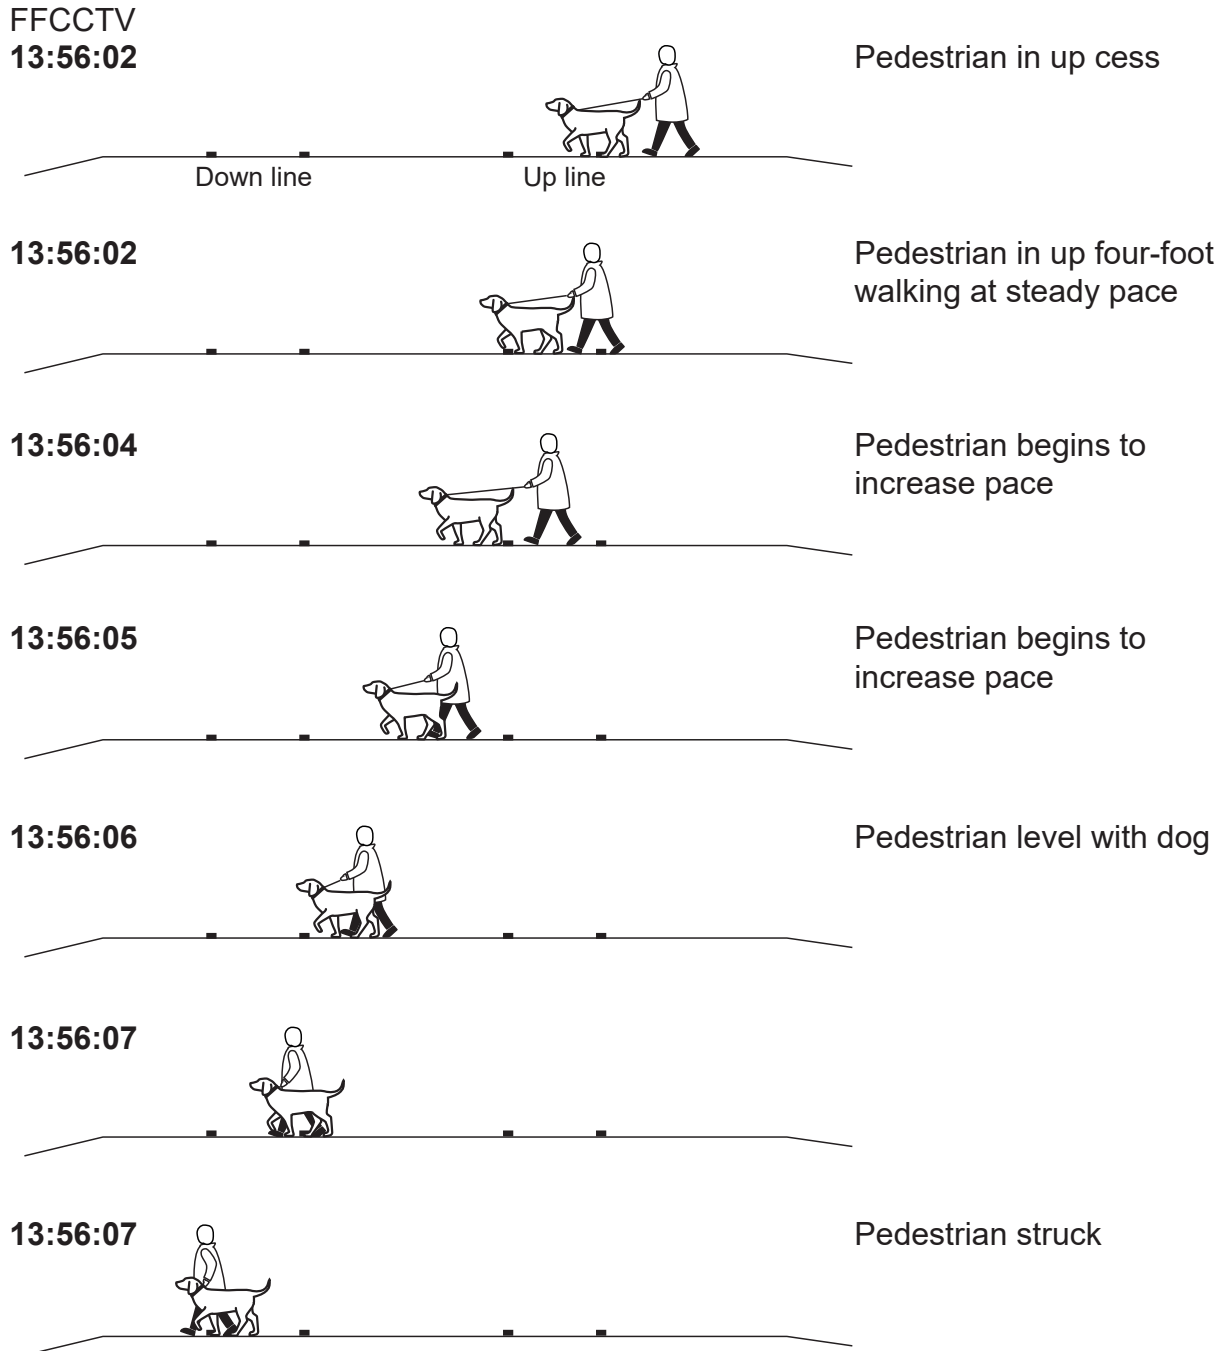
- 30 Around 2.1 seconds before the train reached the crossing, the pedestrian reached a point on the Up Westbury line level with the rail closest to the adjacent Down Westbury line on which the train was approaching. They began to enter the space between the two lines and FFCCTV images show the pedestrian increased their pace towards the southern side of the crossing. When struck by the train, they were almost clear of the crossing but within the swept envelope of the approaching train. The train's emergency brakes remained applied until the train came to a stand about 260 metres beyond the crossing.

Figure 8: Positions of the pedestrian at the crossing during the accident.
