## Accident

| <b>Aircraft Type and Registration:</b> | Bellanca (American Champion) Decathlon<br>8KCAB, G-TALX | |
| <b>Date &amp; Time (UTC):</b> | 30 June 2025 at 1223 hrs | |
| <b>Location:</b> | Tatenhill Aerodrome, Staffordshire | |

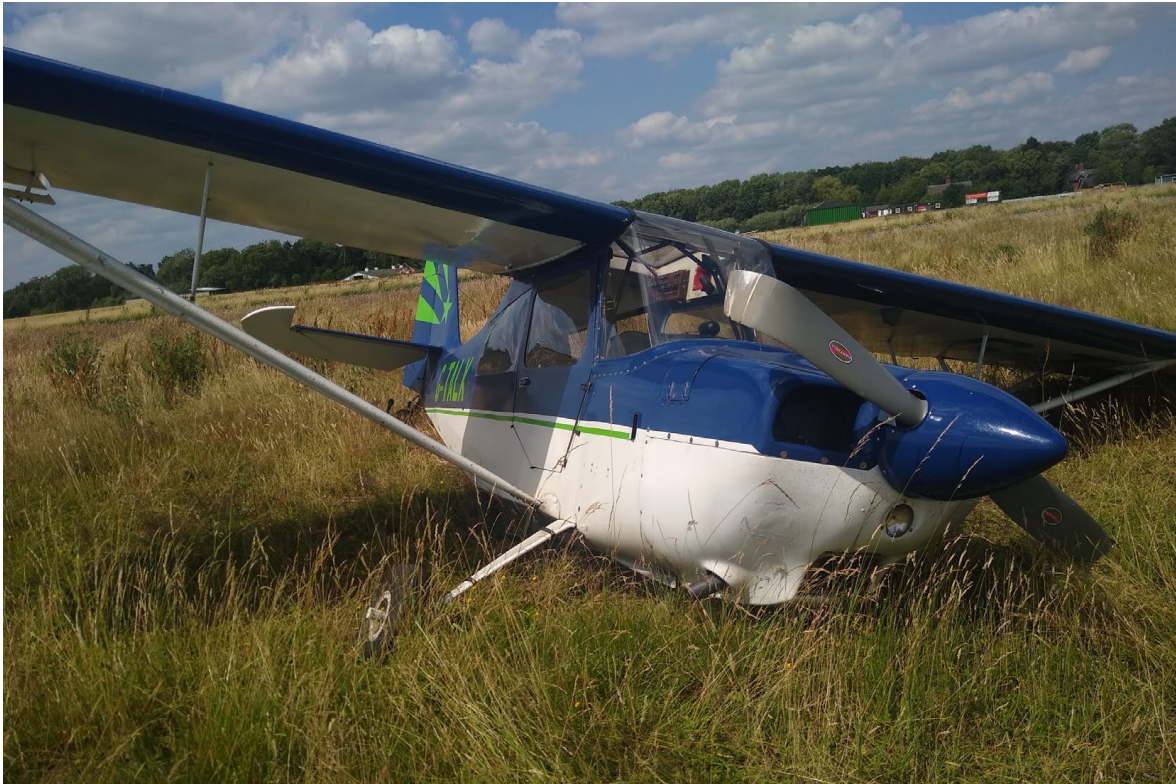
**Figure 1**

The instructor flew the approach to land on Runway 24. Shortly after touching down, he reported that the left landing gear leg separated at the bend at the top of the leg. He applied aileron to hold the left wing up until the airspeed reduced. The left wing subsequently dropped, touching the runway, and the aircraft veered to the left coming to rest off the runway in a grass area. The propeller also struck the ground and suffered damage. Neither occupant sustained injuries, and they exited the aircraft unaided.

Photo of G-TALX after coming to rest in a grassy area

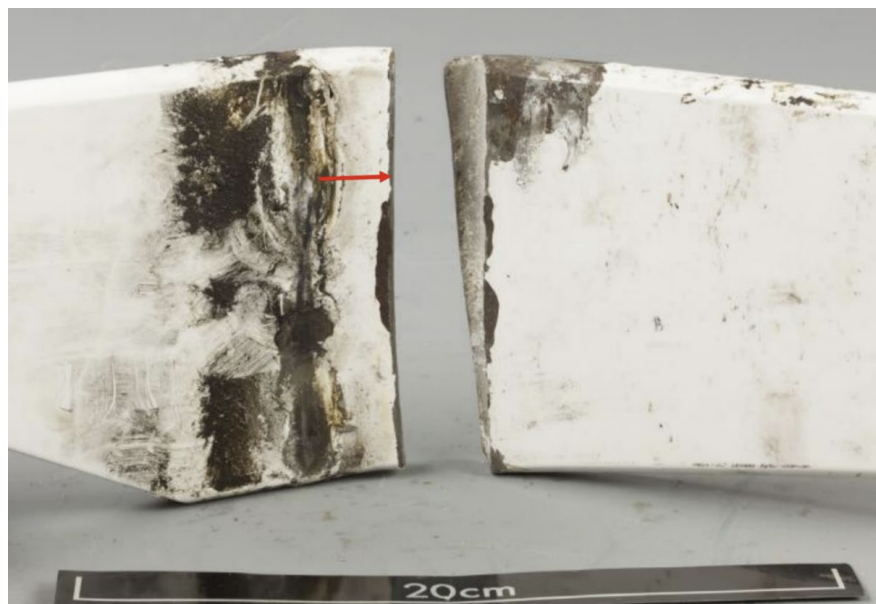
**Figure 3**

There was a loss of paint on the underside of the leg along the line where the fracture had occurred, with corrosion evident on the exposed surface. This is shown in Figure 3. The red arrow indicates a region in which corroded thumbnail-shaped features were observed along the edge of the fracture, shown by Figure 4.

Corrosion on the underside of the landing gear leg

Upon landing, the left landing gear leg failed due overload failure, because of fatigue crack propagation which was initiated by surface corrosion, likely resulting from surface paint loss or damage. G-TALX was operated frequently for flying training, involving multiple takeoffs and landings. Such conditions are conducive to accelerating fatigue crack growth.

It was not possible to determine whether the non-mandatory inspections in Service Letter SL-449 would have detected the damage before the accident to G-TALX occurred. However, operators of this aircraft type may wish to consider incorporating SL-449 into their maintenance programmes, as this would still provide additional opportunities to detect corrosion.
