Accident

Aircraft Type and Registration:	Ikarus C42 FB100 Bravo, G-MOOD	
No & Type of Engines:	1 Rotax 912ULS piston engine	
Year of Manufacture:	2015 (Serial no: 1509-7418)	
Date & Time (UTC):	3 July 2025 at 1030 hrs	
Location:	Field next to Wycombe Air Park, Buckinghamshire	
Type of Flight:	Private	
Persons on Board:	Crew - 1	Passengers - 1
Injuries:	Crew - 1 (Serious)	Passengers - 1 (Serious)
Nature of Damage:	Aircraft destroyed	
Commander's Licence:	National Private Pilot's Licence	
Commander's Age:	61 years	
Commander's Flying Experience:	898 hours (of which 800 were on type) Last 90 days - 135 hours Last 28 days - 8 hours	
Information Source:	Aircraft Accident Report Form submitted by the pilot and other AAIB enquiries

Synopsis

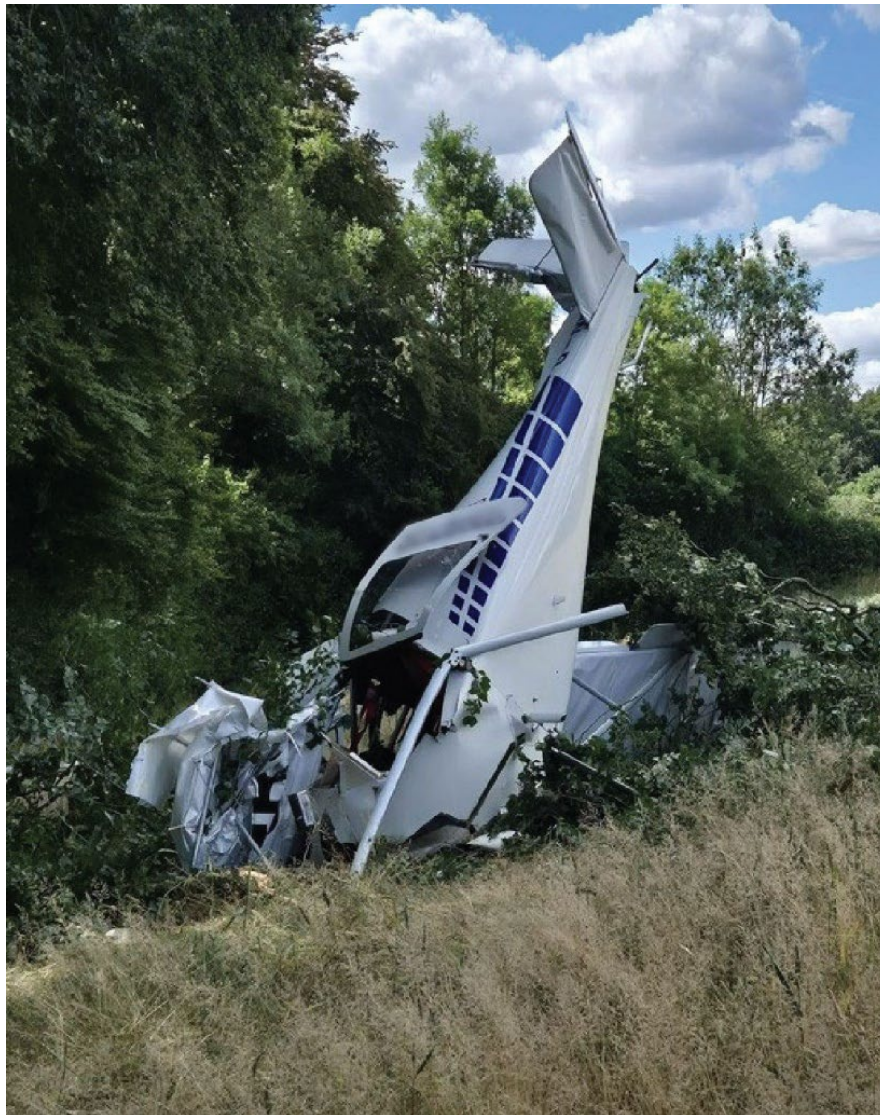
The pilot lowered the nose and reported to the airfield radio operator his intention to land in a field. He did not declare a MAYDAY. The pilot reported switching the fuel pump back on but did not attempt a restart or perform other drills. He reported his focus was to concentrate on the flying and maintaining airspeed. He considered that a landing straight ahead was not possible due to a line of trees and he chose a field to the right to aim for. The pilot was confident of a successful landing in the field but the aircraft collided with trees which pitched the aircraft nose towards the ground resulting in a steep nose-down impact (Figures 1 and 2).

Figure 1
G-MOOD after the accident

The aircraft sustained a total loss of power shortly after takeoff. The pilot made the decision to attempt a forced landing in a field to his right, but struck a line of trees on the edge of the field he was attempting to land in. The aircraft struck the ground seriously injuring both occupants.

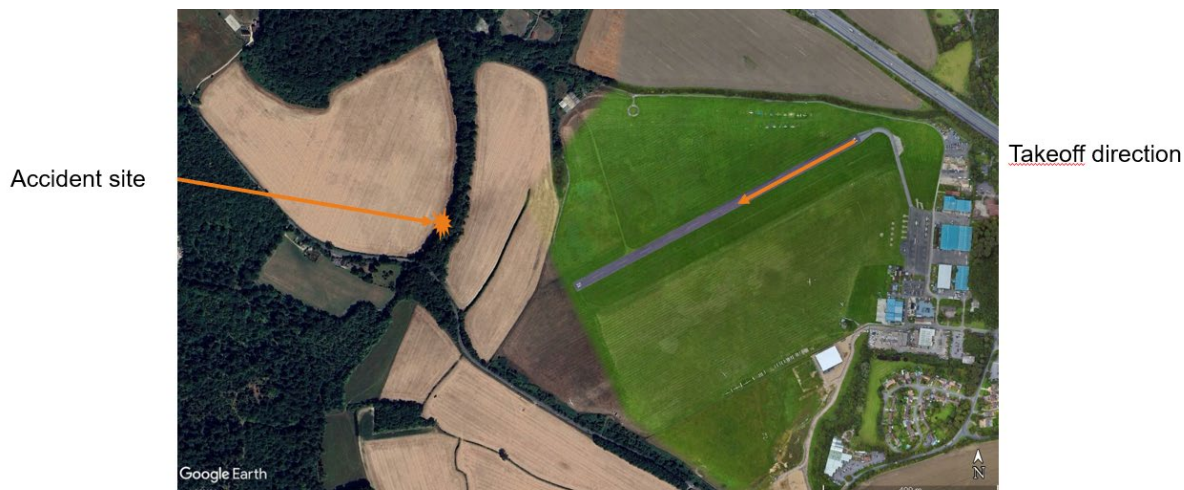
Figure 2
Accident site location

With limited options ahead due to woodland, the pilot of G-MOOD selected an appropriate field and correctly prioritised aircraft control during the emergency. This avoided a stall/spin scenario that may have had worse consequences.
