Serious Incident

Aircraft Type and Registration:	DG Flugzeugbau DG-1000T, G-CKLY	
No & Type of Engines:	1 SOLO 2350 C piston engine	
Year of Manufacture:	2005 (Serial no: 10-66T6)	
Date & Time (UTC):	26 April 2025 at 1623 hrs	
Location:	Court Place Farm Nature Park, Oxfordshire	
Type of Flight:	Private	
Persons on Board:	Crew - 1	Passengers - 1
Injuries:	Crew - None	Passengers - None
Nature of Damage:	Damage to propeller, fuselage and left wing. Propeller coupling separated	
Commander's Licence:	Light Aircraft Pilot's Licence	
Commander's Age:	57 years	
Commander's Flying Experience:	1,500 hours (of which 52 were on type) Last 90 days - 9 hours Last 28 days - 4 hours	
Information Source:	Aircraft Accident Report Form submitted by the pilot and further enquiries by the AAIB

Synopsis

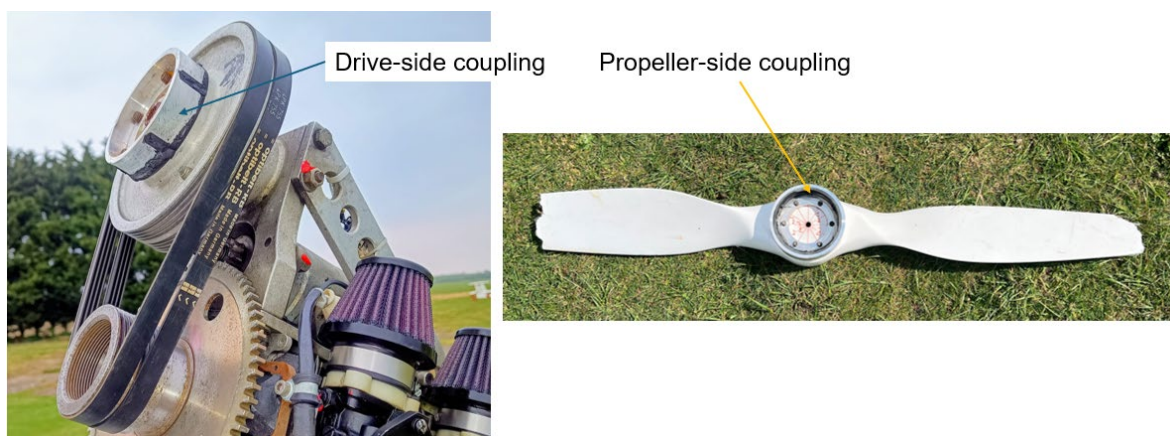
Figure 1

After confirming that the control surfaces were functional, he radioed for a straight-in approach to Runway 01 at Weston-on-the-Green. The landing was uneventful and both occupants exited the aircraft without injury. The propeller was recovered and provided to the AAIB along with the coupling (Figure 1) for further investigation.

Engine and propeller after the flight

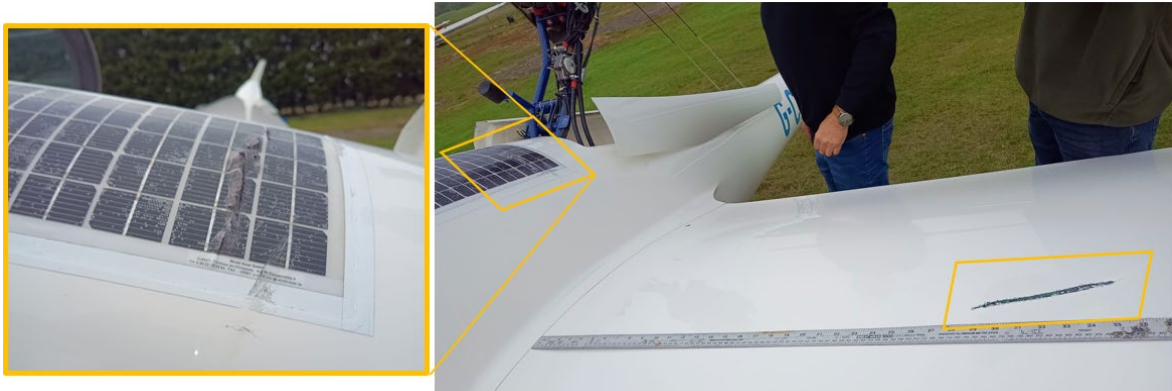
Figure 5

After the landing the aircraft was inspected by the pilot and damage was found on the top of the fuselage, solar panel and the top surface of the left wing (Figure 5).

Damage found to G-CKLY after landing

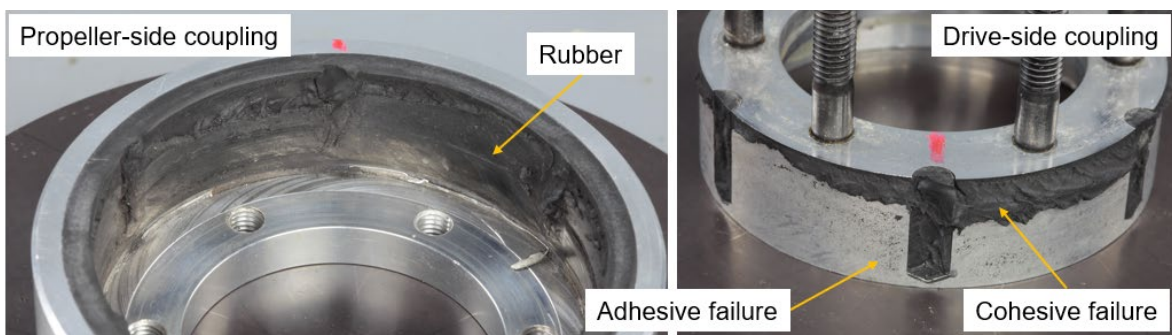
Figure 6

The two halves of the coupling were examined and it was found that the rubber element was predominantly retained within the propeller-side coupling. Both halves showed two distinct regions of the failure, the first; a cohesive failure of the rubber element; and the second, an adhesive failure between the rubber element and the drive-side coupling (Figure 6).

Observed adhesive and cohesive failures

The bonding failure of the NBR dampening component within the drive coupling was primarily a result of an adhesive bond failure between the rubber and the drive-side coupling. This led to a cohesive failure of the rubber that had successfully bonded to both halves of the coupling. The bonded area of the drive-side coupling was approximately 33% of the total area and was insufficient to transmit the engine torque load to the propeller. This resulted in the loss of the propeller when the coupling separated and the damage to the aircraft.

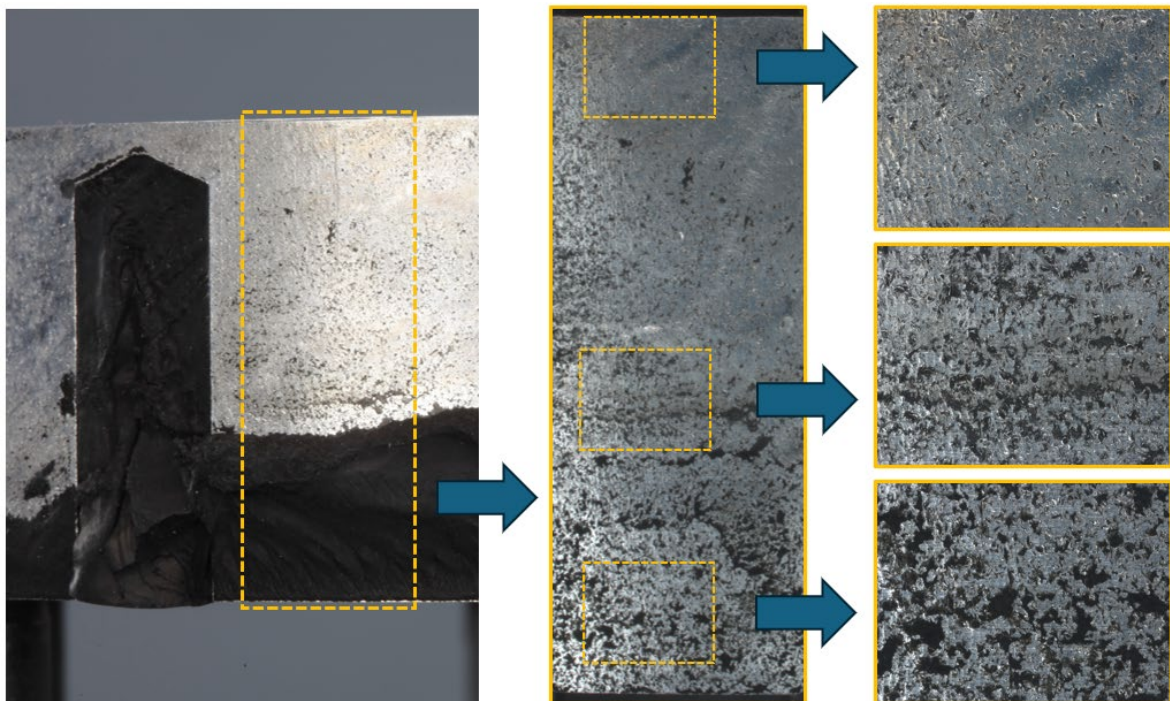
Figure 8

A random section was chosen from the drive-side coupling and by using acetone, as much rubber as possible was removed. It was not possible to completely remove all the rubber from the surface pitting and therefore an accurate surface roughness measurement could not be made. Instead, a qualitative assessment was made at three different locations on the section as shown in Figure 8.

Examination of the drive-side coupling surface finish

The areas where bonding was more effective directly correlated to a rougher surface finish, such that would be expected from the media blasting process. The density of media blast impacts gradually decreased from the bonded to the de-bonded region.
