# ***AAIB Bulletin***

***5/2026***

<b>Aircraft Type and Registration:</b>	Cessna FRA150L, G-PPFS
<b>No &amp; Type of Engines:</b>	1 Continental Motors Corp O-240-A piston engine
<b>Year of Manufacture:</b>	1972 (Serial no: 0126)
<b>Date &amp; Time (UTC):</b>	28 July 2024 at 0845 hrs
<b>Location:</b>	Near Thorganby, North Yorkshire
<b>Type of Flight:</b>	Private
<b>Persons on Board:</b>	Crew - 1                      Passengers - 1
<b>Injuries:</b>	Crew - 1 (Fatal)              Passengers - 1 (Fatal)
<b>Nature of Damage:</b>	Aircraft destroyed
<b>Commander's Licence:</b>	Private Pilot's Licence
<b>Commander's Age:</b>	21 years
<b>Commander's Flying Experience:</b>	153 hours (of which 131 were on type) Last 90 days - 53 hours Last 28 days - 13 hours
<b>Information Source:</b>	AAIB Field Investigation

<b>Aircraft Type and Registration:</b>	Taylor Monoplane, G-AYSH	
<b>No &amp; Type of Engines:</b>	1 Volkswagen 1600 piston engine	
<b>Year of Manufacture:</b>	1973 (Serial no: PFA 1413)	
<b>Date &amp; Time (UTC):</b>	17 June 2025 at 0936 hrs	
<b>Location:</b>	Nayland Airfield, Suffolk	
<b>Type of Flight:</b>	Private	
<b>Persons on Board:</b>	Crew - 1	Passengers - None
<b>Injuries:</b>

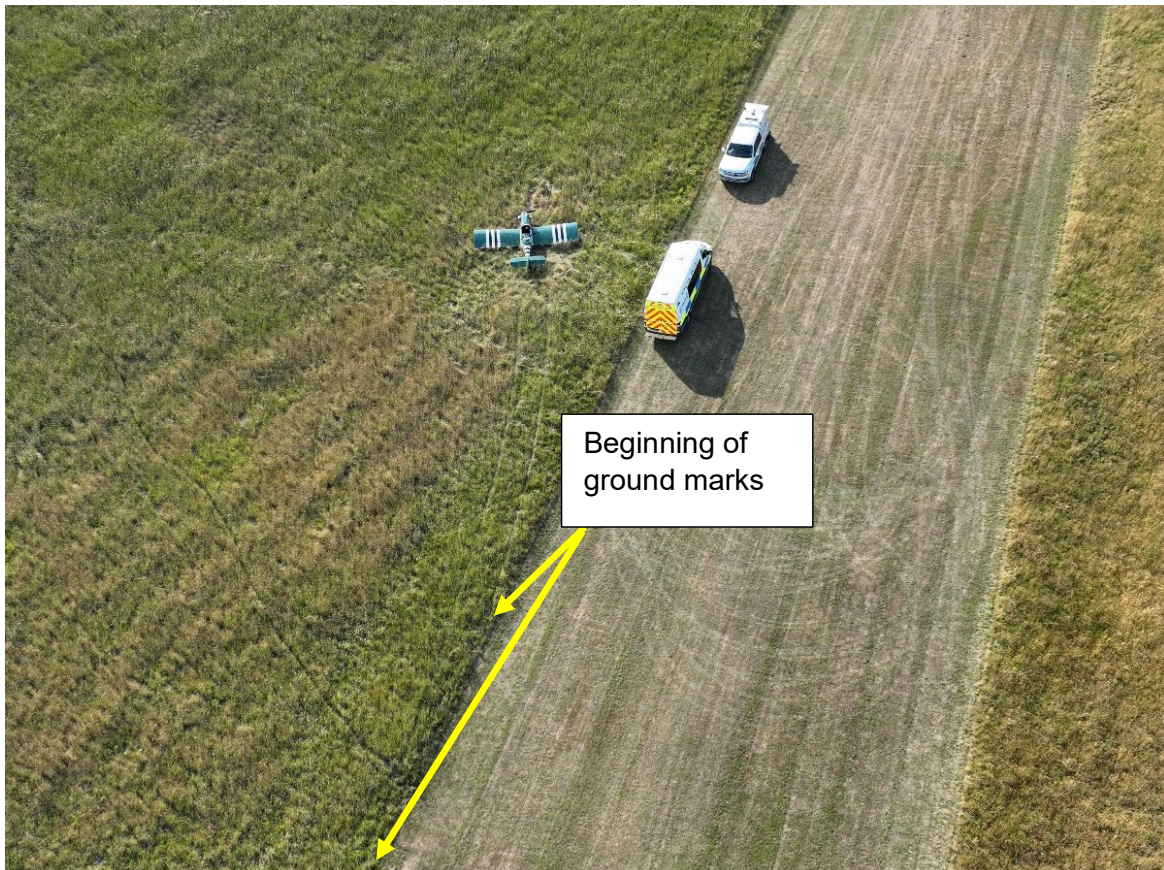
**Figure 1**

The canopy had broken, with all pieces of transparency found next to the aircraft. There had been a fuel leak, but no fire. The aircraft was righted by first responders.

Aircraft position (after righting), viewed from the Runway 32 direction

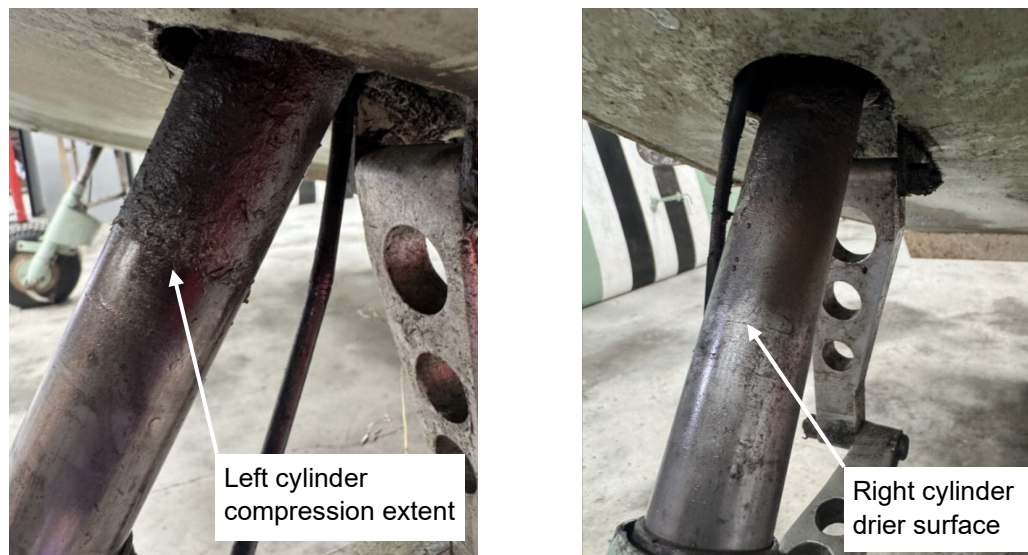
**Figure 5**

The left main landing gear cylinder showed evidence of compression, identified by a defined line in the grease accumulation (Figure 5). There was a cleaner, lightly oiled section of outer surface where it slides into the cylinder housing. With light downward force applied, the gear compressed freely and returned to its extended position unaided.

Left and right gear cylinders

The right main landing gear's cylinder surface in comparison was drier with a poorer finish. Light downward force was applied, but the cylinder was found to be seized in position. With

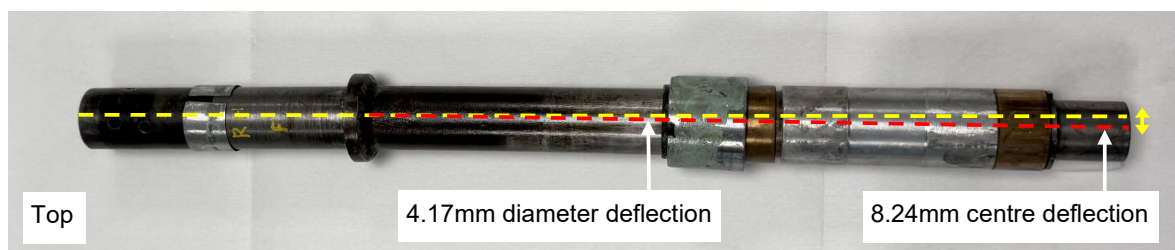
**Figure 6**

The right cylinder was found to be out-of-true by 8.24 mm between centres over its length. The mid-point deflection from centreline to outer surface was 4.17 mm (Figure 6).

Right cylinder measurement

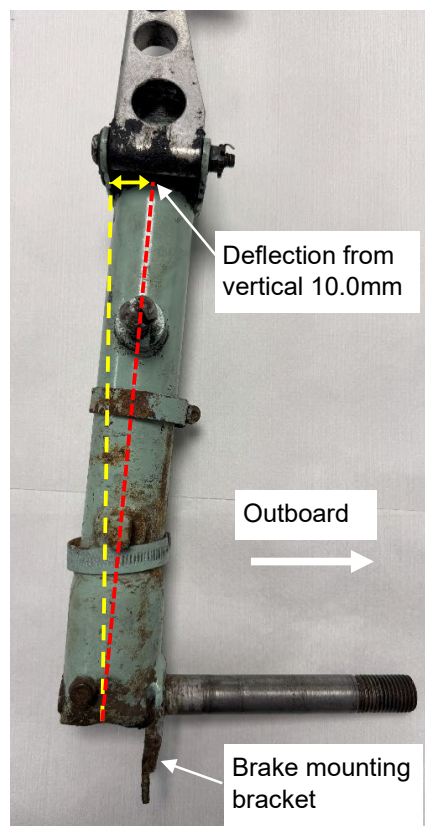
**Figure 7**

Right cylinder housing measurement

The top of the cylinder housing was deflected 10.0 mm outboard in comparison with the base (Figure 7). The brake mounting bracket on the bottom of the cylinder had been damaged previously and a welded repair applied, which was overpainted.

The right main landing gear shock absorber was found to be partially seized and had no rebound. Examination revealed that both the cylinder housing and the cylinder were bent outboard, likely from a historic event due to the amount of main spring outer coil wear and the presence of an overpainted repair. The misalignment of the cylinder and housing led to reduced ability for the cylinder and sleeve assembly to slide within the cylinder housing, resulting in an imbalance in compression between the right and left landing gear assemblies. The condition of the right leg cylinder's outer surface in comparison to the left indicates it may have had restricted compression for some time. The reduced amount of oil recovered from the right cylinder housing would have had contributed to a lower level of damping available if the cylinder was moving normally.

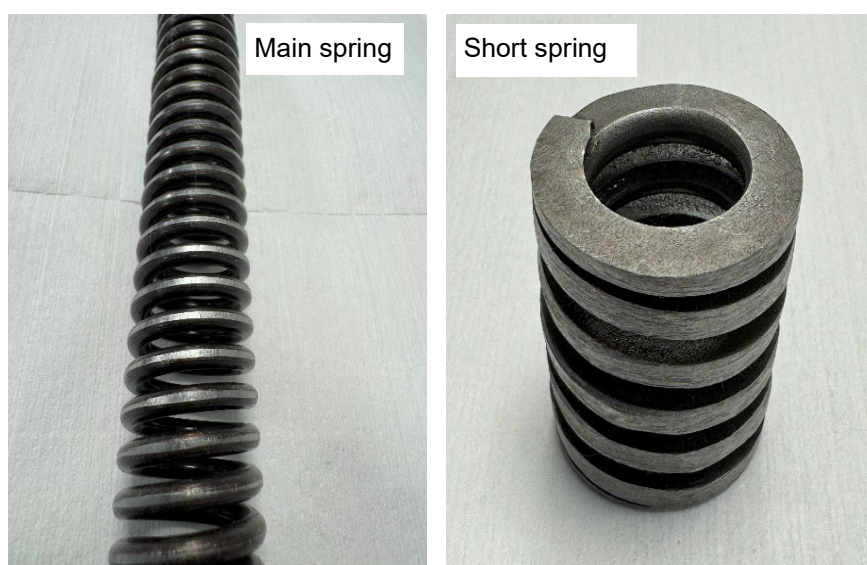
**Figure 8**

Inside the right cylinder, there were witness marks from the springs fretting against the inner surface. The longer main spring showed corresponding areas of wear on the outside of the coils (Figure 8). The shorter spring's outside edges had been ground to a squared-off finish; the inside edges of the coils were rounded. The outer coil surface finish was rough, and they were not consistently circular in shape.

Right landing gear springs

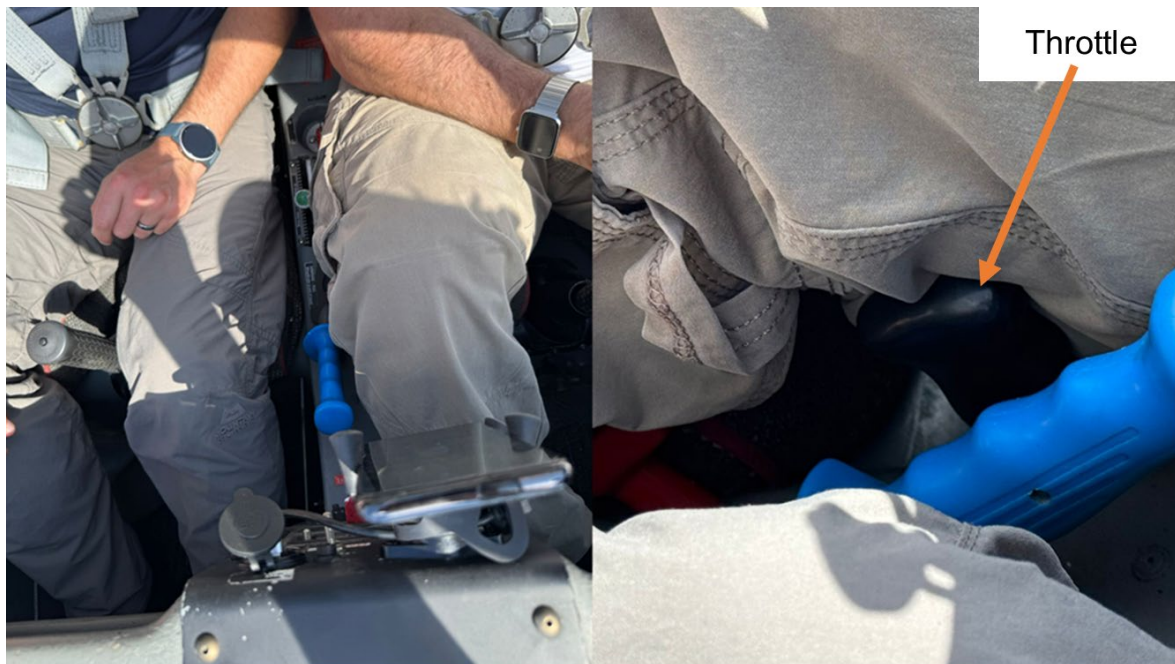
**Figure 13**

In particular, the throttle control was positioned in the crook of the left seat occupant's knee and inadvertent movement was possible, for example if moving the legs to avoid obstructing the rudder pedals (Figure 13). The airbrake control was not obstructed or at risk of inadvertent operation due to its length and direction of movement.

Obstruction of controls on the centre console

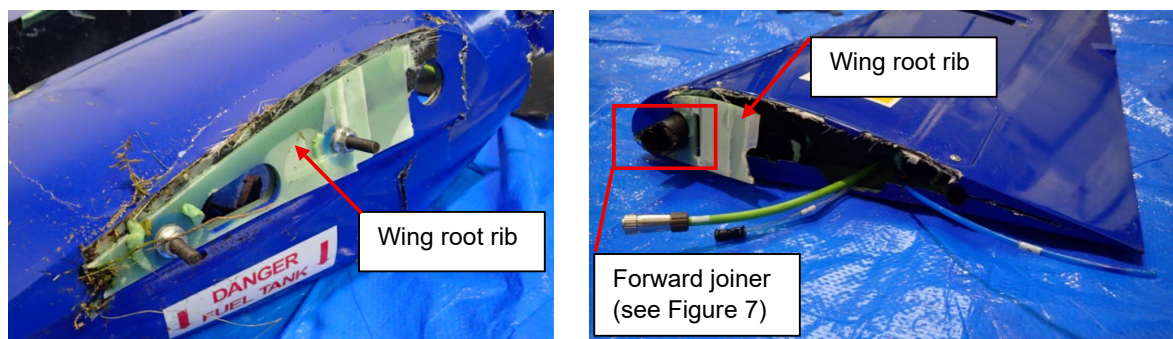
**Figure 6**

Examination of the right wing and wing-to-fuselage connection revealed that the reinforced root rib had been pulled out of the wing structure and had experienced an intra-ply failure. The forward third of the root rib remained loosely attached to the right wing, while the remaining portion of the root rib, along with the inboard wing root skin, remained attached to the fuselage by the wing attachment bolts (Figure 6).

Right wing-to fuselage attachment interface and large portion of wing root rib (left image) and right wing root with remaining small portion of wing root rib attached (right image)

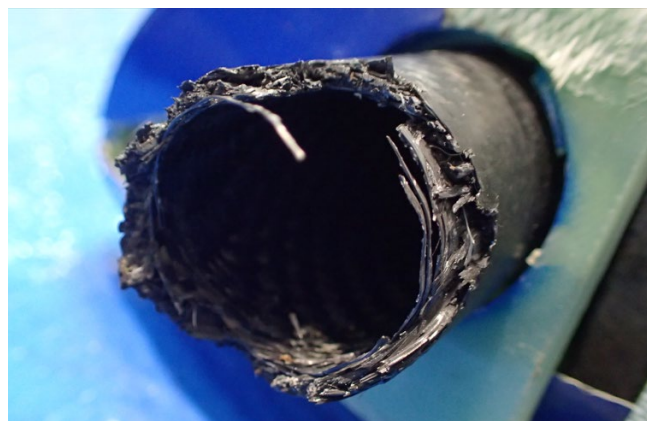
**Figure 7**

The forward and rear single-piece wing joiners had each broken into three parts, with a segment remaining installed in each wing and a central portion remaining within the fuselage. The fracture face of the forward joiner portion remaining in the right wing, which can be seen in Figure 6, is shown in more detail in Figure 7.

Fracture face of right wing forward wing joiner

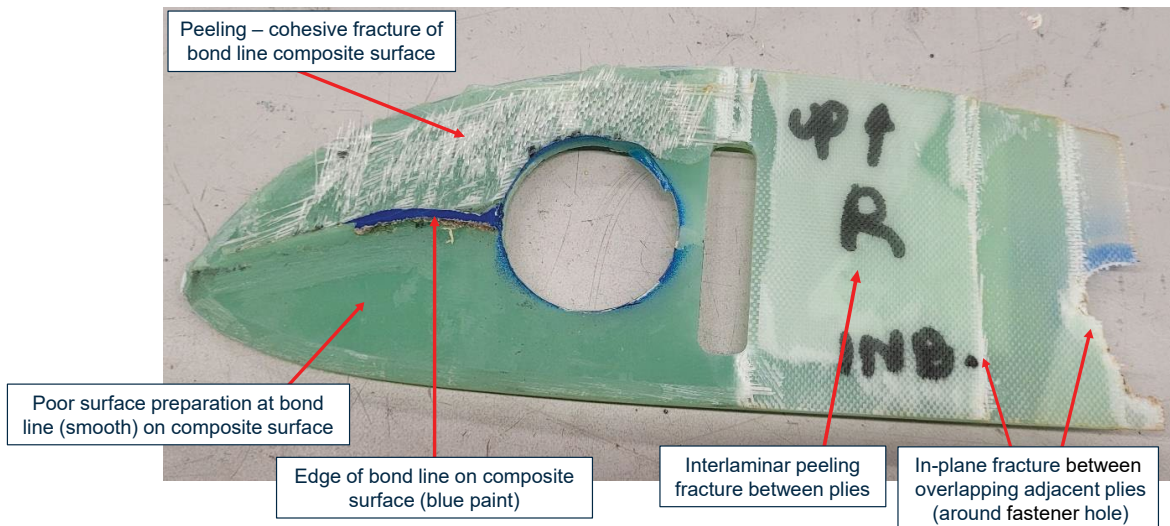
**Figure 8**

Examination of the GFRP root rib reinforcement showed that there was an absence of surface preparation or bonding along the bottom half of the bond line, on the surface that bonded to the wing root skin. This would have compromised the strength of the structure in this area and promoted peeling fracture under the wing bending loads (Figure 8).

Inboard face, forward portion of right wing GFRP root rib

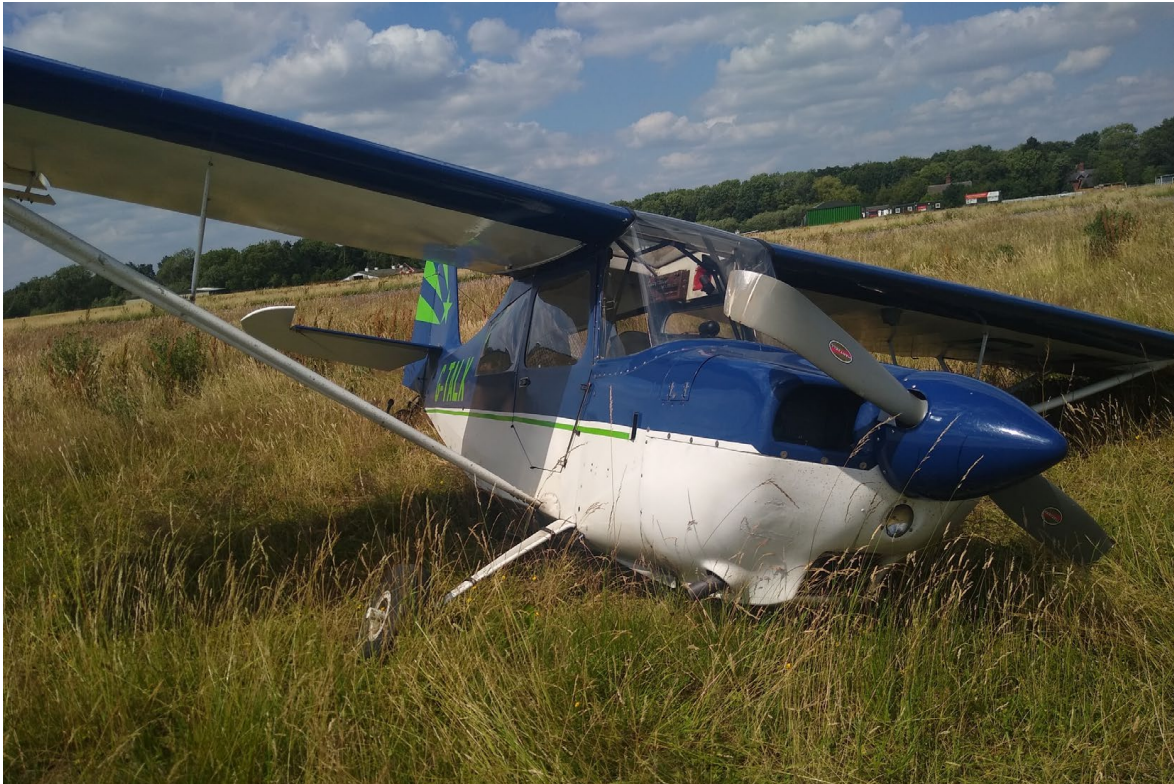
**Figure 1**

The instructor flew the approach to land on Runway 24. Shortly after touching down, he reported that the left landing gear leg separated at the bend at the top of the leg. He applied aileron to hold the left wing up until the airspeed reduced. The left wing subsequently dropped, touching the runway, and the aircraft veered to the left coming to rest off the runway in a grass area. The propeller also struck the ground and suffered damage. Neither occupant sustained injuries, and they exited the aircraft unaided.

Photo of G-TALX after coming to rest in a grassy area

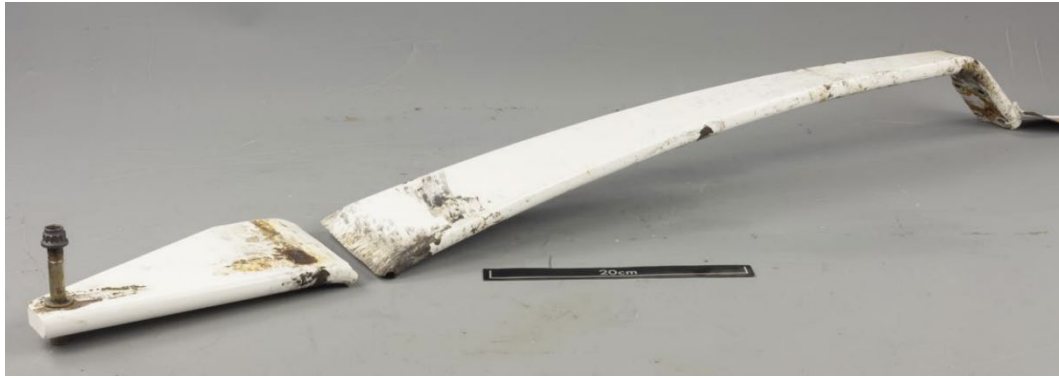
**Figure 2**

The two parts of the fractured left landing gear leg, recovered by the AAIB

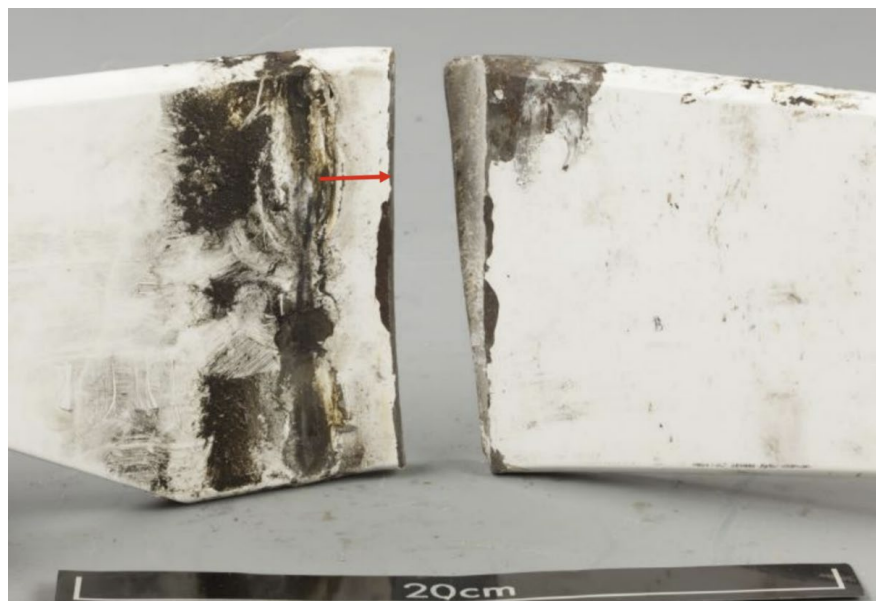
**Figure 3**

There was a loss of paint on the underside of the leg along the line where the fracture had occurred, with corrosion evident on the exposed surface. This is shown in Figure 3. The red arrow indicates a region in which corroded thumbnail-shaped features were observed along the edge of the fracture, shown by Figure 4.

Corrosion on the underside of the landing gear leg

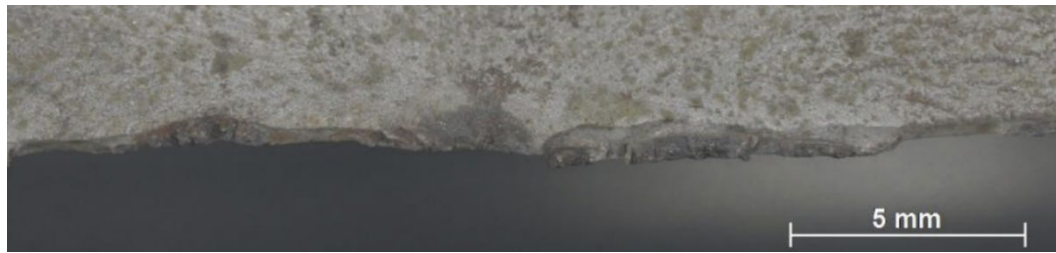
**Figure 4**

Zoomed in view of thumb-nail shaped corroded features

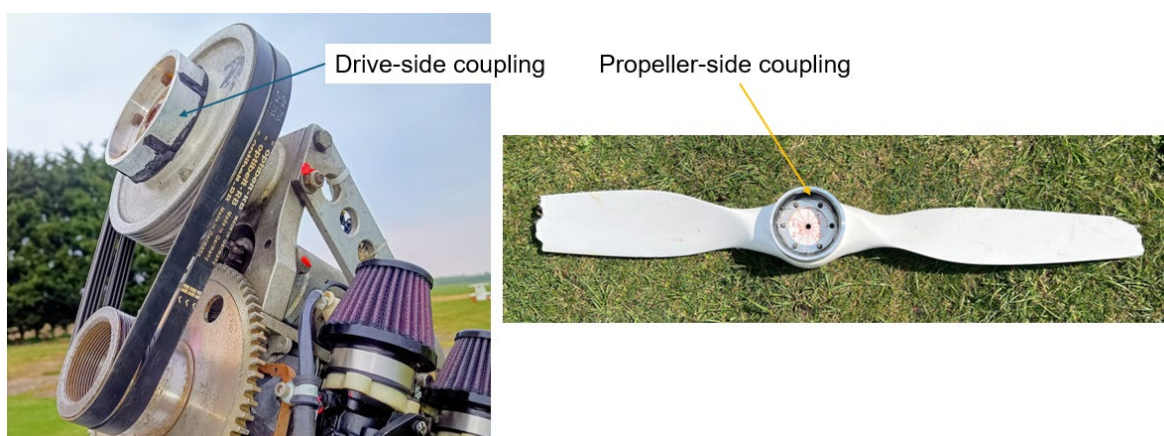
**Figure 1**

After confirming that the control surfaces were functional, he radioed for a straight-in approach to Runway 01 at Weston-on-the-Green. The landing was uneventful and both occupants exited the aircraft without injury. The propeller was recovered and provided to the AAIB along with the coupling (Figure 1) for further investigation.

Engine and propeller after the flight

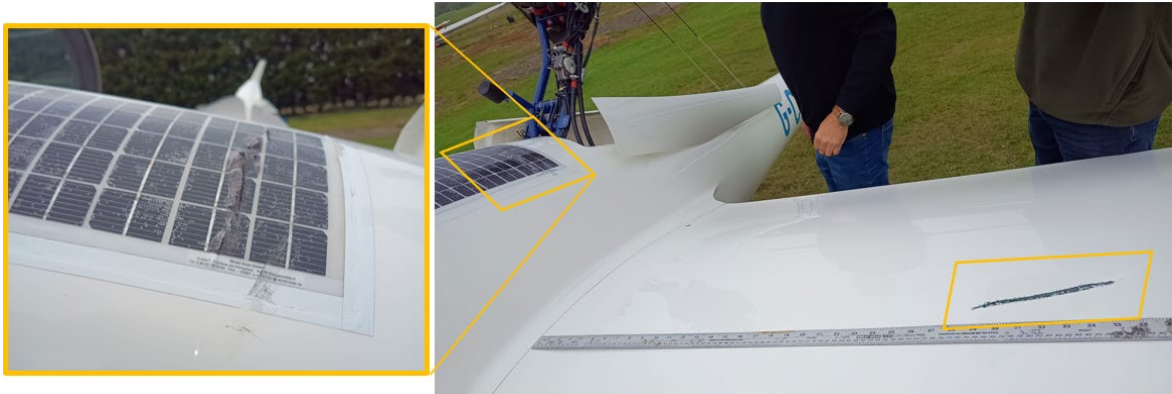
**Figure 5**

Damage found to G-CKLY after landing

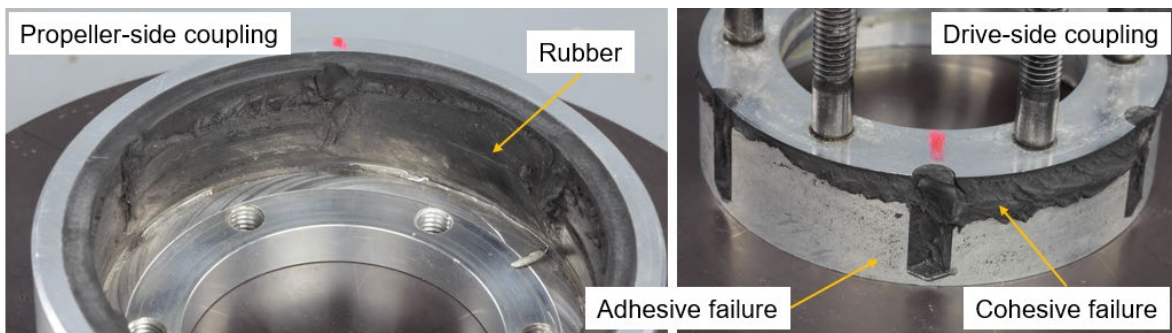
**Figure 6**

The two halves of the coupling were examined and it was found that the rubber element was predominantly retained within the propeller-side coupling. Both halves showed two distinct regions of the failure, the first; a cohesive failure of the rubber element; and the second, an adhesive failure between the rubber element and the drive-side coupling (Figure 6).

Observed adhesive and cohesive failures

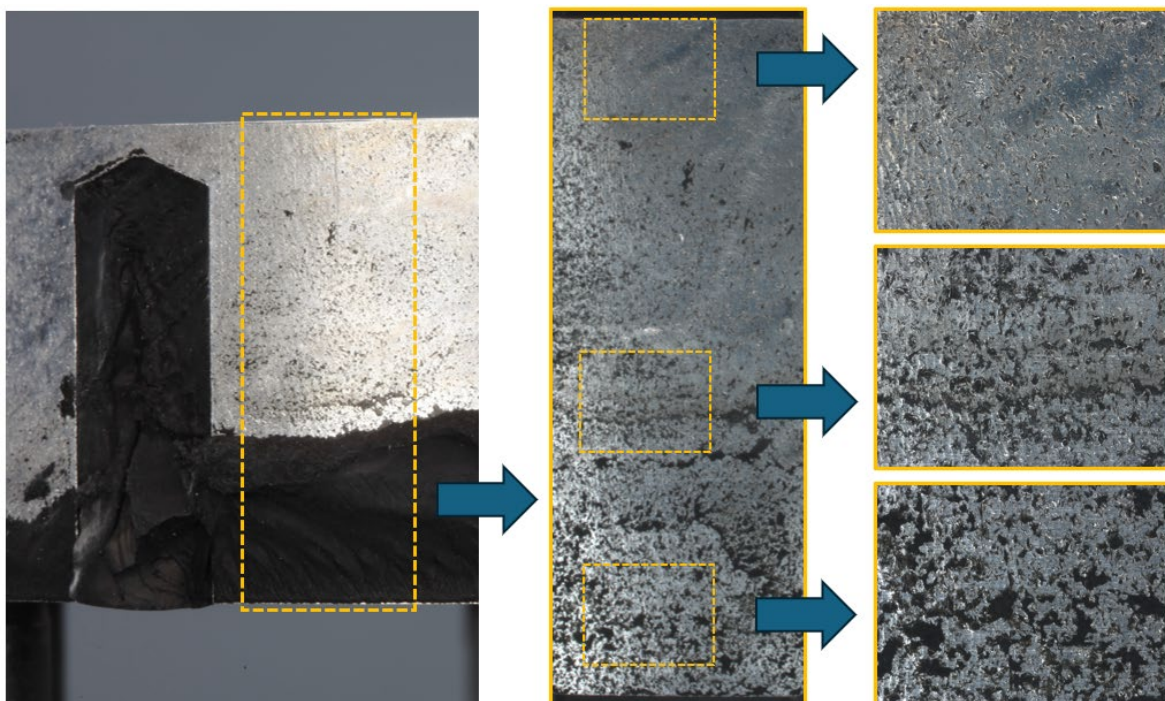
**Figure 8**

A random section was chosen from the drive-side coupling and by using acetone, as much rubber as possible was removed. It was not possible to completely remove all the rubber from the surface pitting and therefore an accurate surface roughness measurement could not be made. Instead, a qualitative assessment was made at three different locations on the section as shown in Figure 8.

Examination of the drive-side coupling surface finish

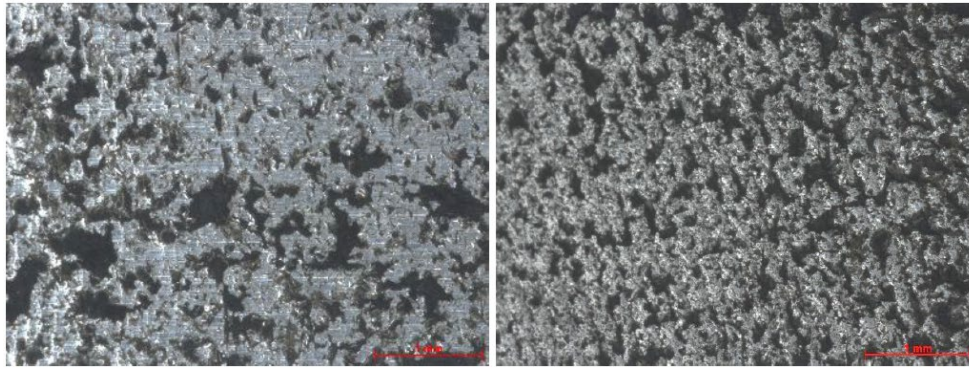
**Figure 9**

A section of the propeller-side coupling was prepared in the same way by removing the rubber and the surface finish was compared between two areas of similarly bonded rubber on each of the coupling halves (Figure 9). The drive-side coupling (left) had visible horizontal machining marks along with a non-uniform distribution and size of media impacts. The propeller-side coupling showed a uniformly distributed and even media blast finish with no visible machining marks.

Comparison between drive-side (left) and propeller-side (right) surface finish
