INTERIM SAFETY INVESTIGATION REPORT

REPORT NO.: 02/2026

MV *Grande Brasile* **Cargo fire and subsequent fire damage** **in position 51° 16.8' N 001° 49.5' E** **18 February 2025**

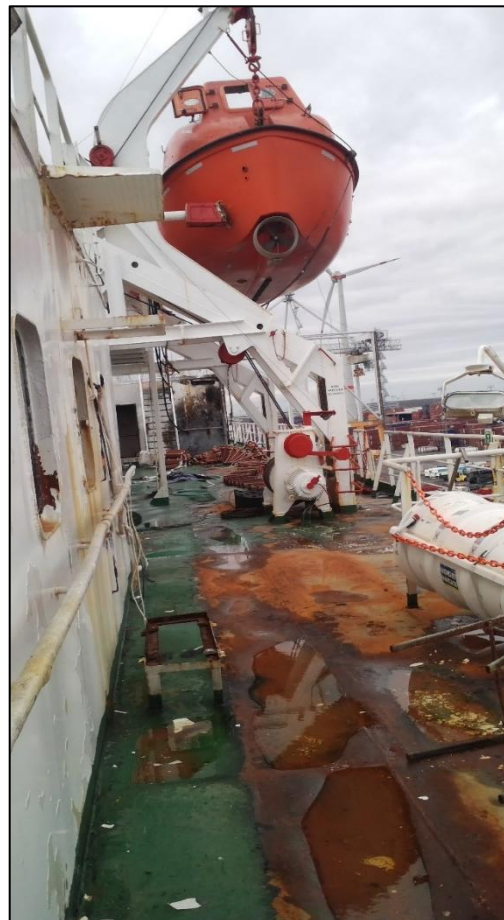
Figure 1: Deformed and scorched deck plating resulting from heat damage

On deck no. 12, fire damage was observed on the starboard side from frames 9 to 64, and on the port side from frames 2 to 36; the affected accommodation spaces included the messroom and four crew cabins located from frames 58 to 64 on starboard side. On deck no. 11, damage extended along the mid-length section from frames 9 to 92 on both starboard and port sides. Moreover, deck no. 10 exhibited heat exposure around frame 55 on the port side, with fire-affected areas from frames 9 to 64 on starboard side, and from frames 9 to 36 on port side.

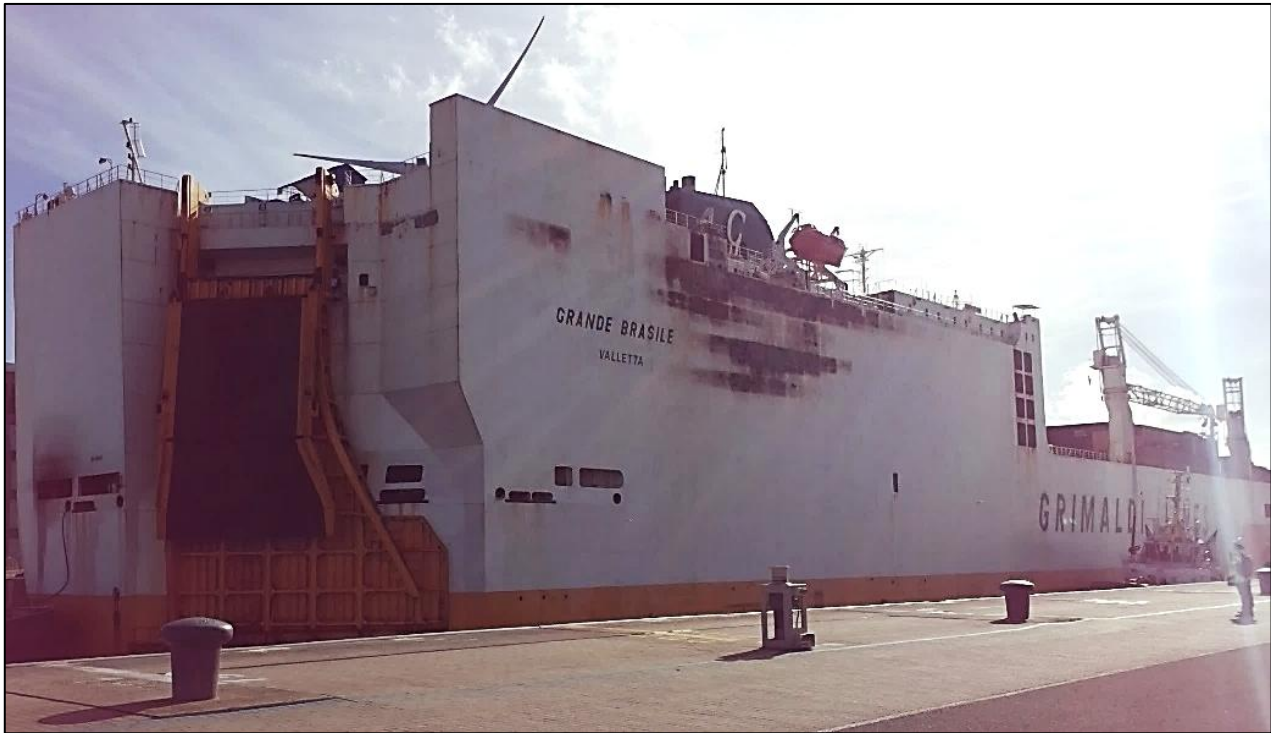
Figure 2: Fire damage visible on the ship's side

Heat-related damage was also identified on the inside of the funnel casing, in way of decks nos. 6 to 12. However, no damage was detected in the engine-room, and no

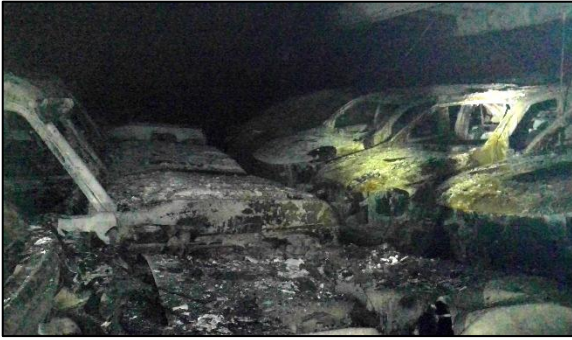
Vehicles stowed on deck no. 8 within the enclosed cargo space, were either completely destroyed by the fire or had sustained extensive heat and soot damage (**Figure 3**).

Figure 3: Damaged vehicles on deck no. 8

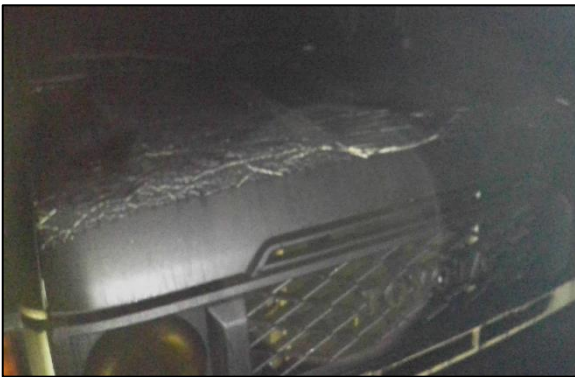
On decks nos. 9, 10, 11, and 12, vehicles stowed in the aft sections were heavily burnt, surrounded by other vehicles which showed significant heat damage. In contrast, vehicles in the forward sections of these decks were not burnt, although heavily covered in soot (Figures 4 and 5).

Figure 4: Vehicles in the forward sections on deck no. 10

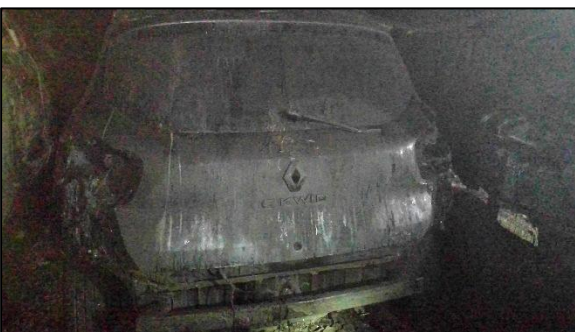
Figure 5: Damaged vehicles on deck no. 12
