Serious Incident

Aircraft Type and Registration:	Leonardo AW139, G-CIMU	
No & Type of Engines:	2 Pratt & Whitney Canada PT6C-67C turboshaft engines	
Year of Manufacture:	2015 (Serial no: 31583)	
Date & Time (UTC):	13 June 2022 at 1801 hrs	
Location:	Norwich Airport	
Type of Flight:	N/A found during maintenance inspection	
Persons on Board:	Crew - None	Passengers - None
Injuries:	Crew - N/A	Passengers - N/A
Nature of Damage:	Bearing failure	
Commander's Licence:	N/A	
Commander's Age:	N/A	
Commander's Flying Experience:	N/A	
Information Source:	AAIB Field Investigation

Synopsis

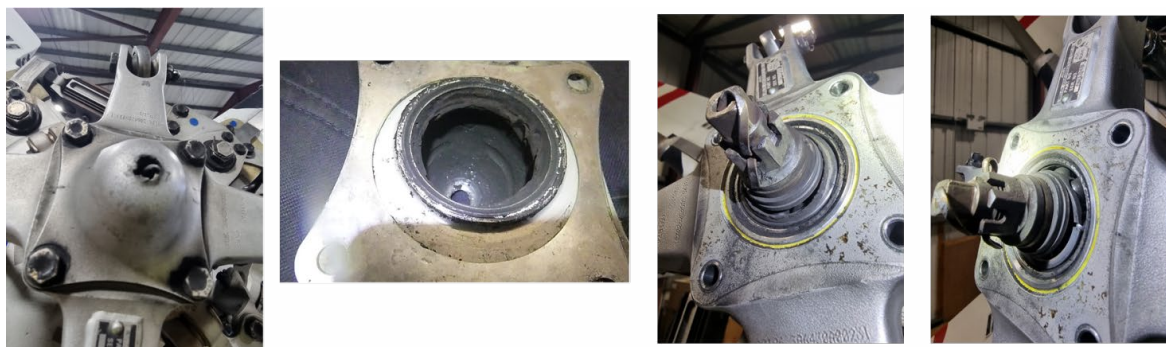
Figure 1

The helicopter had operated a passenger flight to North Sea oil rigs during the day. On its return it was moved into the hangar to perform a daily maintenance inspection. During the walkaround check, the maintenance team noticed that a hole had been worn in the cover mounted over the tail rotor duplex bearing and the end of the tail rotor control actuator. Removal of the cover confirmed the presence of a large amount of carbon dust on the inside. The actuator was protruding further than normal; the bearing race was badly damaged and the ball bearings in the outboard race of the bearing were visible (Figure 1).

Bearing cover, and damaged tail rotor bearing in situ

The maintenance team tried to remove the bearing, but the damage was so severe that the bearing disintegrated into its component parts during this process.

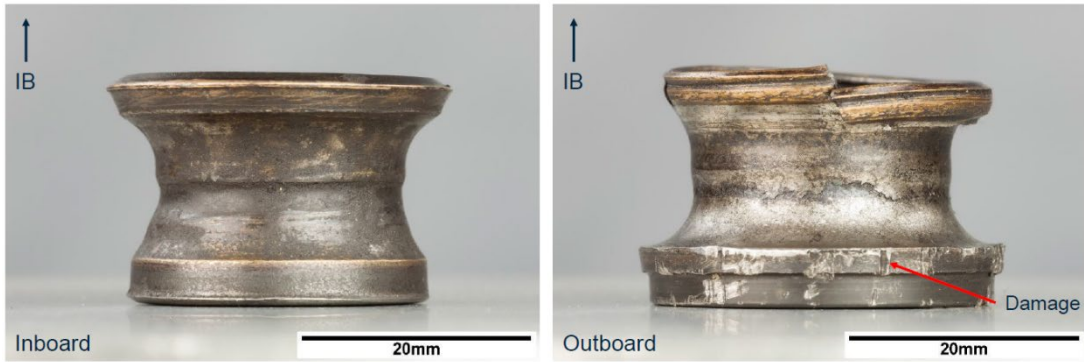
Figure 7

Both inner races were heavily worn and distorted (Figure 7). Some damage had also occurred when the operator was removing the damaged bearing from the control shaft using pliers (Figure 7). The race surfaces showed evidence of cracking and material deposition, notably copper from the cages. This layer of deposited material was approximately 10 µm thick on the inner race, but areas up to 25 µm were also observed.

Hardness testing of the inboard inner race material, resulted in hardness measurements approximately half to a third of the specified value for a new race. Etching of cross-sectional samples of the race material showed evidence of microstructural change due to heating.

Inboard and outboard inner races

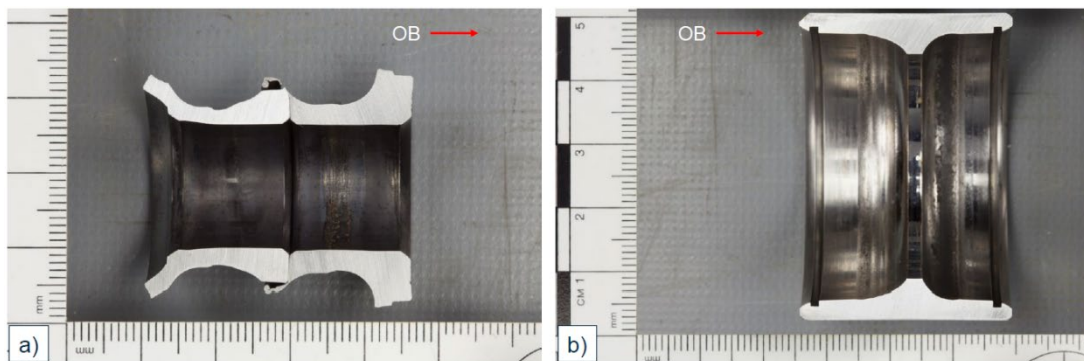
This was also heavily distorted compared to the standard race profile for the bearing.

Cross sections of both inner races and the outer race in Figure 8 show the severe level of damage and distortion.

Cross section of the inner and outer races

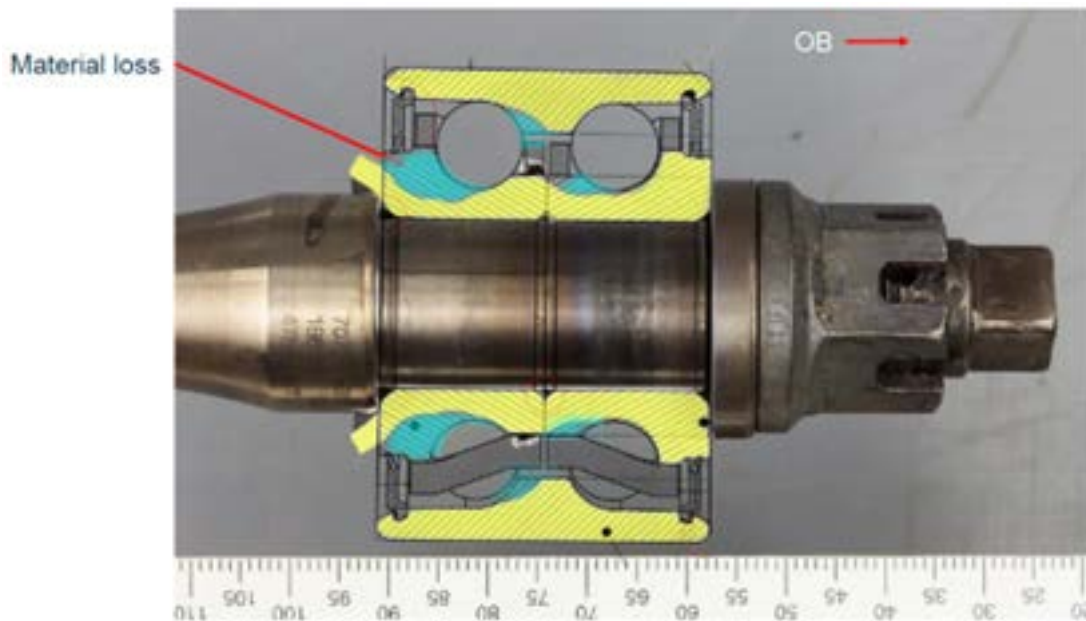
Figure 9

These damaged cross sections were superimposed on the original design cross section to highlight the changes (Figure 9). The yellow hatched sections are the damaged bearing races; the teal coloured sections are the intended design cross section, showing the extent of the missing and deformed material.

Failed bearing cross section (yellow) compared to a new bearing (teal)

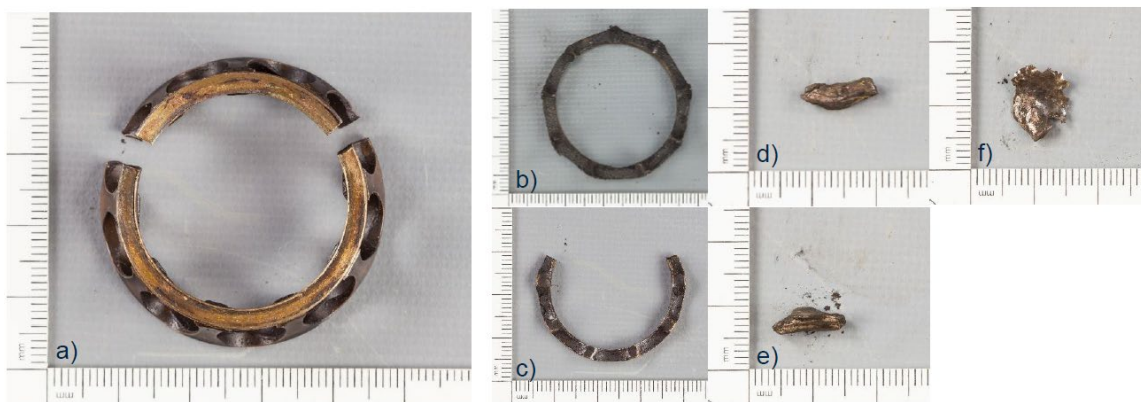
Figure 10

One of the cages had fractured into two pieces. The other cage was heavily worn and fragmented. The fracture surfaces were too heavily damaged to assess the failure mechanism reliably (Figure 10).

Recovered cage fragments: a) cage failed in two pieces, b - e) heavily worn fragments of the second cage

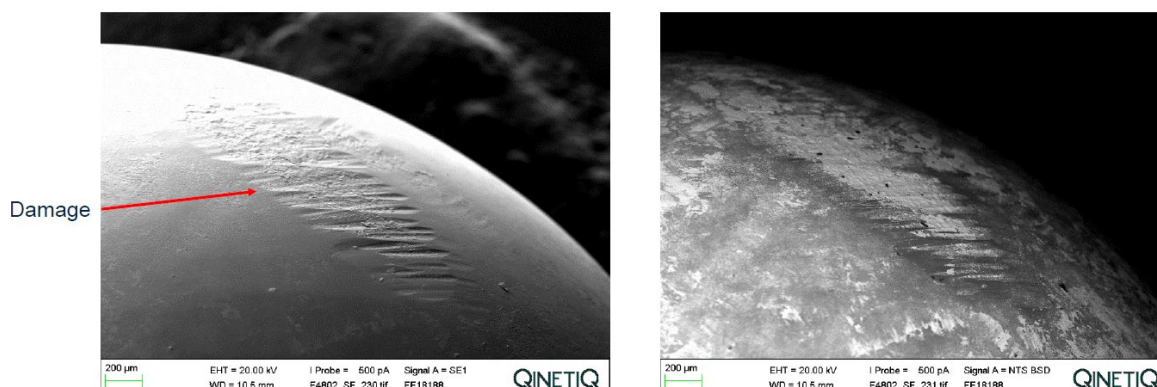
Figure 11

Assessment of the balls identified surface deposits consistent with wear material from the cages and races. The surface of one of the balls displayed damage marks indicative of sliding rather than rolling (Figure 11).

Damage marks on a ball, indicative of sliding rather than rolling

The dimensions of the balls were measured and found to be mostly below the specified diameter. The ball sizes are selected to tight tolerances at manufacture to avoid significant variation across each set of nine balls within a race. The range of measurements recorded suggested that half the balls had worn evenly and still had similar diameters within 1 µm of each other, while the other half had worn unevenly, with between 17-60 µm variation in diameter. It is likely these heavily worn balls were all fitted within the same race.

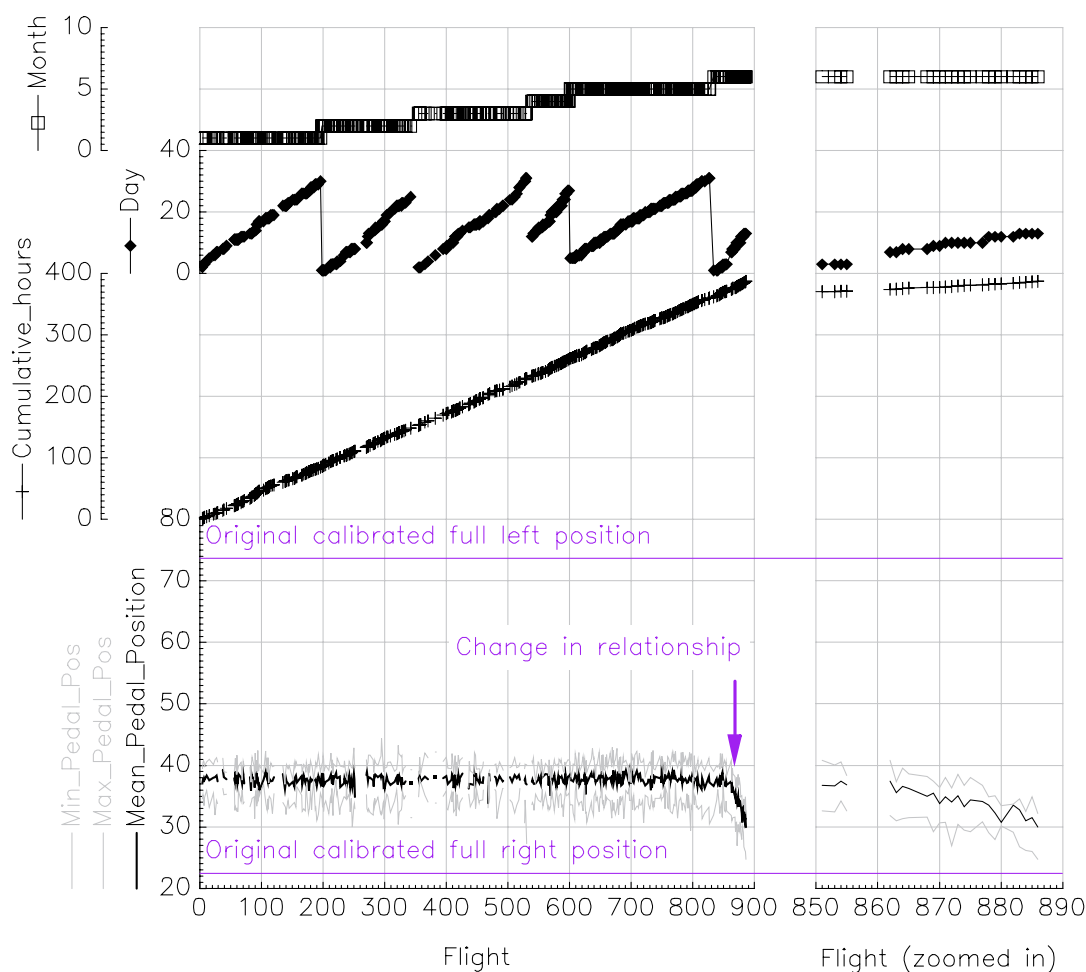
With a serviceable duplex bearing providing a fixed relationship between the pedal position and the tail rotor blade pitch, the average pedal position while cruising at high speed should be approximately stable. The level of damage observed on the tail rotor bearing would have varied this relationship, resulting in a change in the pedal position required to achieve a required tail rotor thrust.

Each flight was filtered to capture periods when the helicopter was flying between 145 and 150 KTAS. If more than 100 seconds of flight was found, the average pedal position was calculated for that period. Figure 12 shows the pedal position data, in recorded units. A changing trend in the relationship between airspeed and average pedal position is apparent starting from approximately 7 June 2022. This is approximately 15 flight hours before the failed bearing was discovered.

Average pedal position when flying between 145 KTAS and 150 KTAS for more than 100 seconds

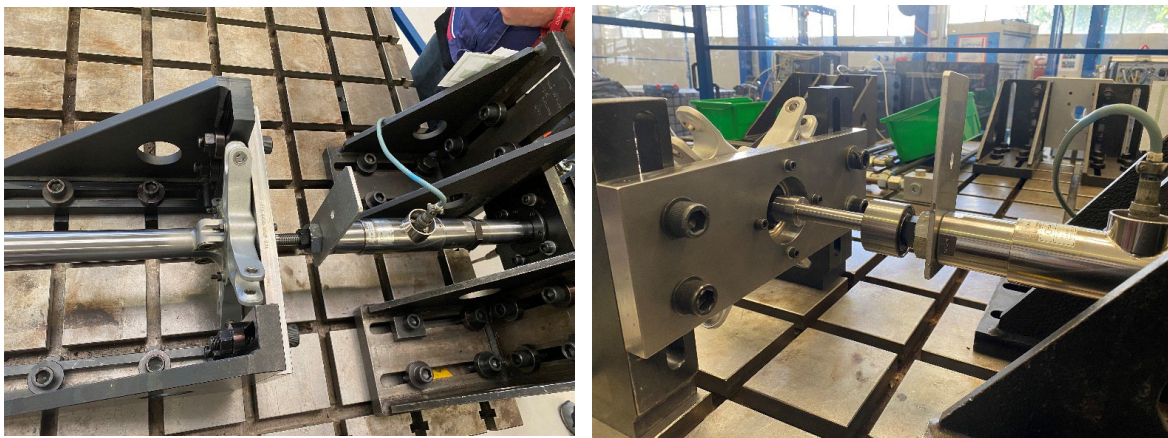
Figure 13

slider housing. The test was conducted with the components at ambient temperature (between 18 and 28 °C). The test bearing and slider were specifically manufactured to the worst case tolerances providing the highest level of interference fit possible (0.025 mm) and the minimum amount of grease (1 g) was used in each side of the bearing. The extraction tool was also offset from perpendicular with the bearing face by 0.9° to increase the applied force on one side, replicating possible maintenance issues. The static limit load in the axial direction (F_z) quoted by the manufacturer's development load spectrum for the AW139 duplex bearing was 12,470 N. During the test the axial (F_z) load was progressively increased until the bearing released from the slider at a measured applied load of 18,894 N. The bearing also suffered a significant impact force after it released, as it unintentionally struck the end of the test rig (Figure 13).

Test bearing before and after it released from the slider/spider assembly

Following removal from the test rig, the test bearing was initially X-rayed using a CT scanner, which did not show any evidence of damage to the race surfaces. It was then returned to the bearing manufacturer's facility for disassembly and inspection. The bearing was visually inspected using a microscope and the inner and outer race circumferential profiles were measured at various heights. The bearing manufacturer concluded that no damage was observed and there was no identifiable difference between the pre and post-test inspections of the bearing.

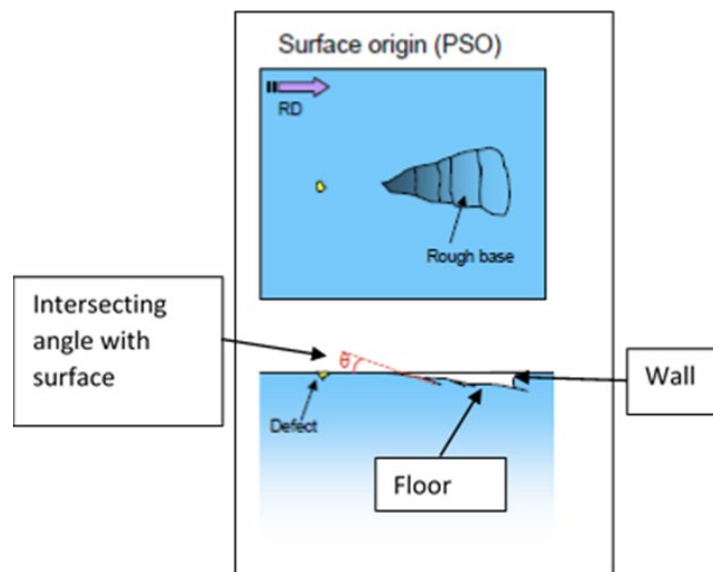
Figure 14

The inner rings also demonstrated the presence of minor debris indentation marks on side one but no RCF. The inner ring from side two exhibited indentation marks and RCF similar to the outer race. Again, there was no evidence of microstructural change or a DER. The location of the damage was also lower than the normal running line of the bearing race, which is where the highest contact pressure usually occurs during in-service operation. In combination with the lack of DER, this suggested the damage may not have resulted exclusively from the operating loads on the bearing. The debris indent marks on the races and scratches on the cage, raised the possibility that contamination may have been present within the bearing leading to the initiation of the surface RCF (Figure 14).

Illustration of typical surface RCF initiated from a surface defect
