Report on the investigation of  
the man overboard from the potting vessel

***Wilaya (M36)***

resulting in one fatality

on 1 May 2025

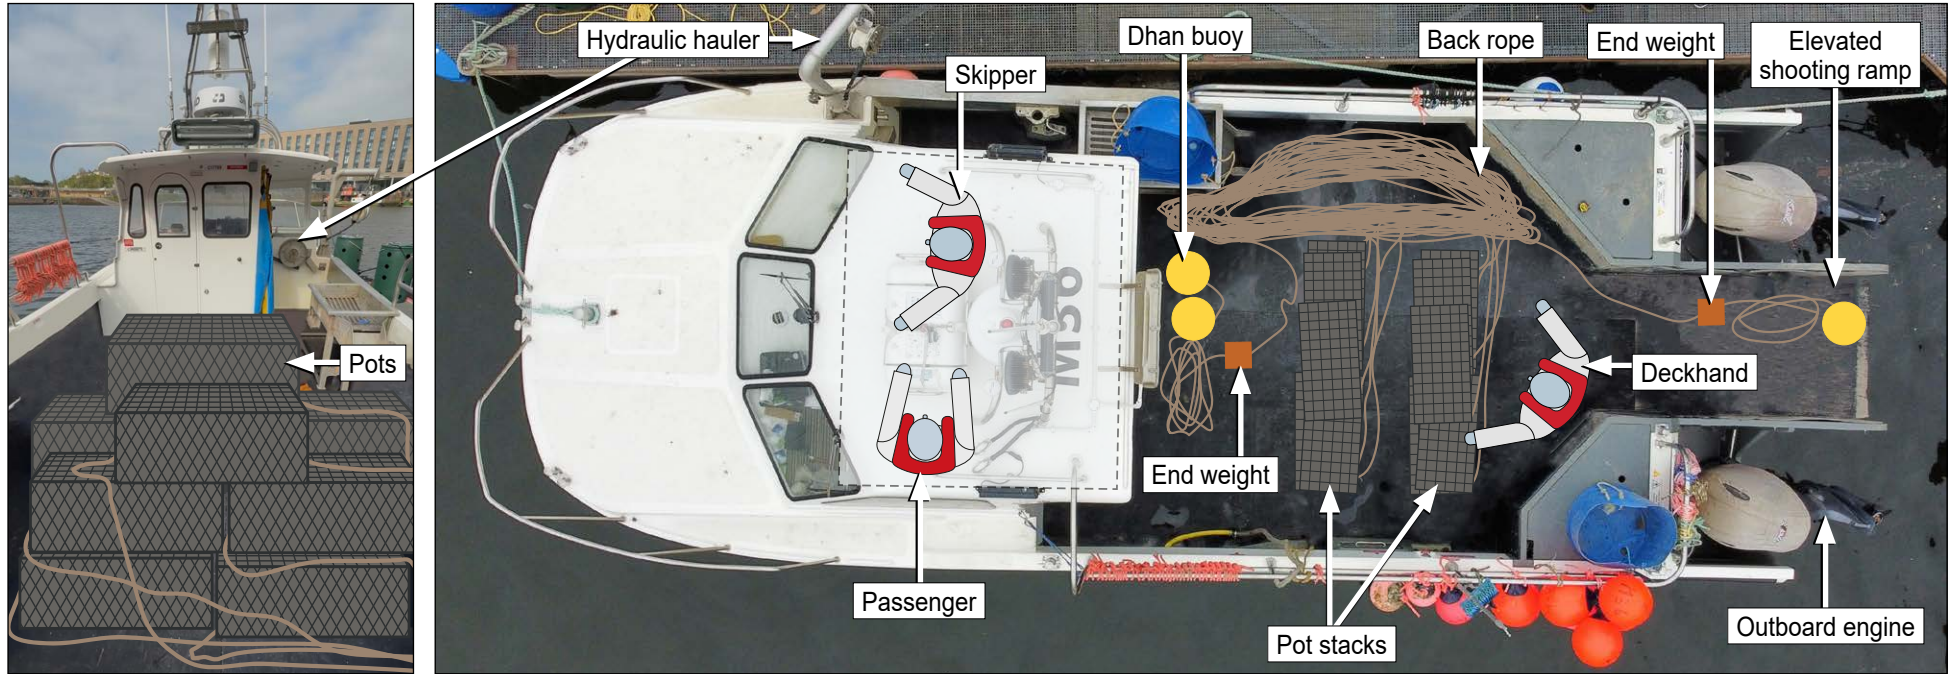
Figure 1: *Wilaya's* working deck arrangement

*Wilaya's* deckhand became entangled in the back rope and was dragged into the sea. Despite wearing a PFD, he was pulled under the surface and drowned.

Effective safe systems of work require consistent application of risk control measures and *Wilaya's* adopted systems of work contradicted the vessel's risk assessments and industry guidance. *Wilaya's* crew did not adhere to the vessel's documented control measures during shooting operations, likely believing that their experience mitigated the existing hazards. This exposed the crew to a significant risk of harm and injury.

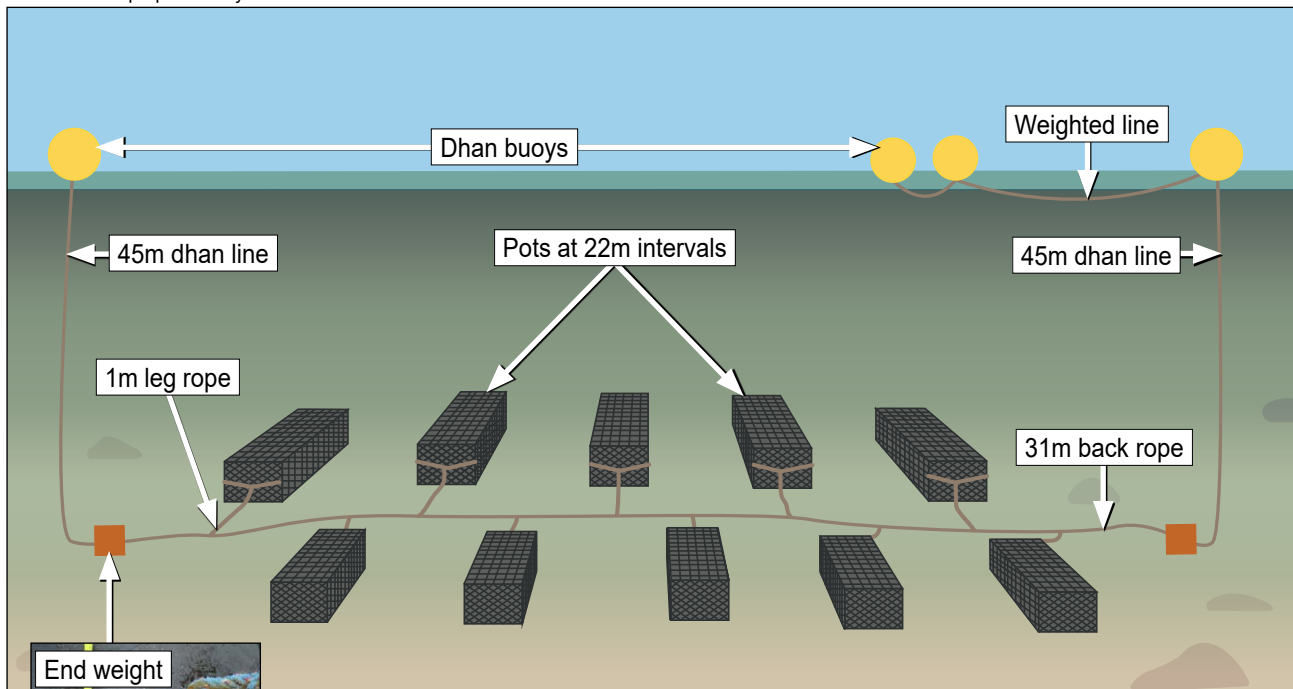
Figure 2: Wilaya's potting arrangement

The system comprised a dhan buoy arrangement at each end of the string. The marker float was connected to a dhan line, which was attached to an end weight. Each of the 10 pots was evenly spaced along a back rope, to which they were permanently attached by leg ropes. The back rope was anchored to the seabed by the end weights attached to the dhan lines and marker floats (**Figure 2**). Before shooting, the 10 pots were arranged into two stacks athwartships in a 2-2-1 formation.
