# Rail Accident Report

**Collision between a passenger train and an agricultural trailer at Nordan Farm user worked crossing, near Leominster, Herefordshire  
22 May 2025**

Report 06/2026  
May 2026

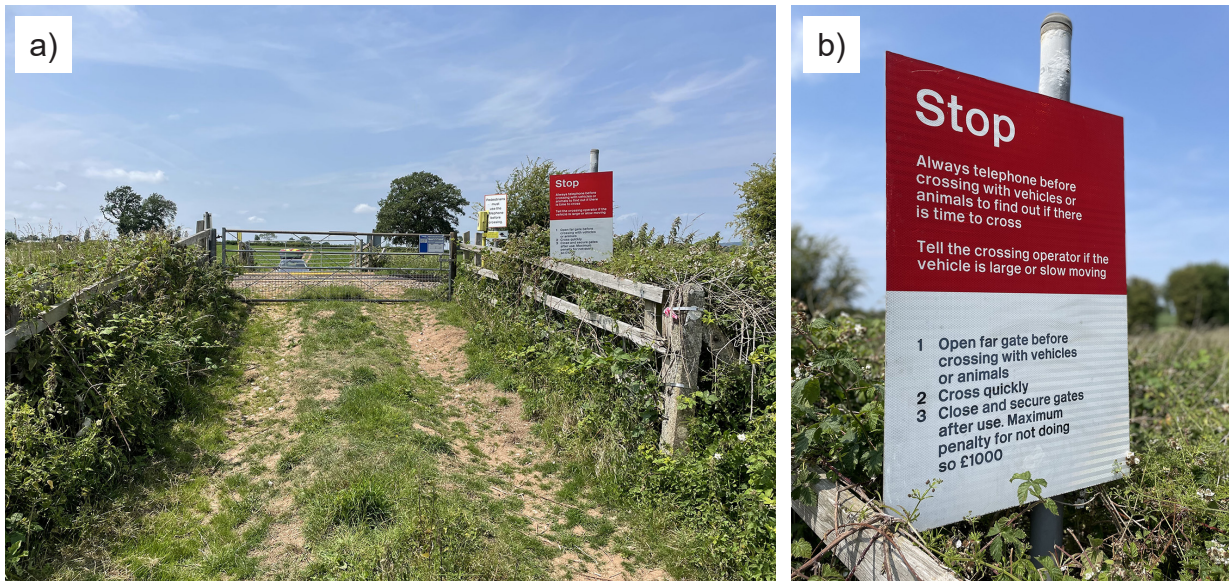
Figure 4: Approach to Nordan Farm UWC(T) from the east showing a) the general signage arrangements and b) the sign with instructions to use the crossing.

- 14 Nordan Farm level crossing is a user worked crossing with telephones (UWC(T)). There are signs displayed at the crossing, giving users instructions on the process to follow. Users wishing to cross are required to use the telephones provided, which connect directly to the supervising signal box at Woofferton, to gain permission from the signaller to cross. During the call, when requested, users should inform the signaller how long they need to cross, including an allowance for opening and closing the gates. The signaller will then grant or deny permission, based on a determination of the position of any approaching trains, and whether there is sufficient time to cross before a train's arrival.

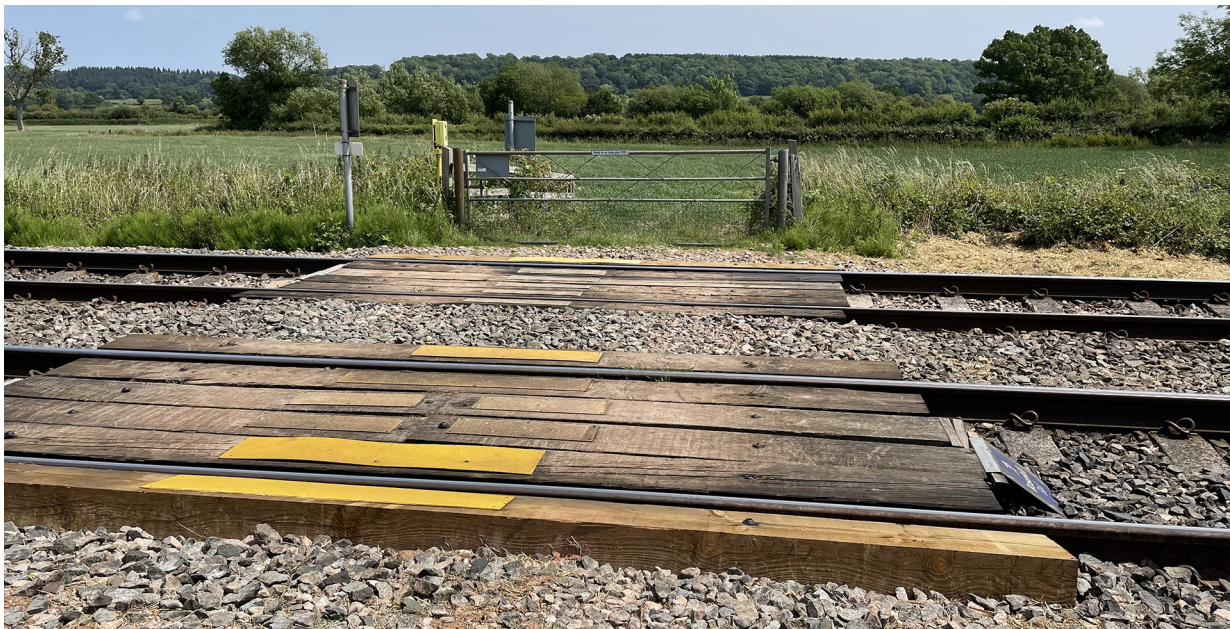
Figure 5: Nordan Farm level crossing, including repair work done after the accident.

16 The railway through this area sits slightly higher than the surrounding farmland, meaning the approach to the crossing on both sides is up a small incline. These approaches are unsurfaced tracks, with a metal gate provided in line with the railway boundary. The crossing itself consists of permanently fixed timber sleepers which provide a crossing surface for vehicles, animals and pedestrians, but only within the limits of the railway tracks themselves. The remainder of the crossing is infilled with standard railway ballast (figure 5). While not intended for ordinary road vehicles, this type of crossing is suitable for the agricultural vehicles which use the crossing, such as the one involved in the accident.

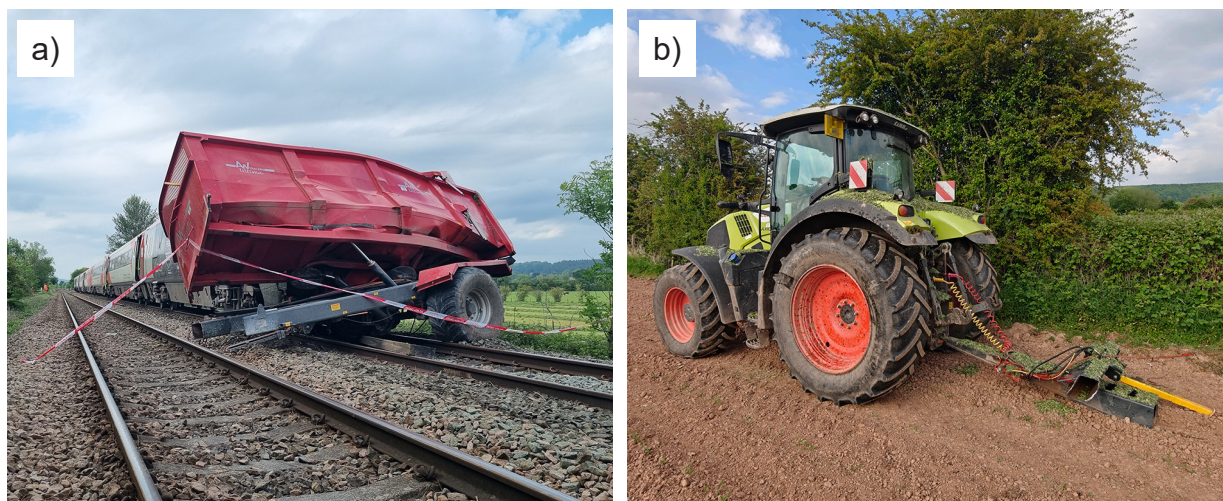
Figure 8: The vehicles after the collision showing a) the train and trailer and b) the tractor.

- 50 Train 1V37 struck the trailer in its midsection, immediately over the first axle. The connection between the trailer's drawbar and its underframe sheared off, leaving the drawbar attached to the tractor, which had just cleared the up line. The trailer deformed around the front of the train and was pushed for around 540 metres along the line, before the train came to a stop with the trailer still wrapped around it (figure 8a).

- 51 The tractor was immediately driven clear of the crossing into the field on the western side of the tracks (figure 8b).

- 54 As well as seriously damaging the trailer, the collision caused damage to the front of the train, including breaking the windscreen. A driver assessor, riding in the train's cab, sustained a nose injury. Of the remaining 7 staff and 66 passengers on board, 6 passengers reported receiving minor injuries and were treated at the scene by the ambulance service. The proximity of the other user worked crossings in the area allowed for passengers to be evacuated to the nearby road for onward transportation. The line reopened in the evening of the following day, 23 May.
