3. Managing risk at the platform-train interface

Purpose of this summary

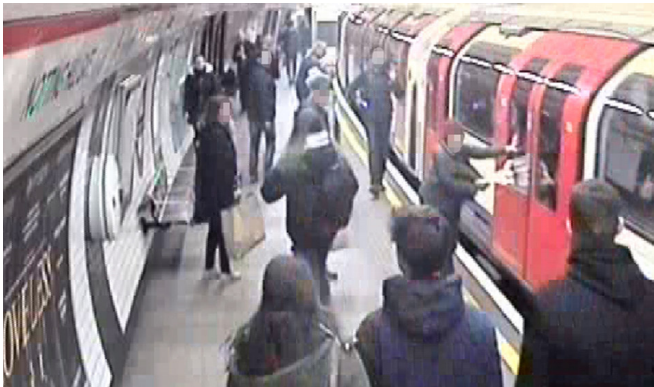
Passenger with bag trapped in train doors at Notting Hill Gate.

At Notting Hill Gate in 2018, a passenger’s bag became trapped in the doors as they attempted to board the train. The trapped bag was not detected by the door control system. The passenger was unable to free herself from the bag, and was dragged along the platform and into the tunnel as the train departed, suffering serious injuries ([report 14/2018](#)).

We believe that more needs to be done to enhance the ability of door control systems to detect the presence of a trapped object. Technology such as sensitive edge and anti-drag systems could be more widely adopted, particularly when new trains are being ordered and specified. We have recommended that these measures should be used on new London Underground trains, and trams.

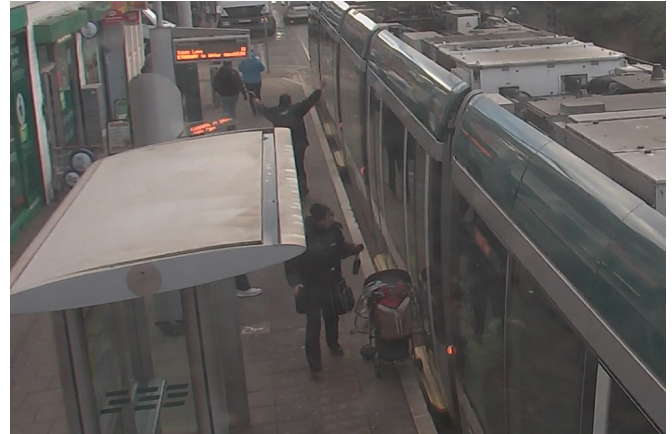
Pushchair trapped in tram doors at Radford Road, Nottingham in 2017.

At Radford Road, Nottingham, in 2017, a pushchair, fortunately unoccupied, became trapped in tram doors and was dragged all the way to the next stop ([report 15/2018](#)). We recommended that the tram operator should review all aspects of its arrangements for minimising the risk of this happening. We found that there was a lack of understanding of risk in this area, which may extend across the tram industry.

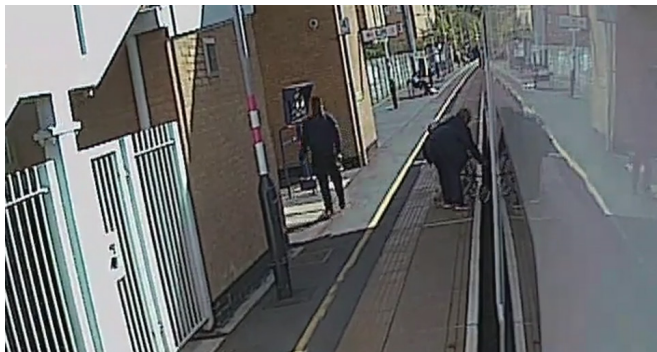
Passenger tries to free dog trapped in train doors at Elstree & Borehamwood.

At Elstree & Borehamwood in 2018 ([report 03/2019](#)), a passenger and her dog were boarding a train. The doors closed in front of

the passenger and the dog's lead became trapped in the doors. The train departed, dragging the dog off the platform and leading to its death, while the passenger remained on the platform. The driver was in the habit of carrying out the final safety check in significantly less time than other drivers on the same route and did so on this occasion. Carrying out the check in a shortened time meant that even a slight loss of attention could have led to him missing the passenger and her dog in the CCTV image.

We have recommended measures to support train and tram drivers in maintaining attention and awareness, particularly when associated with automatic train operations (Notting Hill Gate, Archway and Chalk Farm, Stratford), and research and development of technology to assist staff responsible for train dispatch to determine that passengers are clear of the train (Elstree & Borehamwood, Archway and Chalk Farm).

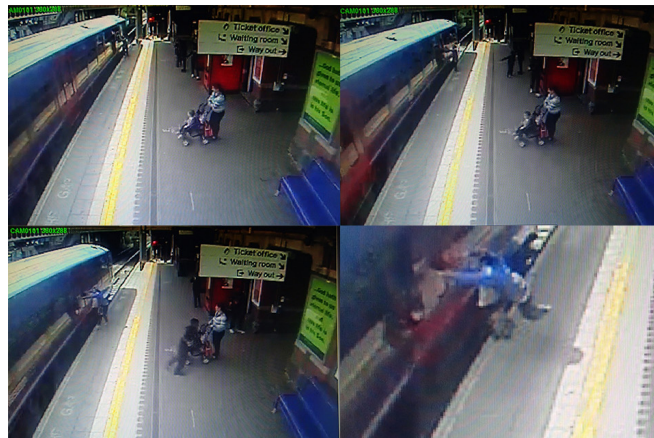
We saw another example of behaviour influenced by this belief at Hayes & Harlington in 2015 ([report 12/2016](#)), when a passenger placed her hand between the closing doors in the expectation that they would reopen and was subsequently dragged along the platform. In our report on this accident, we recommended research to better understand the way that passengers interact with rail vehicle/tram doors.

Passenger trapped in closing doors and dragged along the platform at Hayes & Harlington.

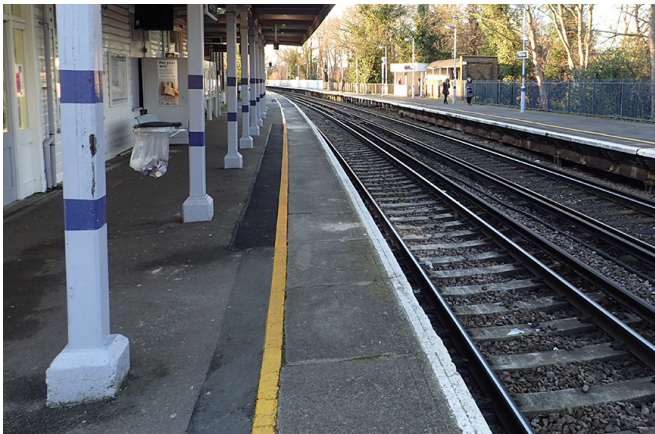
Platform with no tactile surface markings at Eden Park.

At Eden Park ([report 01/2021](#)), a visually and mobility impaired person fell from the edge of a platform into the path of an approaching train. The platform had no tactile surface markings which could have alerted the person to how close they were to the edge, and our investigation found that the railway industry's approach to the provision of tactile surfaces had been ineffective. We recommended that the railway industry and the Department for Transport review their approach to the installation of tactile surfaces and management of risk to visually impaired passengers on station platforms.

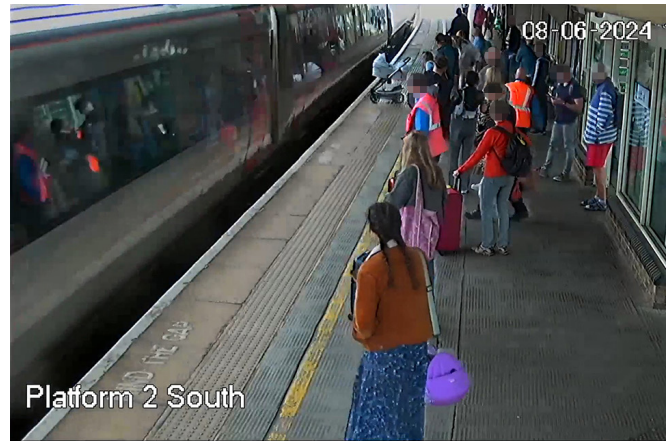
At Banbury station ([safety digest 10/2024](#)) a pram, carrying an infant, rolled towards the platform edge and came into contact with the bodyside of a train. This contact occurred while the train was moving at an estimated 35 mph and caused the pram to spin and tip over, resulting in the infant falling onto the platform surface. The infant sustained a minor injury. The accident demonstrated the importance of station operators taking appropriate steps to understand and effectively mitigate platform hazards and working collaboratively with infrastructure managers to understand and control the risks.

CCTV footage from Banbury station showing the pram and train moments before the accident occurred (courtesy of Chiltern Railways).
