Serious Incident

Aircraft Type and Registration:	Boeing 767-316F, G-DHLS	
No & Type of Engines:	2 General Electric Co CF6-80C2B6F turbofan engines	
Year of Manufacture:	2012 (Serial no: 42213)	
Date & Time (UTC):	9 October 2025 at 1841 hrs	
Location:	Scottish Flight Information Region	
Type of Flight:	Commercial Air Transport (Cargo)	
Persons on Board:	Crew - 2	Passengers - 1
Injuries:	Crew - None	Passengers - None
Nature of Damage:	None	
Commander's Licence:	Airline Transport Pilot's Licence	
Commander's Age:	47 years	
Commander's Flying Experience:	8,968 hours (of which 670 were on type) Last 90 days - 22 hours Last 28 days - 11 hours	
Information Source:	AAIB Field Investigation

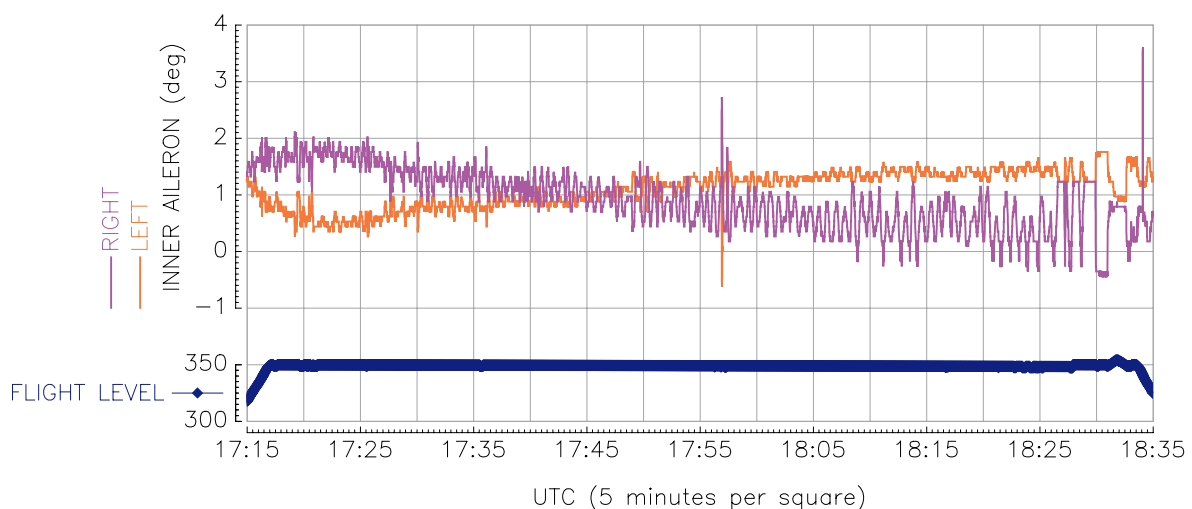
Figure 1 plots the inner aileron deflection, with the autopilot on, recorded on the flight data recorder, for the 75 minutes the aircraft was at FL350. Prior to this period and during the 52 hours of recorded data from the previous 22 flights, both ailerons moved in equal but opposite amounts about a nominal position. However, Figure 1 shows that at the beginning of this period, the right aileron was starting to move more than the left aileron, and this differential in movement grew to over four times the amount by the end.

Inner aileron deflection during flight while at FL350

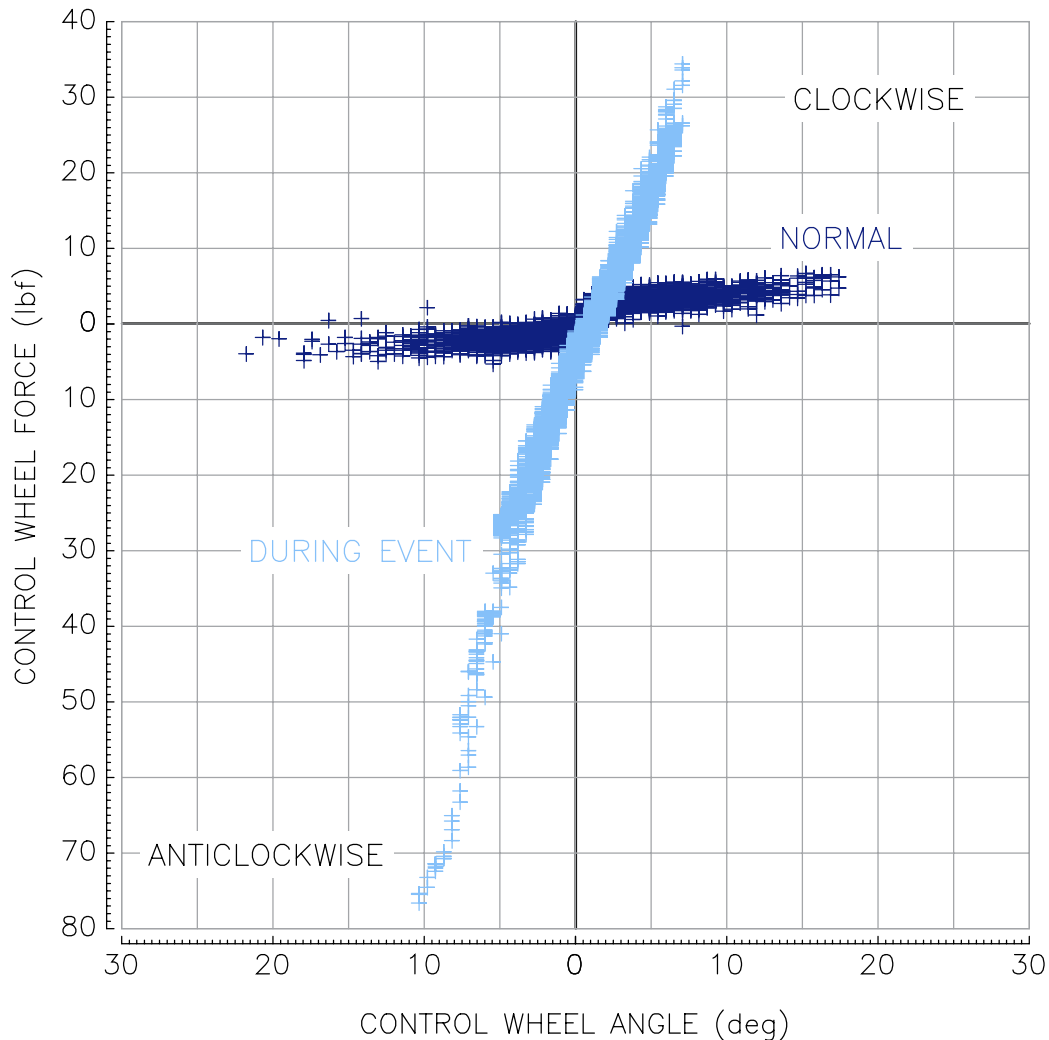
Figure 2 plots the force applied to the control wheel versus the angular movement of the control wheel with the autopilot off. The dark blue points (labelled 'NORMAL') are for the previous 22 flights and the light blue points (labelled 'DURING EVENT') are for the event

flight during the descent from FL350 to FL200. The figure shows that the force required to move the wheel during the event was 15 times more than 'NORMAL'.

The maximum recorded force was 76.6 lbf after which the force required to move the wheel returned to those in the 'NORMAL' region.

Figure 2
Control wheel force versus control wheel angle
