Bulletin Correction

AAIB File:	AAIB-30943
Aircraft type and registration:	Robinson R66, G-WBRN
Date and Time (UTC):	11 June 2025 at 0714 hrs
Location:	Chalfont St Peter, Buckinghamshire
Information Source:	Aircraft Accident Report Form

AAIB Bulletin No 02/2026, page 19 refers

Robinson R66 (G-WBRN), loss of control in flight, Chalfont St Peter, Buckinghamshire, 11 June 2025

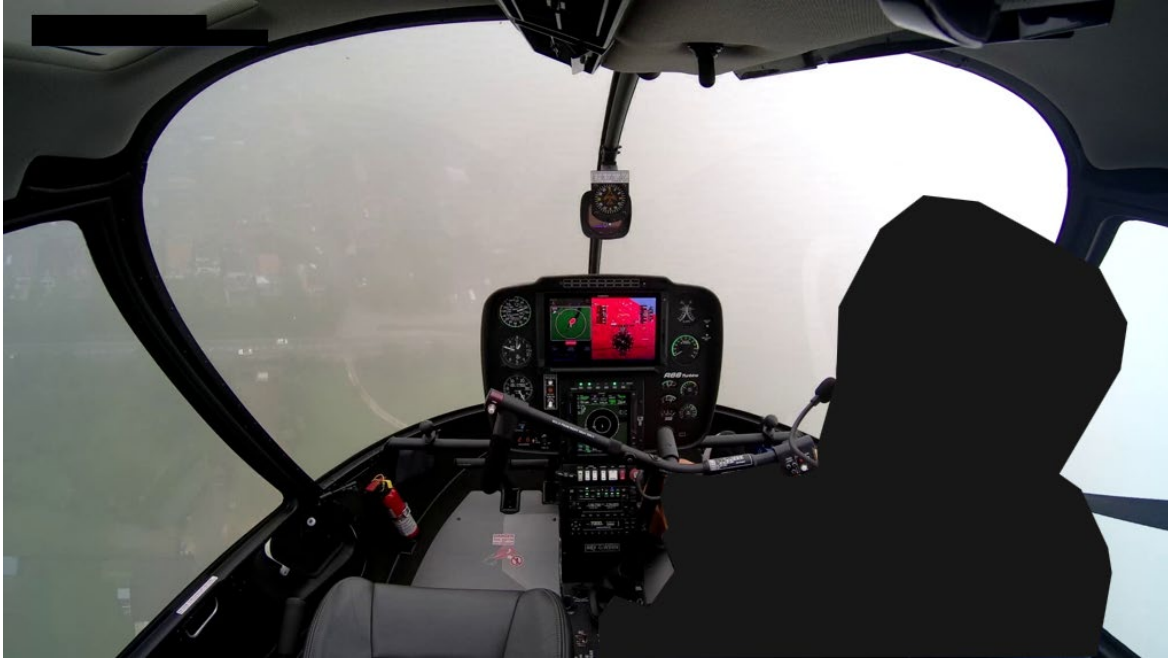
Figure 2
Terrain warning

The helicopter pitched to 15° nose-up, climbed 250 ft, to approximately 1,450 amsl, and slowly banked left to 35° angle of bank (AOB). The nose then dropped below the horizon, and the helicopter entered a descending left turn. With a 25° nose-down attitude and 50° left AOB the pilot attempted to re-engage the autopilot, selecting SAS, HDG and ALT modes. Approximately five seconds later, the helicopter emerged from the base of the cloud at approximately 600 ft agl with a 2,000 ft/min rate of descent and an audio warning: "WARNING TERRAIN TERRAIN" (Figure 2).

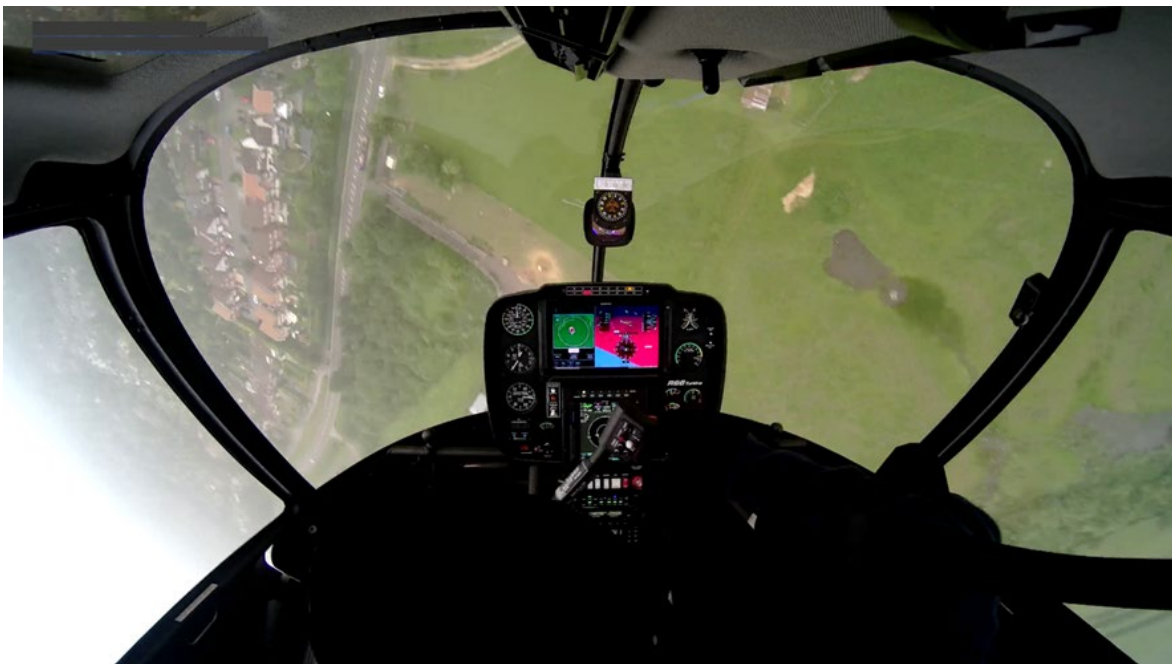
Figure 3
Emerging from base of cloud nearly inverted

The pilot rolled level and pulled up, the hdg and alt modes disengaged leaving the SAS mode light green, and the helicopter entered cloud again, pitching to 60° nose-up. The pilot pressed the SAS button again, which disengaged the autopilot system. The helicopter rolled right to approximately 170° AOB, the nose dropped rapidly, and the helicopter emerged from the base of the cloud near inverted at approximately 450 ft agl with 3,000 ft/min rate of descent (Figure 3).

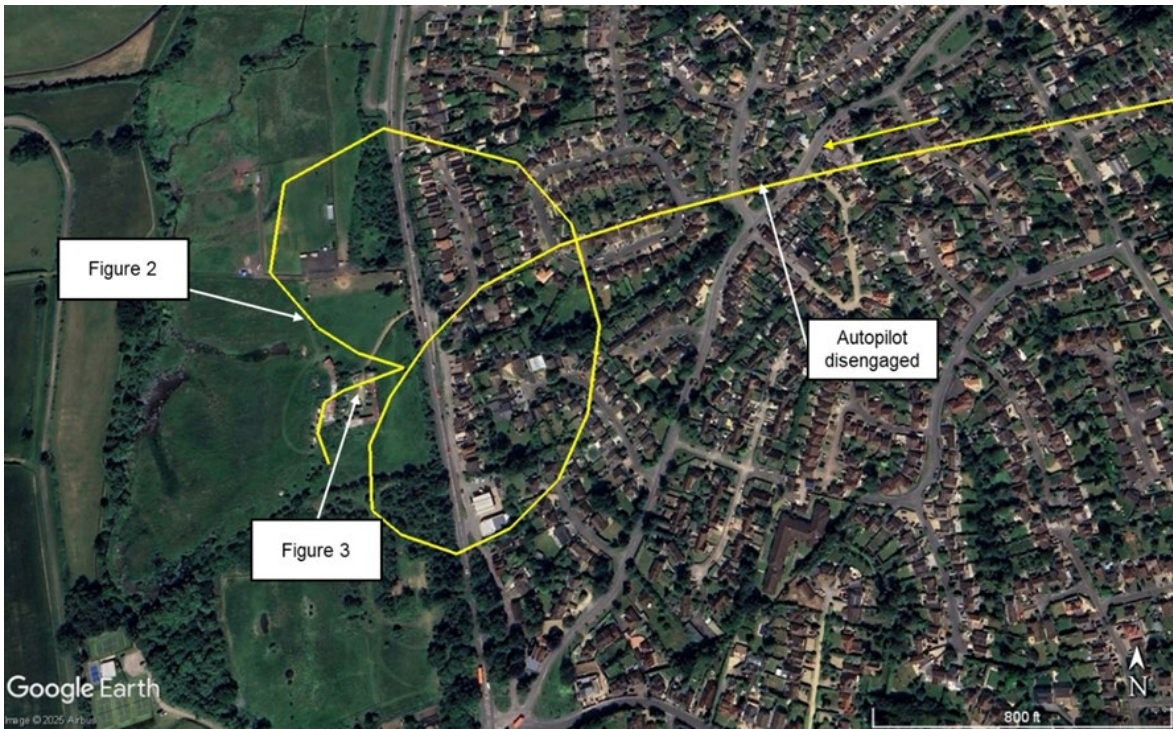
Figure 4
ADS-B flightpath data from FlightAware

The helicopter rolled level with the pilot applying full power, but the main rotor RPM quickly fell below 80%, probably due to overpitching³. The pilot had been thrown to the left when the helicopter rolled inverted causing his left foot to push forward on the yaw pedal and it remained in that position as the helicopter entered a rapid yaw to the left. The yaw continued until the helicopter struck the ground in a field next to a paddock with outbuildings. A plan view of the flightpath is shown in Figure 4.

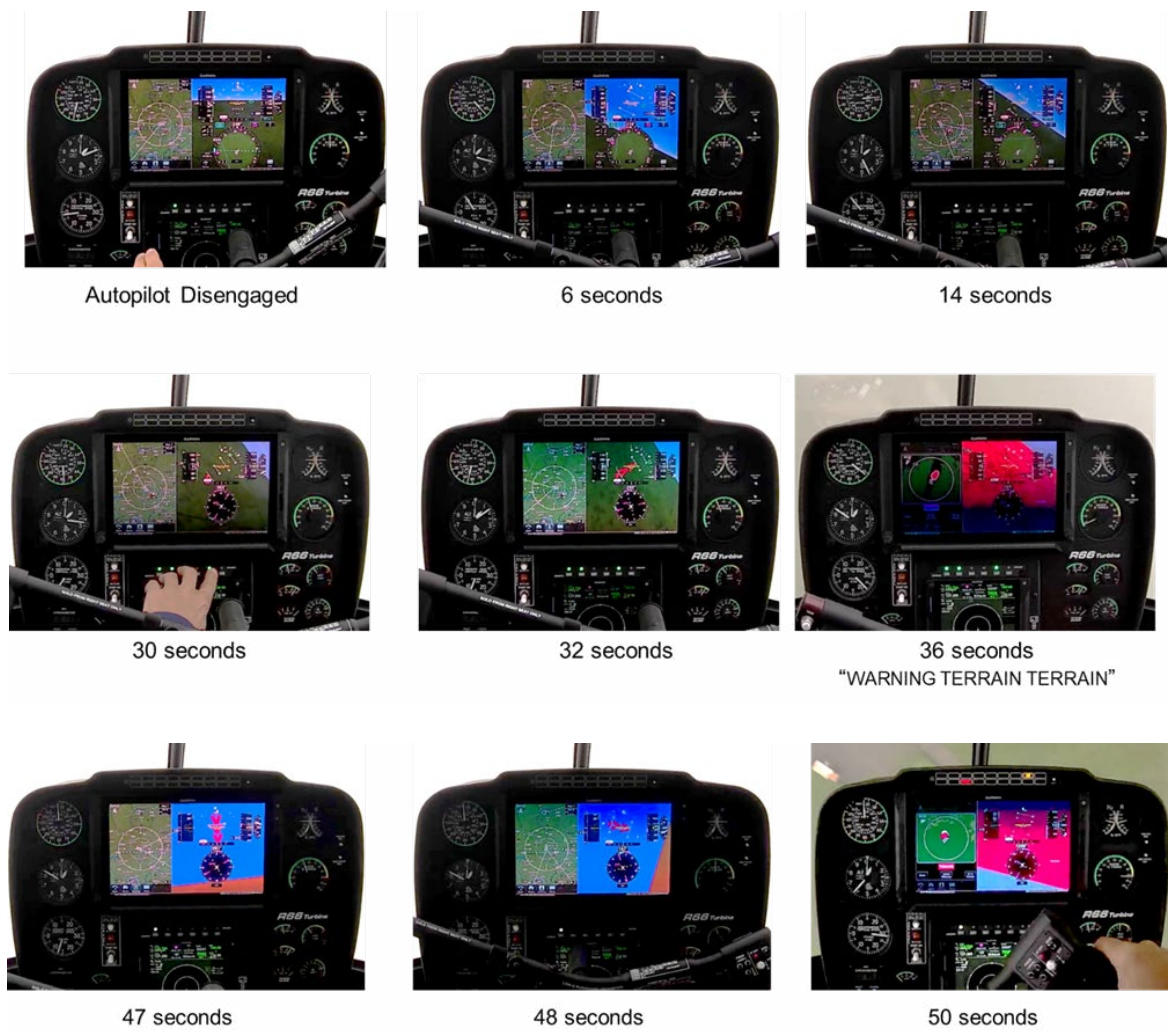
Figure 6
Loss of control sequence of events

Figure 6 shows a sequence of images of the instrument panel during the loss of control described above.

In what appeared to be an attempt to correct the situation, the pilot pressed the SAS button once, and the annunciator turned white to indicate the autopilot system had disengaged. The subsequent flightpath of the helicopter, described earlier and exemplified in Figures 2 and 3, included high nose-up and nose-down attitudes, and AOB up to almost 180°. During this period, the pilot glanced at his tablet and tried to engage the autopilot even with the helicopter in a nose-low, high AOB attitude, and with a high rate of descent while close to the ground. It appeared to be the sight of the ground (Figure 2) that re-orientated the pilot briefly, leading him to reduce the AOB and enter a climb. However, once in cloud again, there was a further loss of control, leading to the final accident sequence.

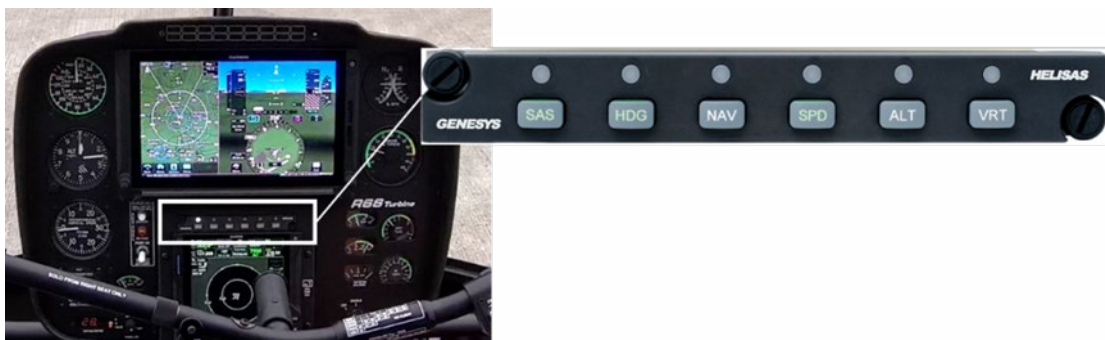
Figure 8
HeliSAS control panel

The HeliSAS control panel is located on the main instrument panel below the PFD. It consists of a row of buttons and corresponding annunciator lights. A dark annunciator indicates that the mode is off, white indicates that the mode is in standby or armed, and green indicates that the mode is engaged (Figure 8).
