Accident

Aircraft Type and Registration:	Dyn Aero MCR-01, G-TOMX	
No & Type of Engines:	1 Rotax 912ULS piston engine	
Year of Manufacture:	2009 (Serial no: PFA 301-14624)	
Date & Time (UTC):	4 May 2025 at 1558 hrs	
Location:	Shenstone Hall Airfield, Staffordshire	
Type of Flight:	Private	
Persons on Board:	Crew - 1	Passengers - None
Injuries:	Crew - 1 (Fatal)	Passengers - N/A
Nature of Damage:	Destroyed	
Commander's Age:	60 years	
Commander's Flying Experience:	1,368 hours (of which 890 were on type) Last 90 days - 1 hour Last 28 days - 0 hour	
Information Source:	AAIB Field Investigation

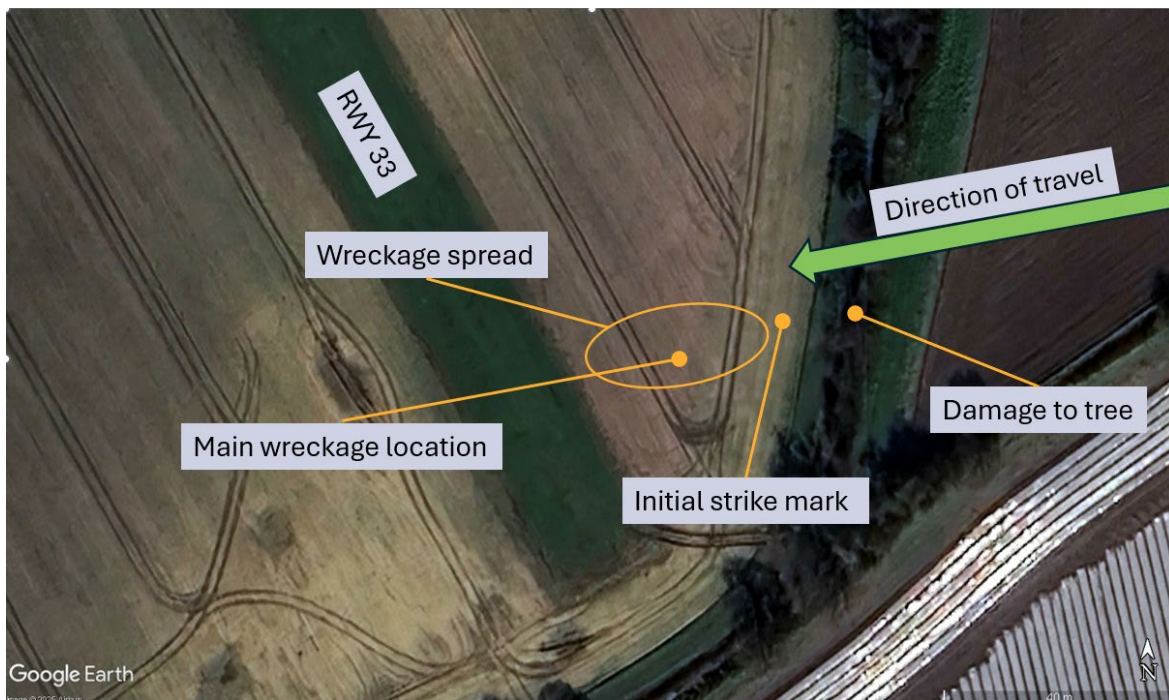
Figure 1

The aircraft had come to rest in cultivated farmland to the east of the grass strip of Shenstone Hall Airfield (Figure 1).

G-TOMX accident site location

Small fragments of tree debris were found to the west of the airfield's easterly boundary, suggesting the aircraft struck the treetops before ground contact. An initial ground scar was located 15 m from the tree line, with the main impact point being 5 m beyond that. The main wreckage was 32 m from the tree line.

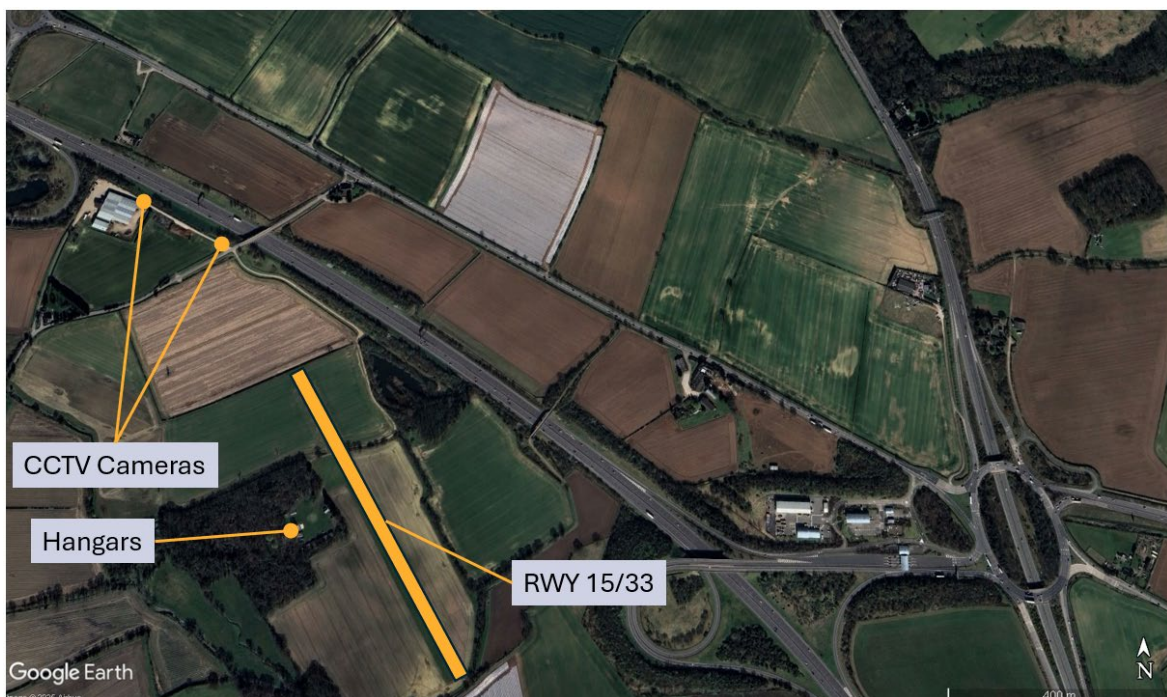
Figure 2

Two CCTV cameras, one positioned at a gateway opposite the entrance to the farm strip with a view down the runway and the other on a farm building approximately 200 m further away from the strip captured most of the accident flight (Figure 2).

Shenstone Hall Airfield and location of CCTV cameras
