AAIB Bulletin

6/2026

Leonardo AW139	G-CIMU	13-Jun-22	3
----------------	--------	-----------	---

Aircraft Type and Registration:	Leonardo AW139, G-CIMU	
No & Type of Engines:	2 Pratt & Whitney Canada PT6C-67C turboshaft engines	
Year of Manufacture:	2015 (Serial no: 31583)	
Date & Time (UTC):	13 June 2022 at 1801 hrs	
Location:	Norwich Airport	
Type of Flight:	N/A found during maintenance inspection	
Persons on Board:	Crew - None	Passengers - None
Injuries:	Crew - N/A	Passengers - N/A
Nature of Damage:	Bearing failure	
Commander's Licence:	N/A	
Commander's Age:	N/A	
Commander's Flying Experience:	N/A	
Information Source:	AAIB Field Investigation

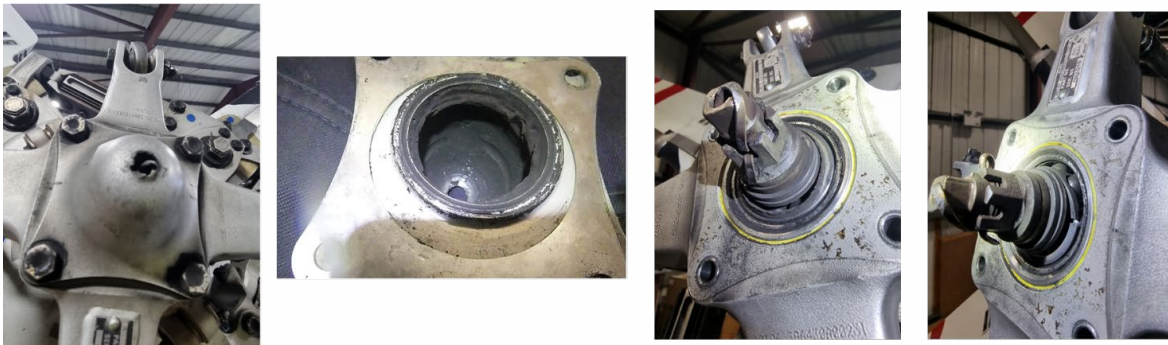
Figure 1

The helicopter had operated a passenger flight to North Sea oil rigs during the day. On its return it was moved into the hangar to perform a daily maintenance inspection. During the walkaround check, the maintenance team noticed that a hole had been worn in the cover mounted over the tail rotor duplex bearing and the end of the tail rotor control actuator. Removal of the cover confirmed the presence of a large amount of carbon dust on the inside. The actuator was protruding further than normal; the bearing race was badly damaged and the ball bearings in the outboard race of the bearing were visible (Figure 1).

Bearing cover, and damaged tail rotor bearing in situ

The maintenance team tried to remove the bearing, but the damage was so severe that the bearing disintegrated into its component parts during this process.

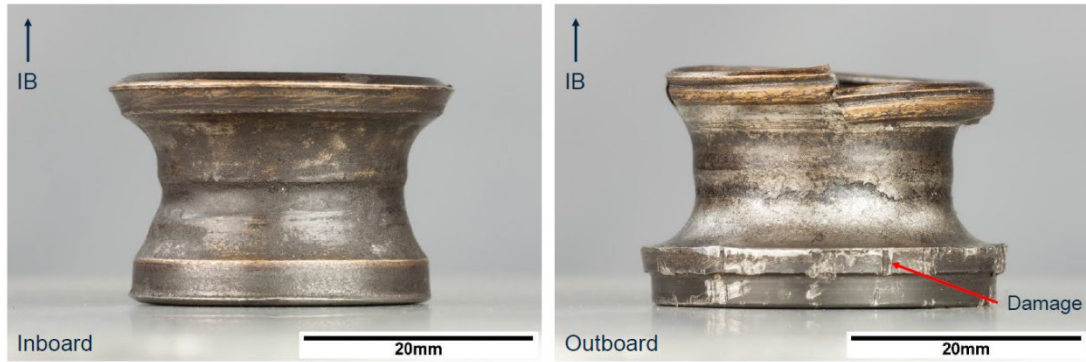
Figure 7

Both inner races were heavily worn and distorted (Figure 7). Some damage had also occurred when the operator was removing the damaged bearing from the control shaft using pliers (Figure 7). The race surfaces showed evidence of cracking and material deposition, notably copper from the cages. This layer of deposited material was approximately 10 µm thick on the inner race, but areas up to 25 µm were also observed.

Hardness testing of the inboard inner race material, resulted in hardness measurements approximately half to a third of the specified value for a new race. Etching of cross-sectional samples of the race material showed evidence of microstructural change due to heating.

Inboard and outboard inner races

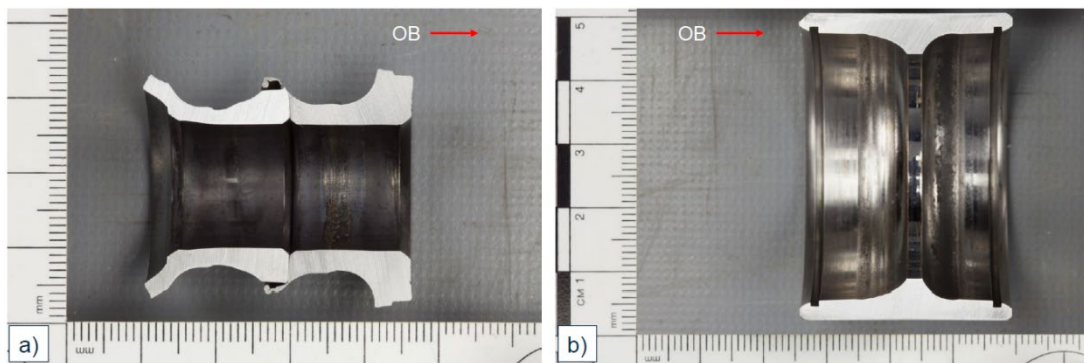
This was also heavily distorted compared to the standard race profile for the bearing.

Cross sections of both inner races and the outer race in Figure 8 show the severe level of damage and distortion.

Cross section of the inner and outer races

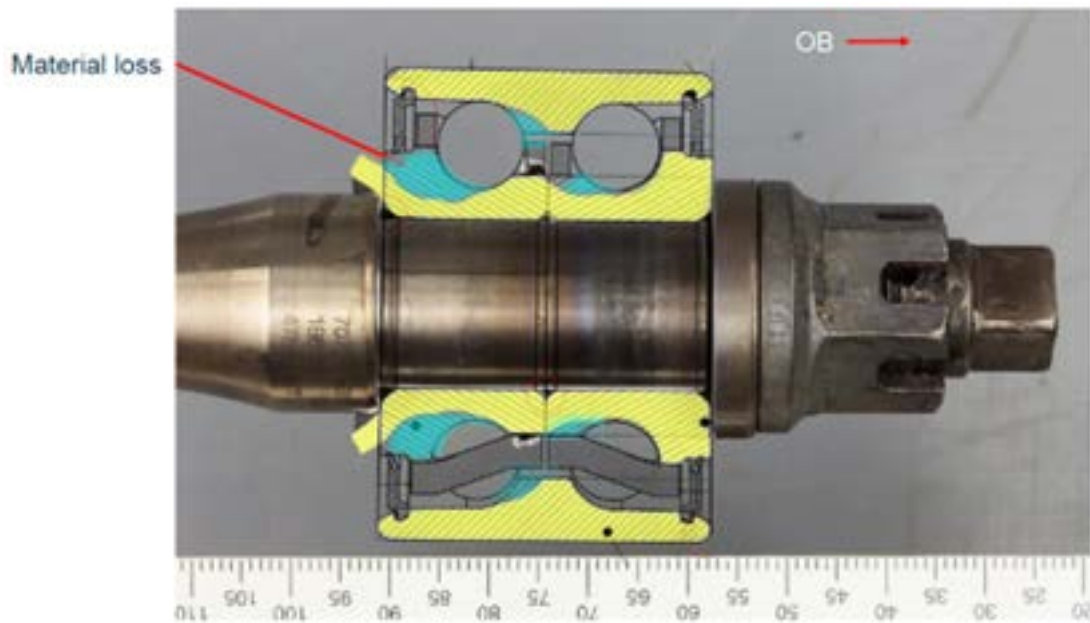
Figure 9

These damaged cross sections were superimposed on the original design cross section to highlight the changes (Figure 9). The yellow hatched sections are the damaged bearing races; the teal coloured sections are the intended design cross section, showing the extent of the missing and deformed material.

Failed bearing cross section (yellow) compared to a new bearing (teal)

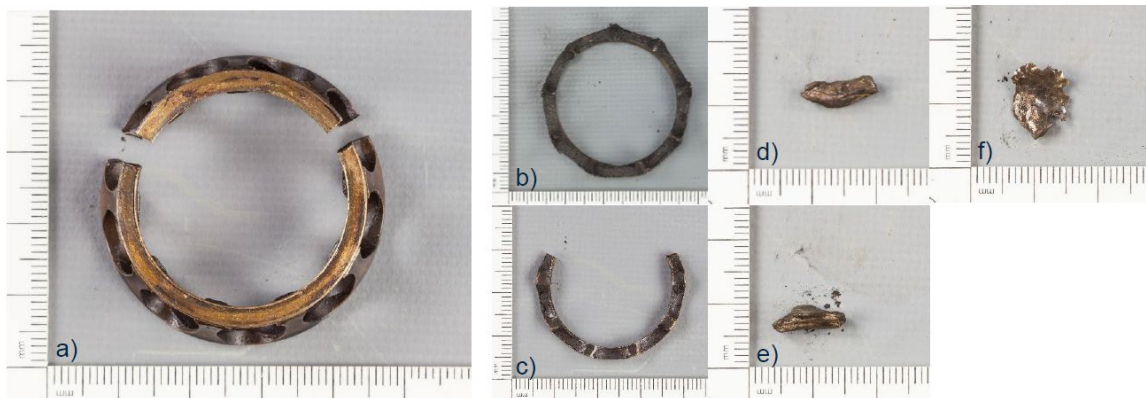
Figure 10

One of the cages had fractured into two pieces. The other cage was heavily worn and fragmented. The fracture surfaces were too heavily damaged to assess the failure mechanism reliably (Figure 10).

Recovered cage fragments: a) cage failed in two pieces, b - e) heavily worn fragments of the second cage

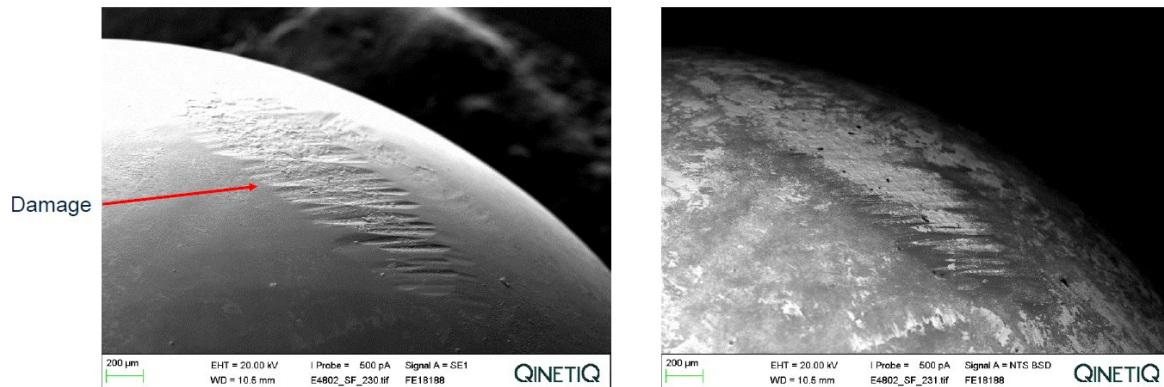
Figure 11

Assessment of the balls identified surface deposits consistent with wear material from the cages and races. The surface of one of the balls displayed damage marks indicative of sliding rather than rolling (Figure 11).

Damage marks on a ball, indicative of sliding rather than rolling

The dimensions of the balls were measured and found to be mostly below the specified diameter. The ball sizes are selected to tight tolerances at manufacture to avoid significant variation across each set of nine balls within a race. The range of measurements recorded suggested that half the balls had worn evenly and still had similar diameters within 1 µm of each other, while the other half had worn unevenly, with between 17-60 µm variation in diameter. It is likely these heavily worn balls were all fitted within the same race.

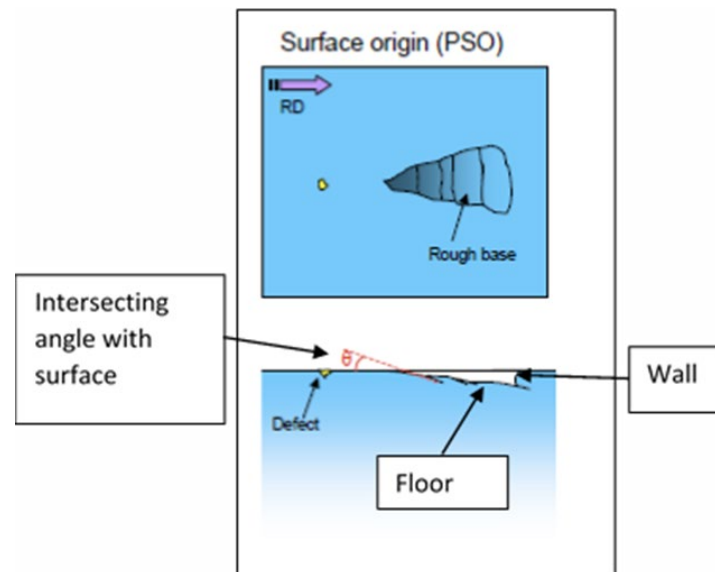
Figure 14

The inner rings also demonstrated the presence of minor debris indentation marks on side one but no RCF. The inner ring from side two exhibited indentation marks and RCF similar to the outer race. Again, there was no evidence of microstructural change or a DER. The location of the damage was also lower than the normal running line of the bearing race, which is where the highest contact pressure usually occurs during in-service operation. In combination with the lack of DER, this suggested the damage may not have resulted exclusively from the operating loads on the bearing. The debris indent marks on the races and scratches on the cage, raised the possibility that contamination may have been present within the bearing leading to the initiation of the surface RCF (Figure 14).

Illustration of typical surface RCF initiated from a surface defect
