Rail Accident Investigation Branch

Rail Accident Report

**Pedestrian struck by a train at Pewsey footpath crossing, Pewsey, Wiltshire
26 February 2025**

Report 05/2026
May 2026

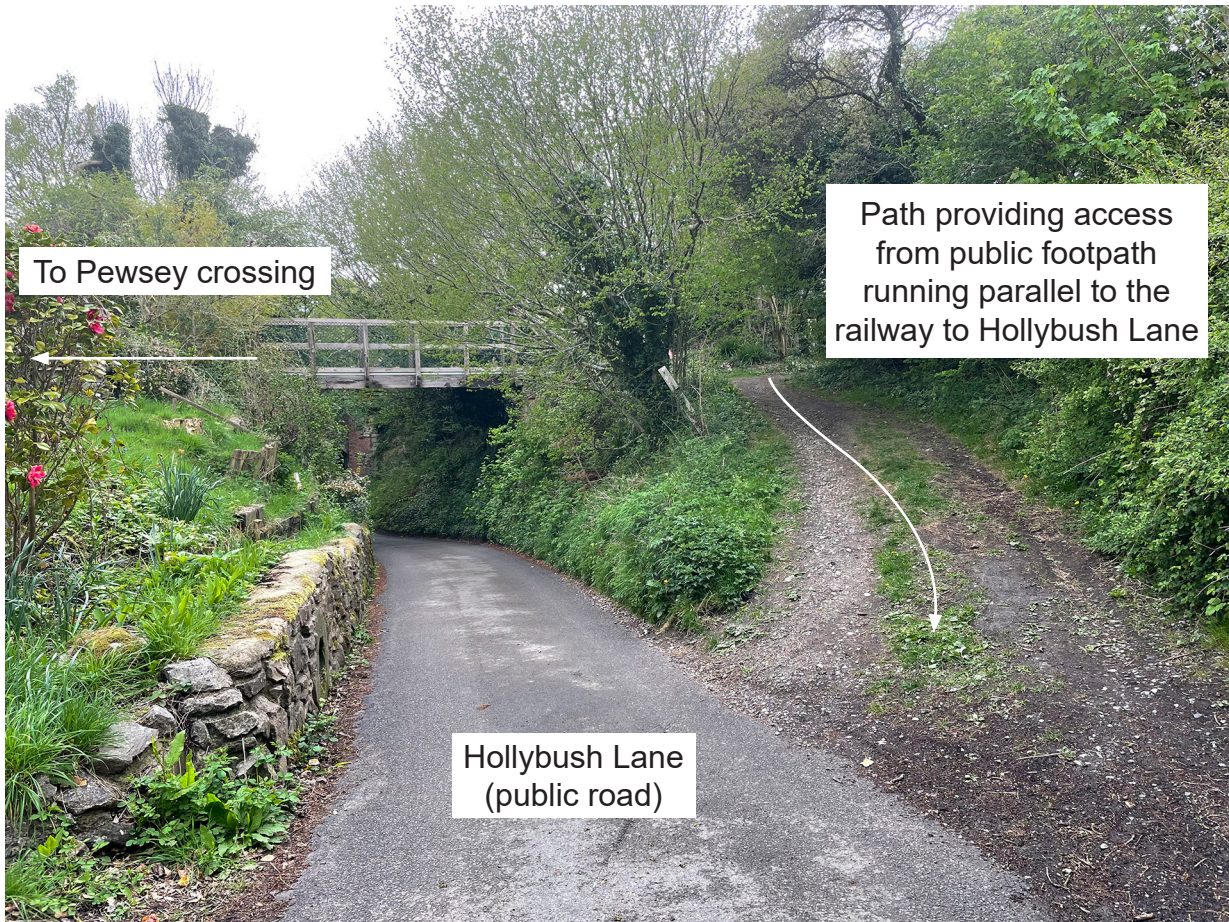
Figure 3: Hollybush Lane side bridge.

- 172 Network Rail records show that detailed examinations of Hollybush Lane side bridge had been conducted annually since at least 2018 due to the bridge's timber construction. Condition reports from 2018 to 2021 show consideration of decay of the timber structure and in 2022 Network Rail decided to replace the bridge with a new structure. This replacement was expected to be completed in 2023 or 2024. However with insufficient funding being available, and other locations being deemed a higher priority, Network Rail delayed the replacement of the bridge.

- 173 A further detailed examination of the bridge in 2023 showed no further deterioration of the structure. In September 2024, a detailed examination noted worsening deterioration and recommended the bridge for immediate closure. Initially, in September 2024, Network Rail decided not to replace the bridge but to progress a repair of the timber elements which was planned for January 2025. However, in October 2024 the repair of the bridge was delayed until beyond 2028 due to budget constraints.

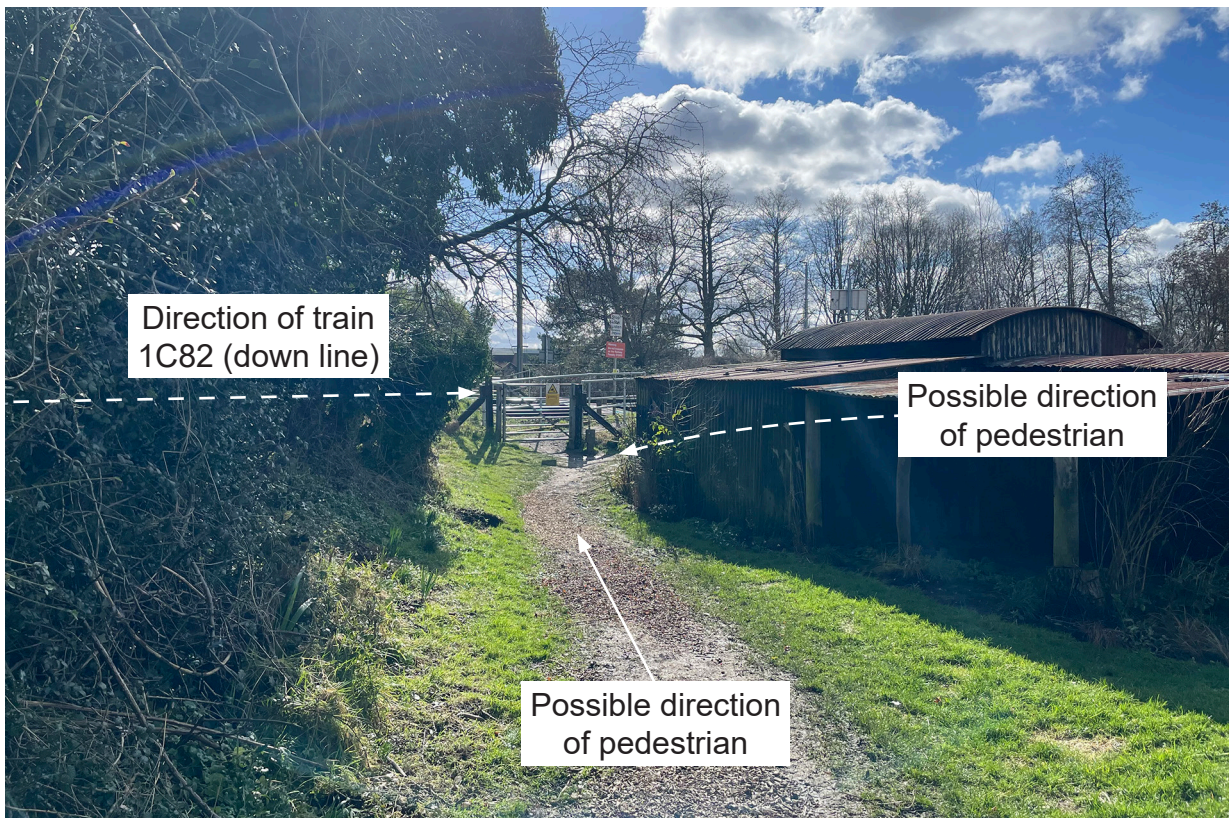
Figure 4: Possible approaches used by the pedestrian to reach the north side of the crossing. The approach parallel to the railway is obscured by a building.

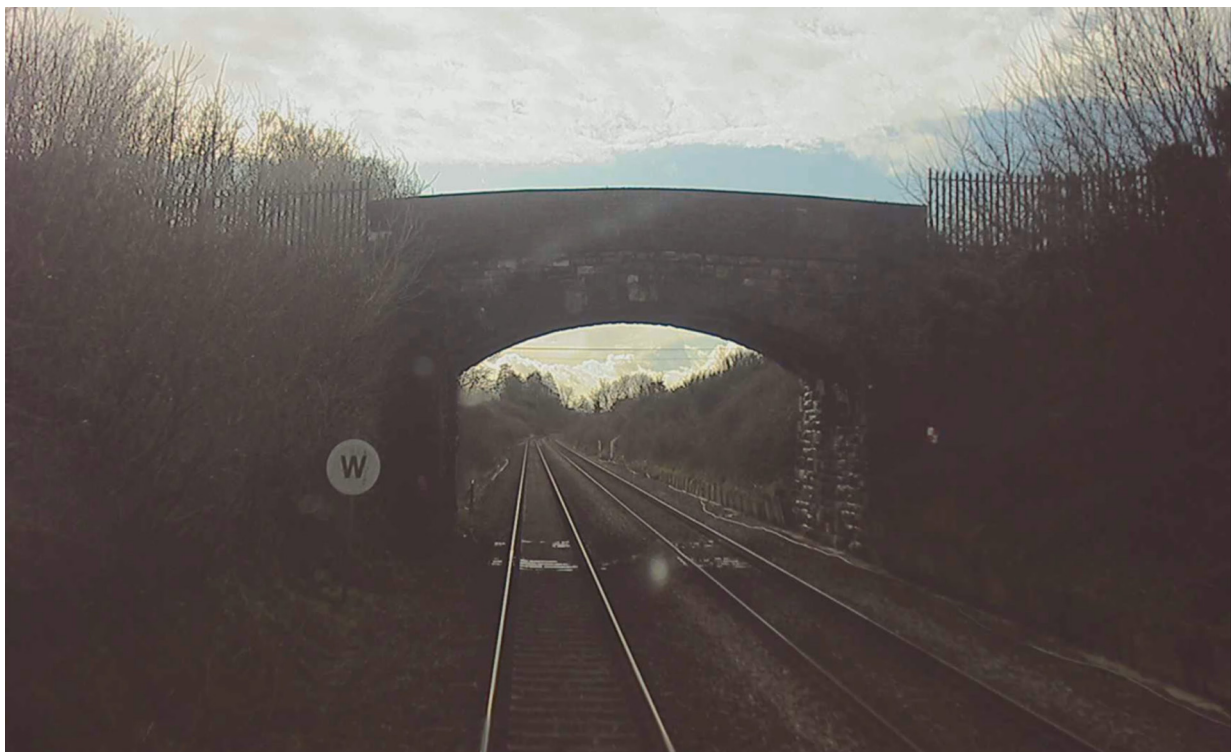
- 7 A whistle board sign is provided lineside at around 580 metres north-east of the crossing (figure 7). The sign indicates to train drivers that they must sound their train's warning horn as they pass. The purpose of trains sounding their horn at this location is to warn pedestrians using the crossing of trains approaching on the down line. A further whistle board is provided lineside around 400 metres south-west of the crossing to warn pedestrians of trains approaching on the up line.
- 8 The pedestrian approached the crossing from the north side (figures 4 and 6). When inspected by RAIB on the day after the accident, the path at this location was uneven in places and muddy. Woodchips had been placed on parts of the surface, likely to improve underfoot conditions.

Figure 7: Forward-facing CCTV showing whistle board sign adjacent to down line near Dursden Lane bridge (courtesy of Great Western Railway).

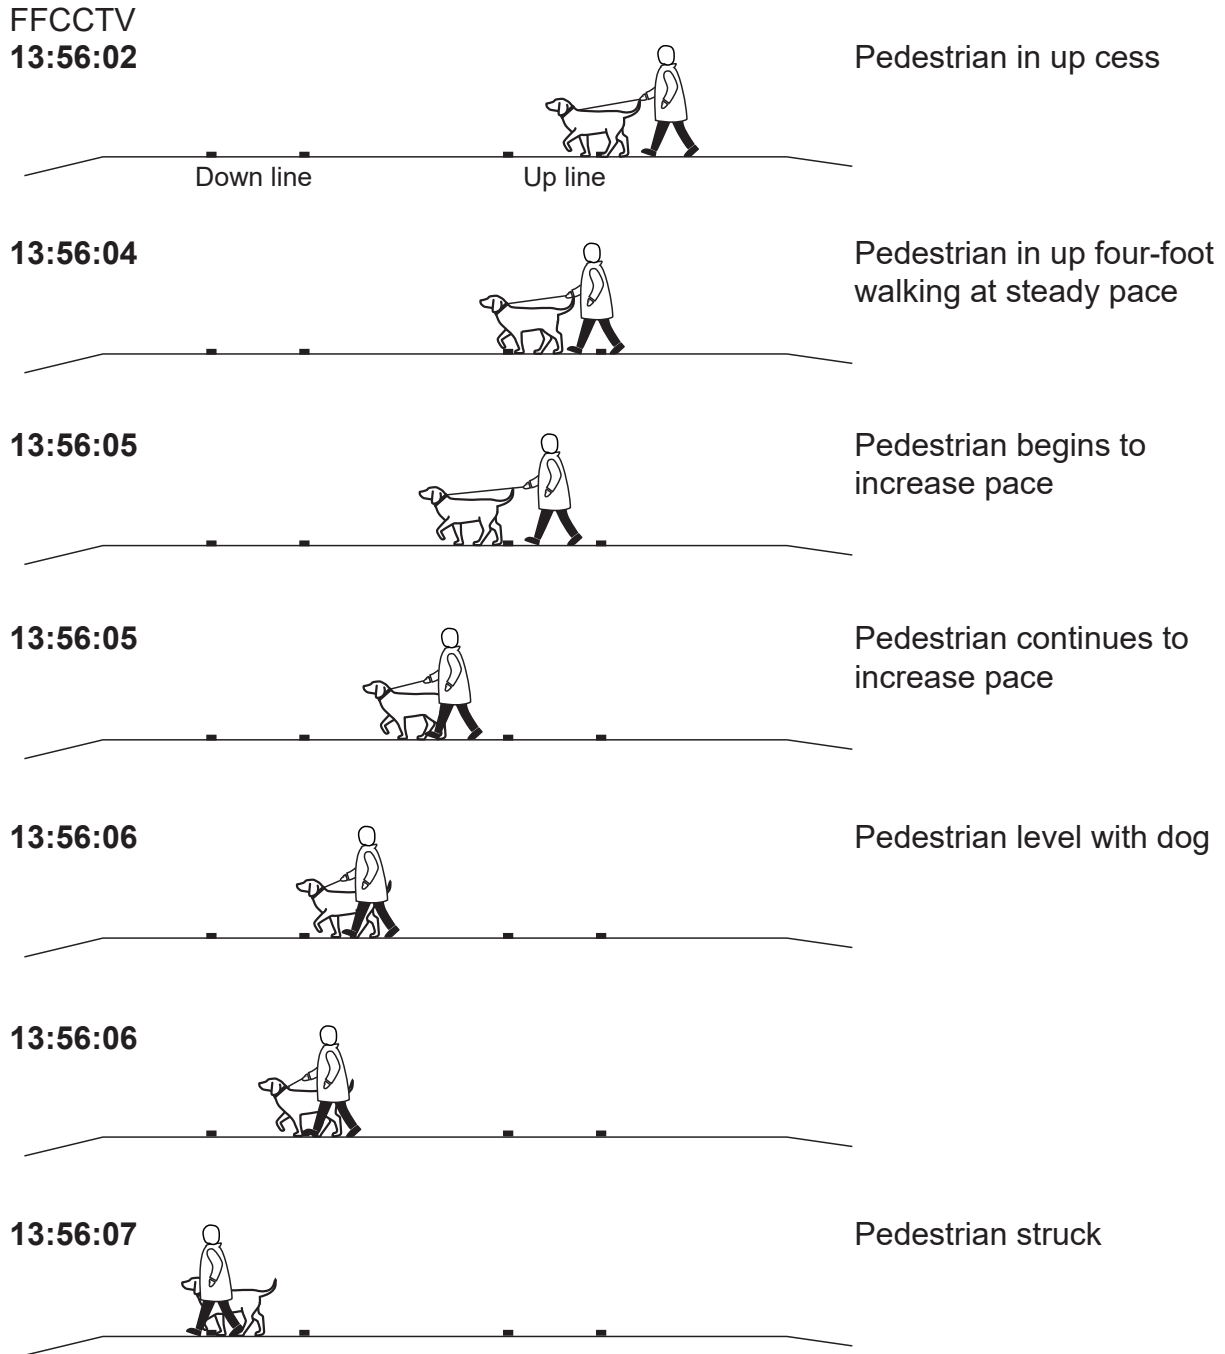
- 30 Around 2.1 seconds before the train reached the crossing, the pedestrian reached a point on the Up Westbury line level with the rail closest to the adjacent Down Westbury line on which the train was approaching. They began to enter the space between the two lines and FFCCTV images show the pedestrian continued to increase their pace towards the southern side of the crossing. When struck by the train, they were almost clear of the crossing but within the swept envelope of the approaching train. The train's emergency brakes remained applied until the train came to a stand about 670 metres beyond the crossing.

Figure 8: Positions of the pedestrian at the crossing during the accident. The positions shown are indicative only and the diagram is not to scale.

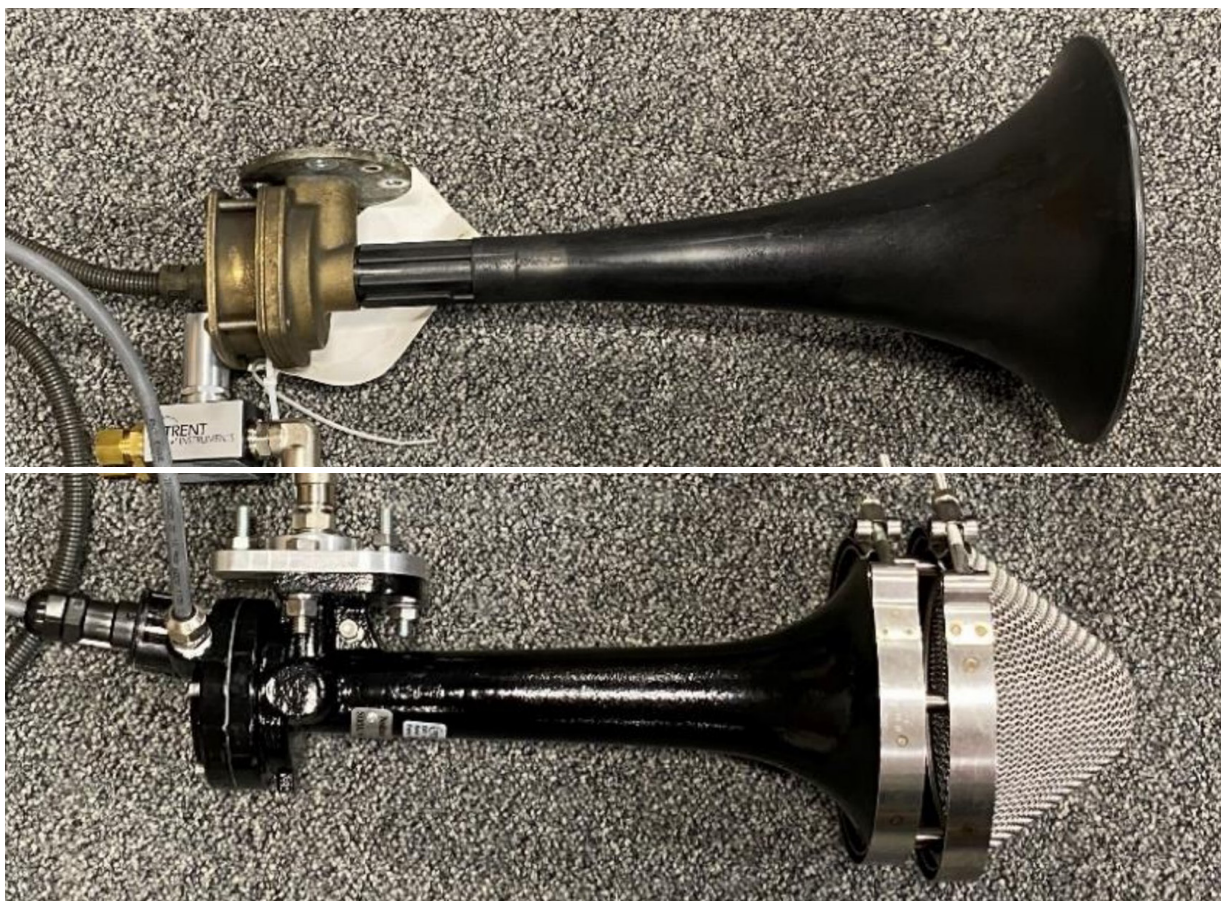
- 51 Some AT300 type trains (including class 800s) were originally fitted with 311 Hz 'Low Tone Horn' and 370 Hz 'High Tone Horn' (figure 9). Since these trains entered service, Hitachi noted the design was vulnerable to damage from bird and ballast strikes. The valance grille, directly in front of the horn, was also susceptible to obstruction which prevented the horn from functioning correctly. Hitachi identified this was due to a combination of the horn's plastic design and its low mounted position on the vehicle.

Figure 9: Top image, horn originally fitted to AT300 trains, and, bottom image, retrofitted KSJ horns installed from January 2022 (courtesy of RSSB).

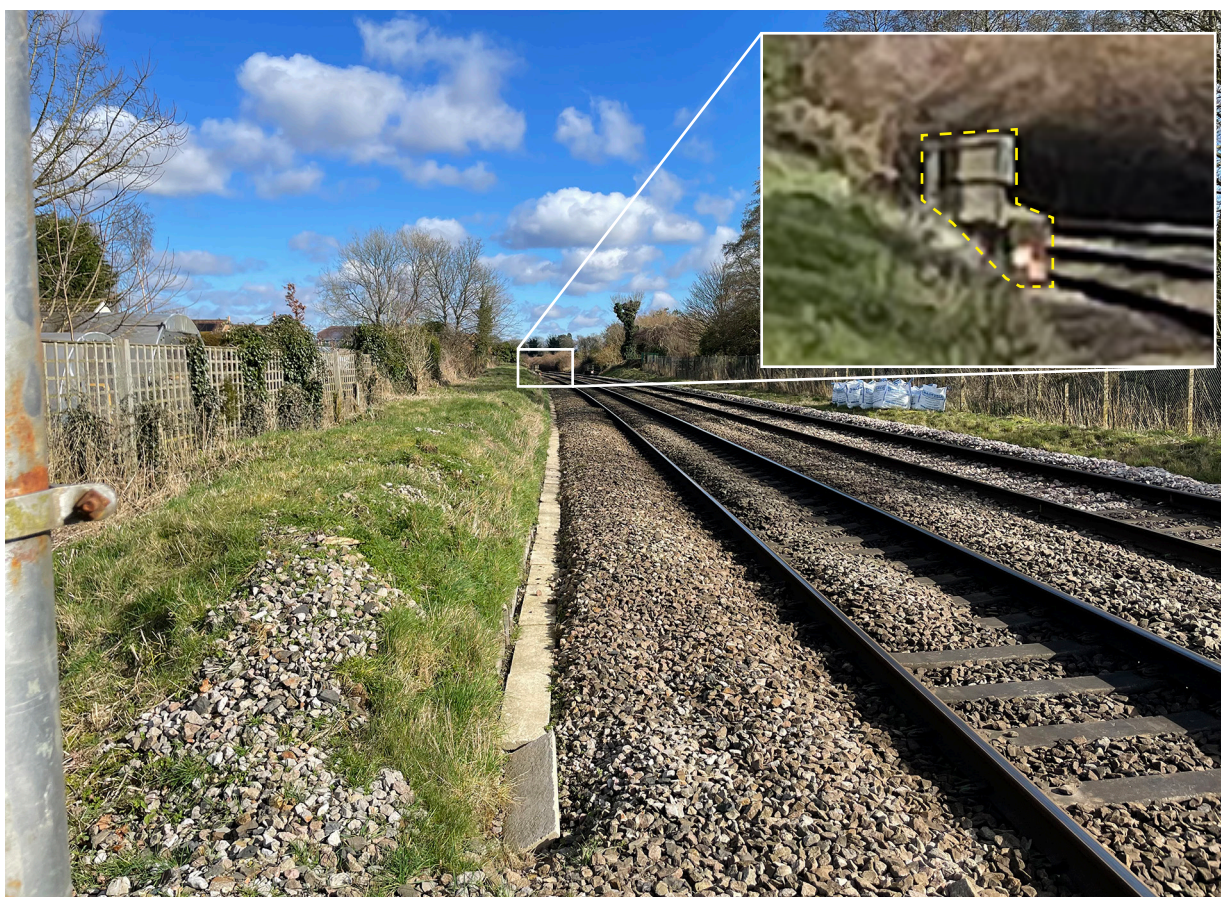
- 62 At the northern entrance to Pewsey crossing (used by the pedestrian), crossing users have a restricted view of trains approaching along the down line from the decision point due to track curvature and partial obscuration from a parapet running alongside the railway (associated with the Hollybush Lane underbridge, figure 10). RAIB measured the sighting distance at this location and found that approaching trains could be seen from around 170 metres, with partial sighting extending to around 218 metres.

- 63 A train travelling at the maximum permitted speed of 100 mph (161 km/h) on approach to Pewsey crossing will travel 170 metres in 3.8 seconds and Network Rail calculated it would take 7.8 seconds for a pedestrian to safely traverse the crossing. Therefore, pedestrians at the north side of Pewsey crossing did not have sufficient sighting distance of trains approaching on the down line to decide whether it was safe to cross by looking for approaching trains alone. The Down Westbury line whistle board sign provided lineside (paragraph 7, figure 7) instructs train drivers to sound the horn to warn pedestrians of trains approaching on the down line to help mitigate the risk of this insufficient sighting.

Figure 10: View from the decision point on the north side of the crossing of trains approaching on the down line. Inset image showing parapet (yellow outline) running alongside the railway, associated with the Hollybush Lane underbridge.

- The sighting distance available for trains approaching in the down direction at the decision point on the north (Up Westbury line) side of the crossing had been recorded as 265 metres. RAIB measured the sighting distance at this location and found that sighting was partially obstructed at 170 metres due to the bridge parapet where the railway travels over the road at Hollybush Lane and that partially obstructed sighting ended at around 218 metres (figure 10). The sighting distance at this location had also been incorrectly inputted into ALCRM.

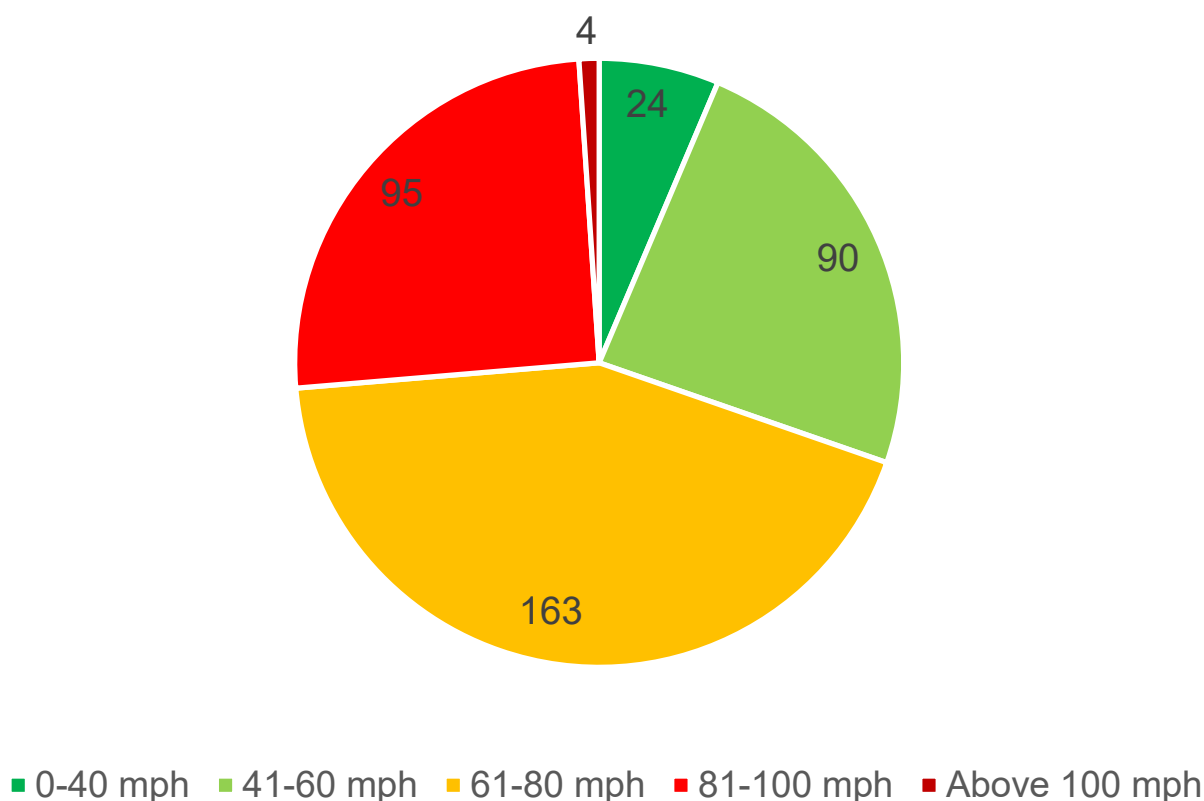
Figure 13: Line speeds at crossings fitted with whistle boards with insufficient sighting.

130 Network Rail's analysis (figure 13) shows that around 70% (262) of the crossings analysed have maximum line speeds greater than 60 mph (97 km/h). LCG05 states that whistle boards should only be used on crossings at locations with low line speeds; the guidance does not define this term (paragraph 106).

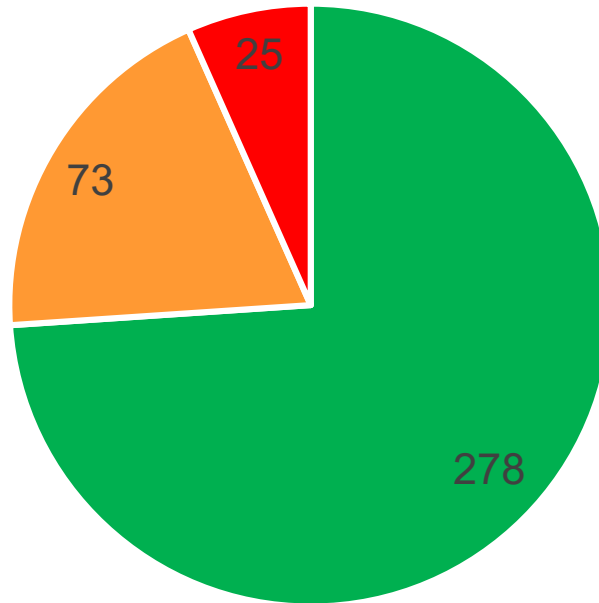
131 LCG05 also states that whistle boards should not be positioned further than 400 metres from a level crossing. Network Rail's Technical Authority reported that they generally apply a 10% tolerance (440 metres) to this to allow a pragmatic buffer for real-world constraints, including local noise conditions, sighting and structural limitations, and the practical cost and disruption of relocating infrastructure. Network Rail's analysis (figure 14) shows that 376 crossings fitted with whistle boards with insufficient sighting, and around 7% (25 crossings) had whistle boards that were outside this 440 metre limit. Of these crossings 44% (11 crossings) were in Network Rail's Western route.

Figure 14: Distance between crossings and whistle boards.

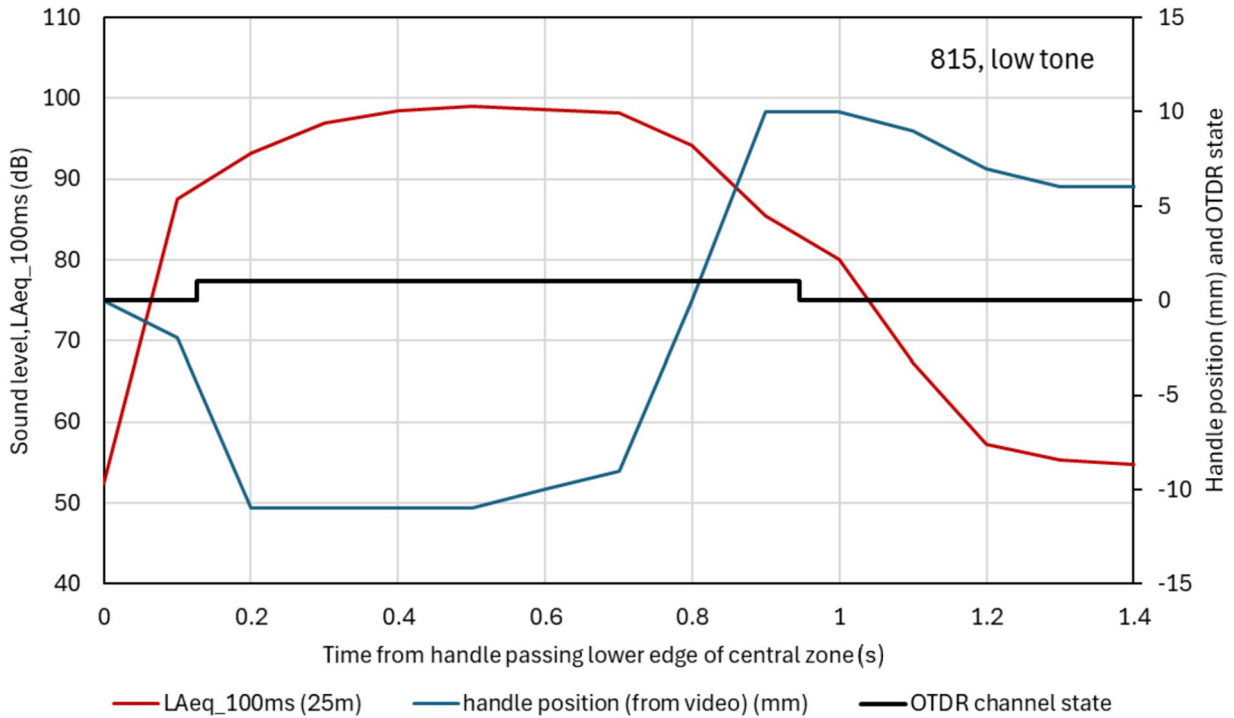
Figure C1: Sound level (left-hand axis) and horn handle position (right-hand axis) as a function of time (bottom axis). OTDR is 0 when the horn is not activated, and has a value of 1 throughout the duration that the OTDR detects that the horn is activated.

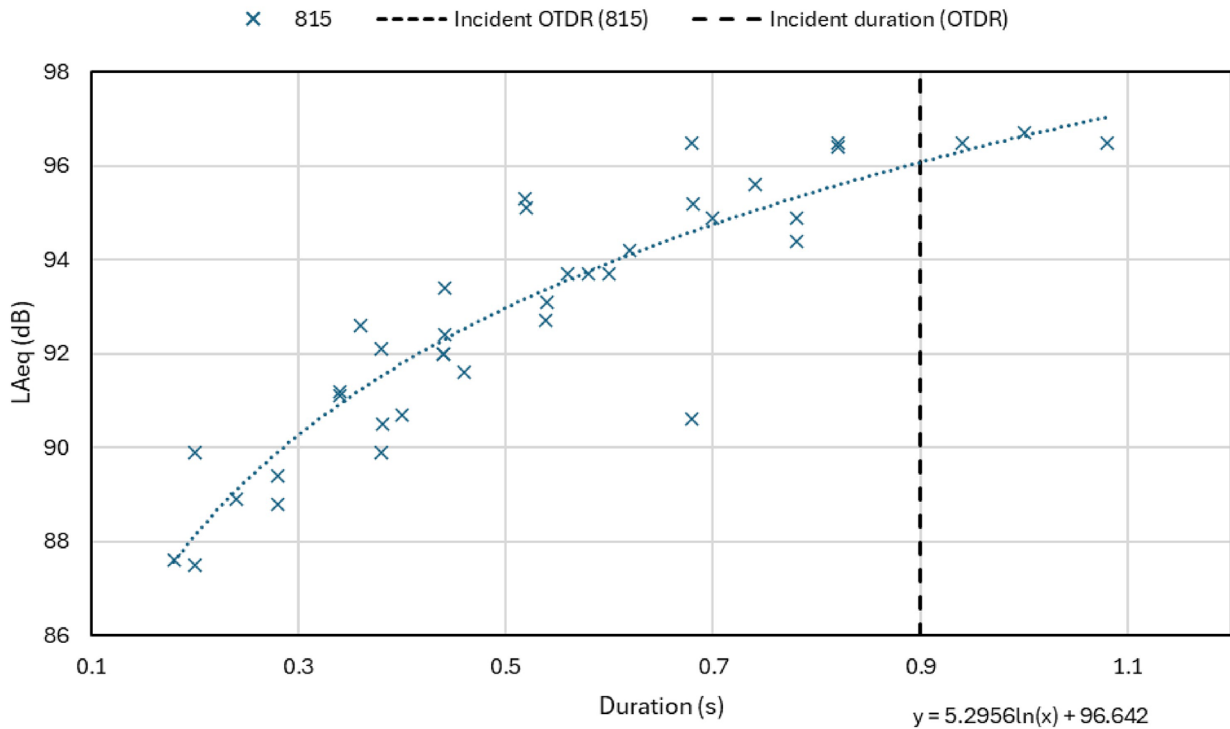
- C3 RAIB also found that the duration of the sounding of the horn affected sound levels, with a longer application/duration delivering a greater sound level. This marginal increase diminished for longer applications over the range measured (up to around 1 second, figure C2). RAIB's testing also determined that the condition of the horn grille, extent of the horn control lever being moved by the driver and the choice of the low tone or high tone horn being used did not have an effect on the sound levels produced.

Figure C3: Sound level of horn at 25 m as a function of horn duration.

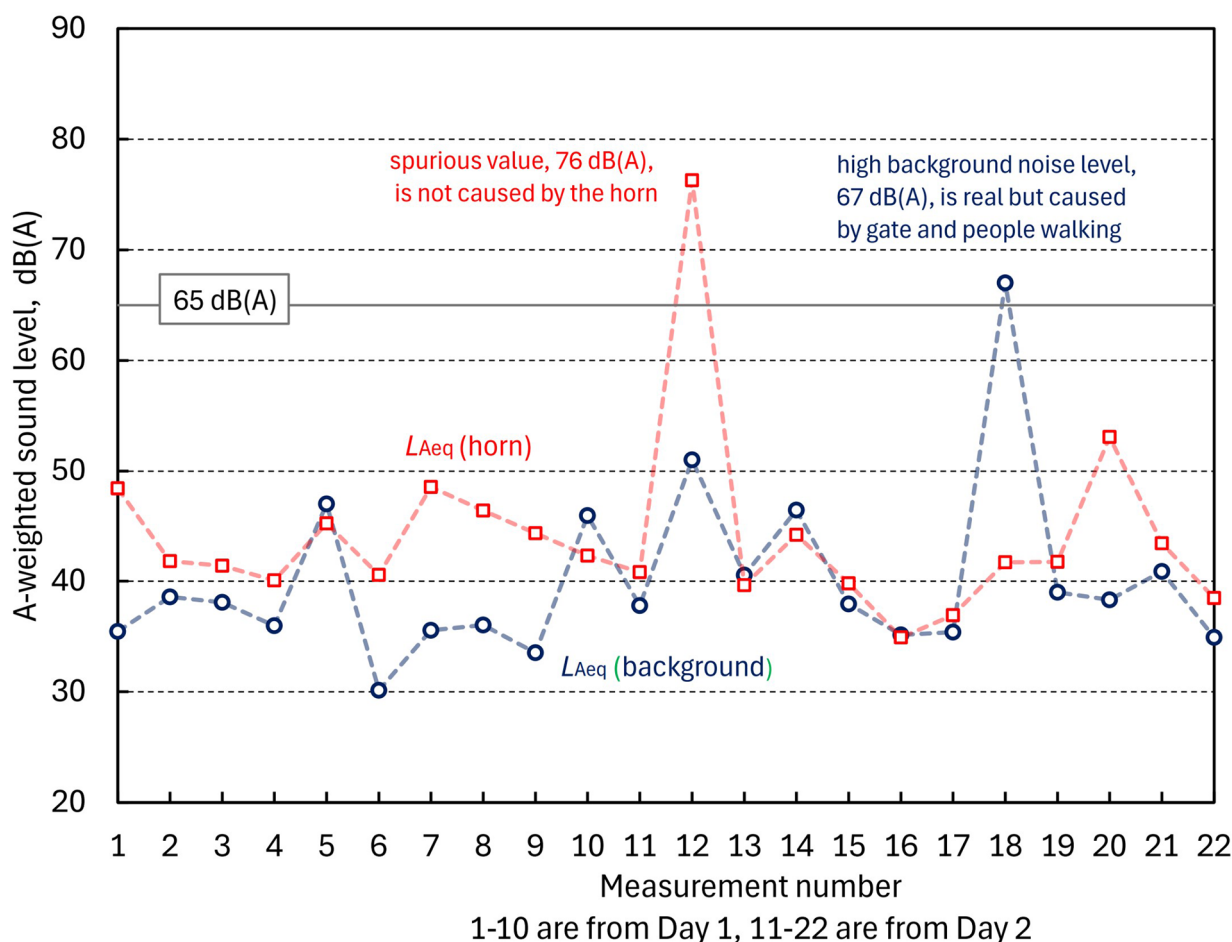
Figure C4: The sound levels measured at the north crossing gate, blue circles are background sound and red squares are horn sounds. The value recorded for measurement 12 reflected the sound of the creaking crossing gate, which masked the sound of the train horn.

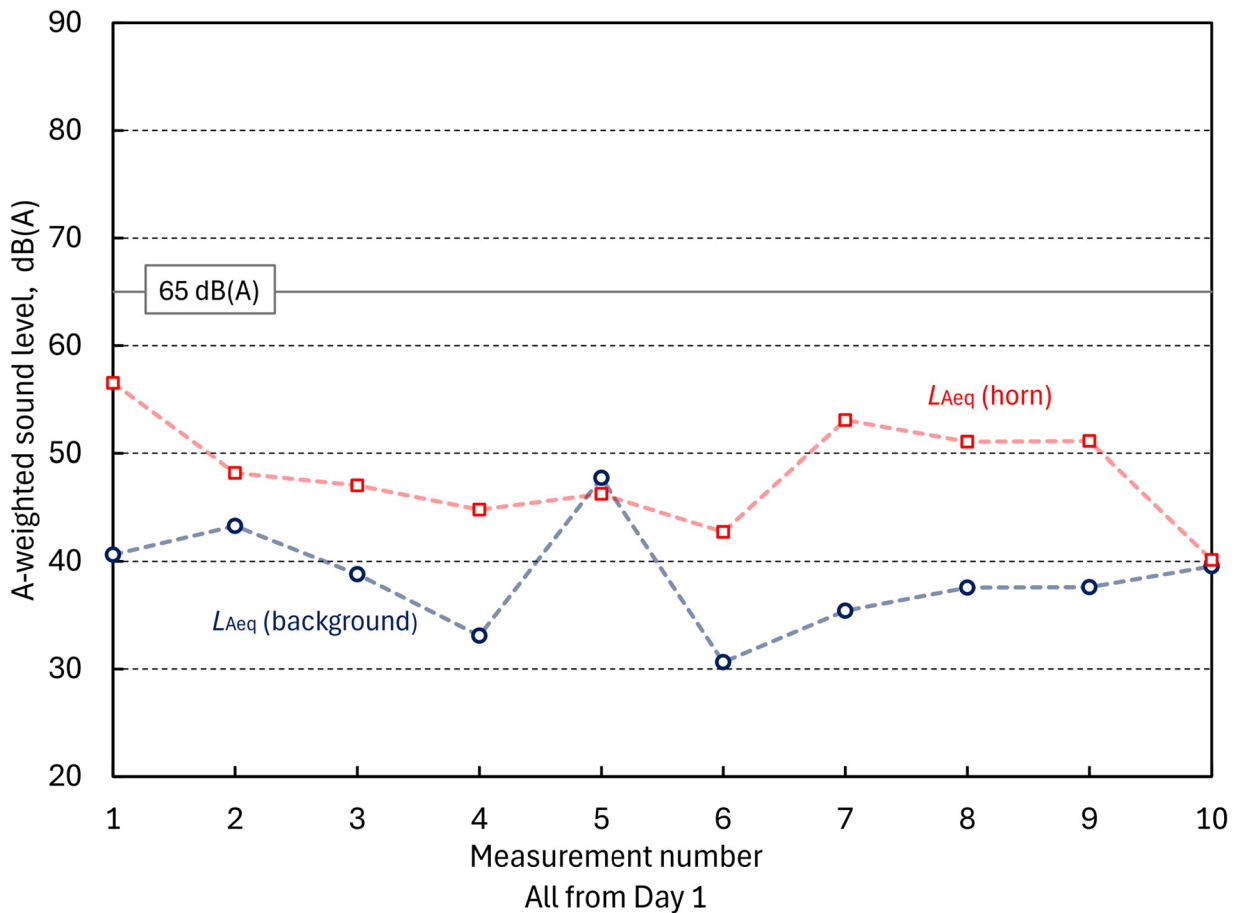
C11 At the crossing, the sound level had reduced to an average of 48.1 dB(A) at the decision point and 42.6 dB(A) at the crossing gate (figure 6). The attenuation of sound during the testing was measured to be 9 dB to 13 dB per doubling of distance (9 to 13 dB/dd) with the median rate of approximately 12.0 dB/dd. The rates of attenuation due to distance were similar to the data that had been collected during previous research in the railway environment (paragraph 46).

Figure C5: The sound levels measured at the decision point, blue circles are background sound and red squares are horn sounds.
