Rail Accident Investigation Branch

Rail Accident Report

Near miss with track workers at Bookham Tunnel, Surrey 29 April 2025

Report 07/2026
June 2026

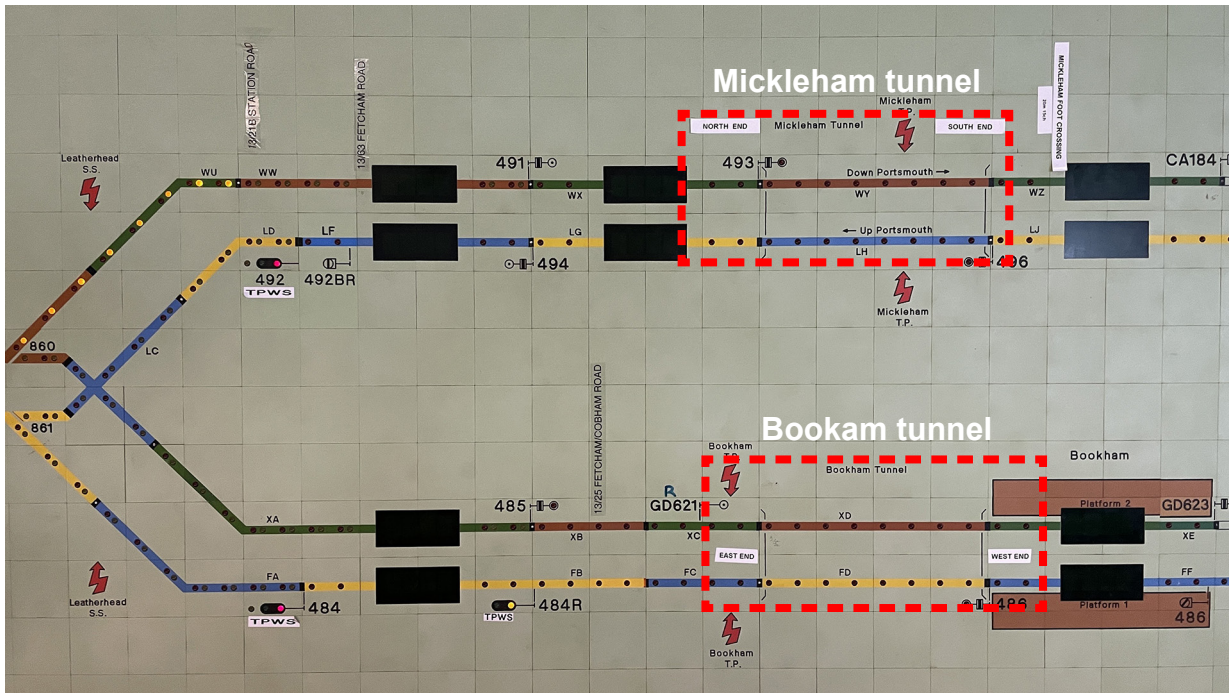
- 56 The signaller found the line blockage information using the reference number provided by the PIC (figure 7). This information had been provided to the signaller at the start of their shift on a printed list of pre-arranged line blockages. This showed that the line blockage being requested was for Mickleham Tunnel. The signaller asked for the PIC’s contact details and how long they required for the work. The phone call ended with the signaller telling the PIC that a train was approaching and hence the line blockage could not be taken at this time. The signaller said that they would call the PIC back about the line blockage. The signaller did not realise that the PIC was at Bookham Tunnel and not at Mickleham Tunnel during this initial call (figure 8).

Figure 8: Signaller's panel showing the location of the tunnels (highlighted in red dotted boxes).

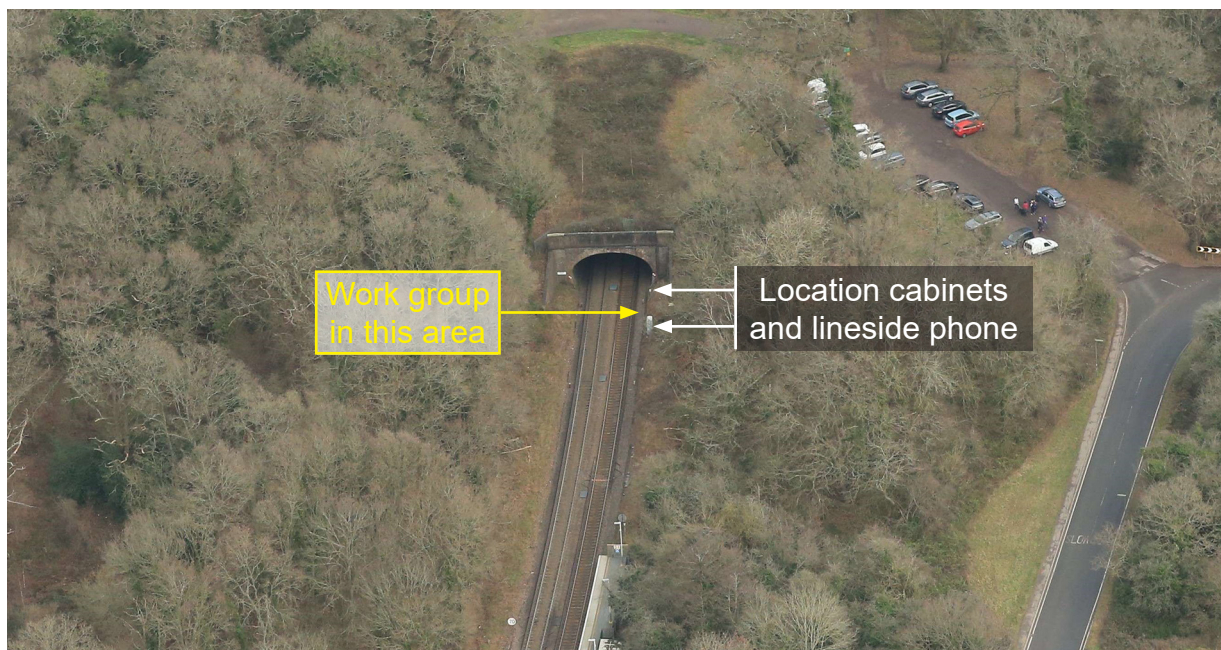
58 At 11:12, the signaller called the PIC back to grant the line blockage. During the conversation, the signaller confirmed the blocking points (defined railway features, such as signals, used to geographically bound a line block) given in their copy of the line blockage documentation, which matched the documentation held by the PIC (figure 7). There was no repeat of the blocking point information by the PIC back to the signaller and no mention of the physical location of the line blockage. The line blockage was granted, and a handback time was agreed. The Down Portsmouth line through Mickleham Tunnel was now blocked but the Down Bookham line through Bookham Tunnel, where the team was, remained open. The PIC and the track workers walked from west to east, on the Down Bookham line through the tunnel (figure 10).

Figure 10: Track workers location after taking first line blockage (courtesy of Network Rail with RAIB annotations).

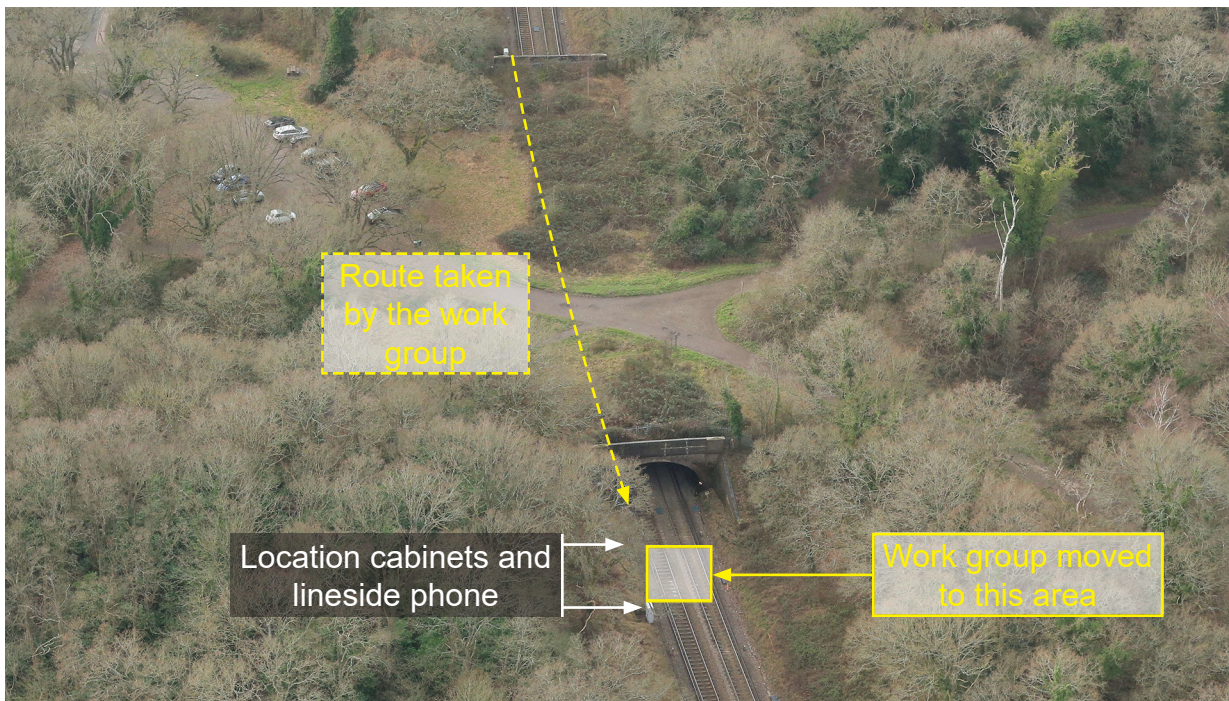
- 62 At 11:39, the signaller phoned the PIC back to confirm the line was clear for the requested line blockage. The signaller confirmed the blocking points and agreed a handback time with the PIC. This again blocked the Down Portsmouth line through Mickleham Tunnel, while the down line through Bookham Tunnel remained open. The team set off back to Bookham station with the PIC leading, followed by trackworker 2 and trackworker 1. At the same time, train 2D23 left Leatherhead station.

Figure 12: Track workers location before taking second line blockage (courtesy of Network Rail with RAIB annotations).

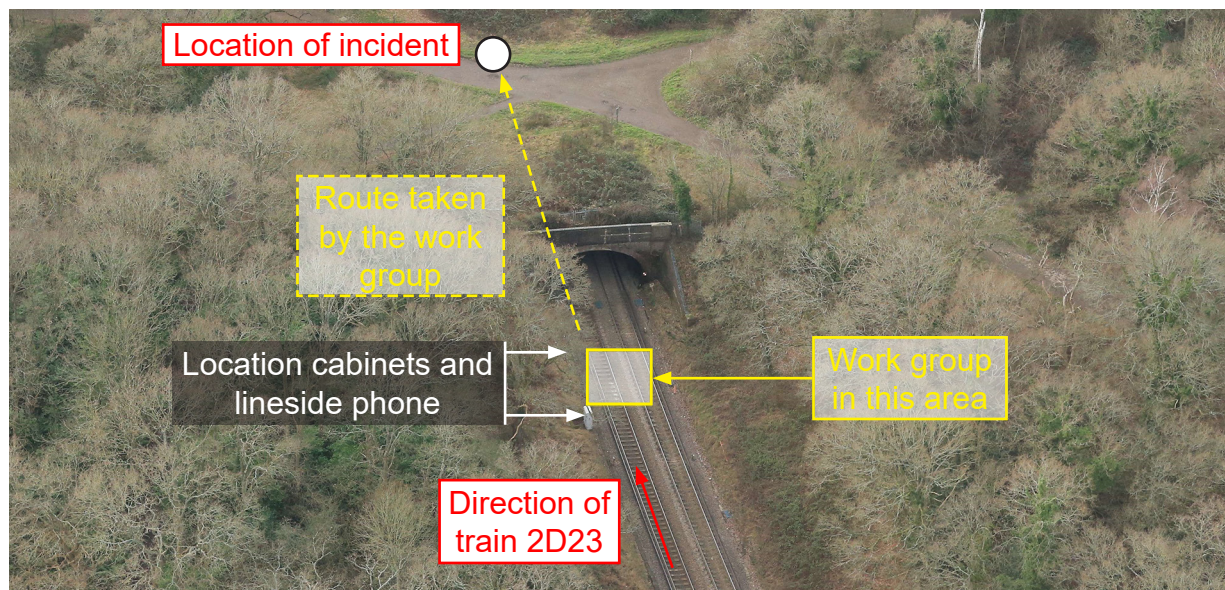
- 63 At approximately 11:41, while walking inside the tunnel, trackworker 1 heard a train approaching behind them and shouted a warning to the rest of the group. At around the same time, the train driver saw the group and sounded the horn. The group then moved quickly to the side of the tunnel. Once the train had passed, the group then headed toward Bookham station (figure 13).

Figure 13: Track workers location after taking second line blockage and during incident (courtesy of Network Rail with RAIB annotations).

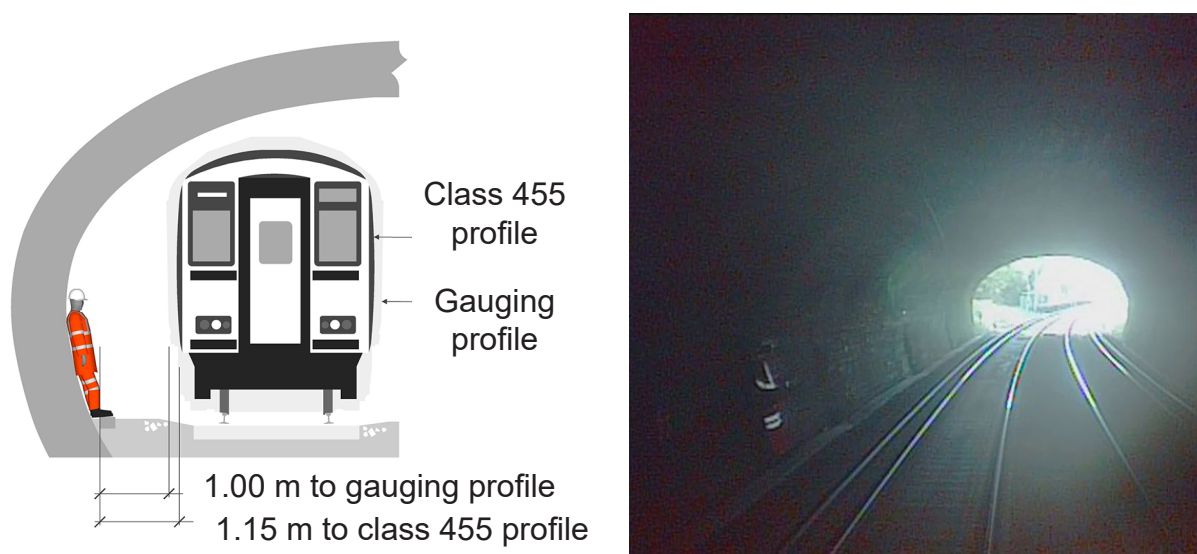
- 67 The Rule Book (paragraphs 28 and 30) requires anyone working on or near the line to be in a position of safety at least 10 seconds before a train passes them. For line speeds below 100 mph (161 km/h), a position of safety should be a minimum of 1.25 metres from the nearest running rail.

- 68 The distance between the tunnel wall and the nearest running rail of the down line where the track workers were walking is about 1.6 metres. The available space between the tunnel wall and the passing train was between 1 and 1.15 metres (figure 15).

Figure 15: Position of track worker inside the tunnel as the train passed, based on gauging information from Network Rail (left-hand image) and from FFCCTV (right-hand image, courtesy of South Western Railway).

- 69 The length of time the track workers had between becoming aware of the approaching train and positioning themselves against the tunnel wall or in the refuges is unknown from the FFCCTV footage. Witness evidence, however, indicates that, due to the track curvature and because the train approached the group from behind, the track workers only had seconds to react when they became aware of the train. Knowing that they were in a tunnel of limited clearance, the track workers moved to either put themselves against the tunnel wall (as one did) or move into a refuge before the train passed (as the other two did).
