Rail Accident Investigation Branch

Rail Accident Report

Near miss with track workers at Bookham Tunnel, Surrey 29 April 2025

Report 07/2026
June 2026

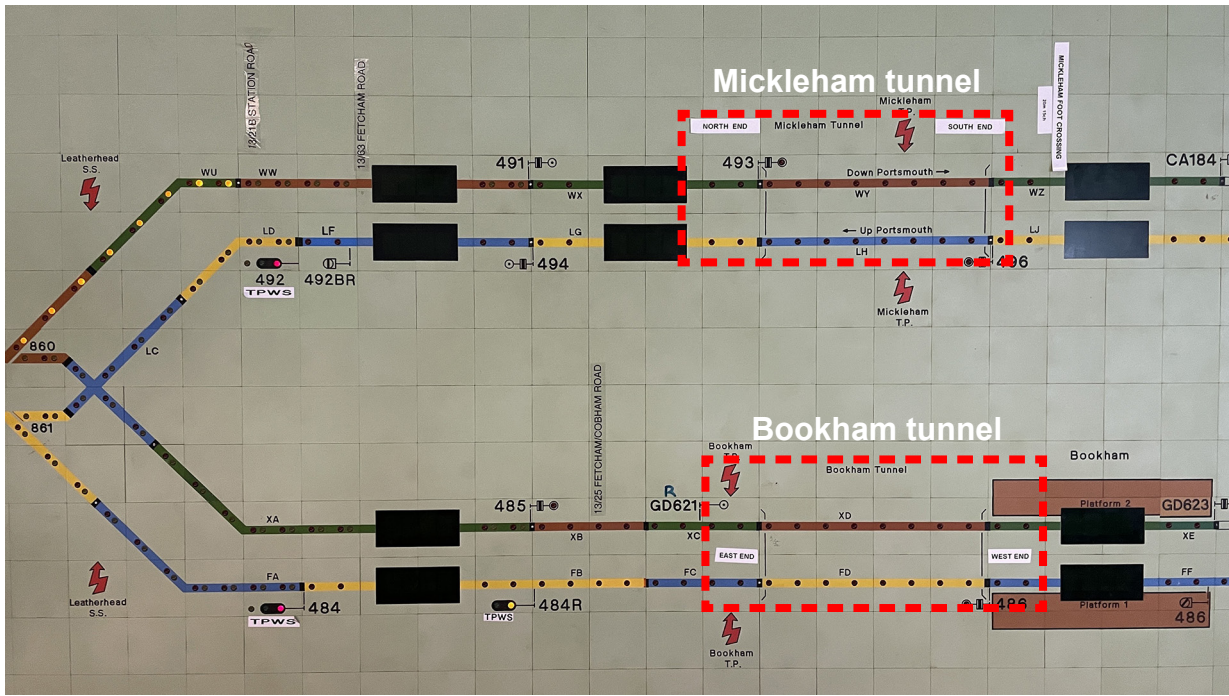
Figure 8: Signaller's panel showing the location of the tunnels (highlighted in red dotted boxes).

- 56 The signaller found the line blockage information using the reference number provided by the PIC (figure 7). This information had been provided to the signaller at the start of their shift on a printed list of pre-arranged line blockages. This showed that the line blockage being requested was for Mickleham Tunnel. The signaller asked for the PIC’s contact details and how long they required for the work. The phone call ended with the signaller telling the PIC that a train was approaching and hence the line blockage could not be taken at this time. The signaller said that they would call the PIC back about the line blockage. The signaller did not realise that the PIC was at Bookham Tunnel and not at Mickleham Tunnel during this initial call (figure 8).

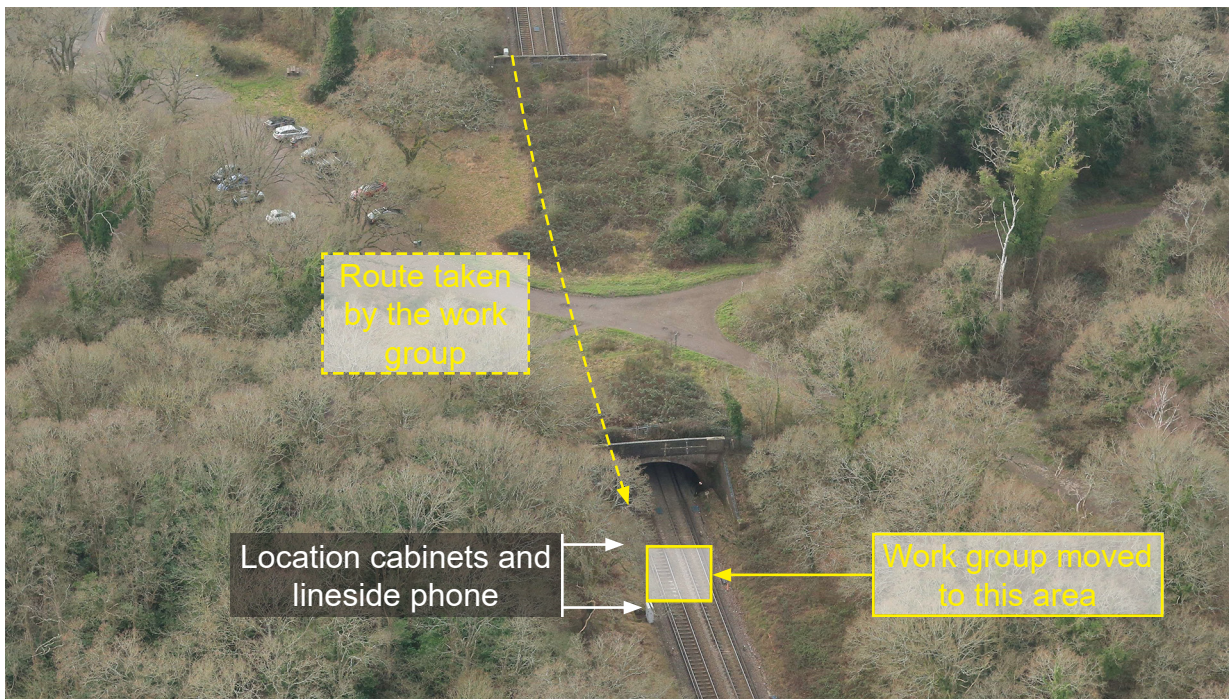
Figure 12: Track workers location before taking second line blockage (courtesy of Network Rail with RAIB annotations).

- 62 At 11:39, the signaller phoned the PIC back to confirm the line was clear for the requested line blockage. The signaller confirmed the blocking points and agreed a handback time with the PIC. This again blocked the Down Portsmouth line through Mickleham Tunnel, while the down line through Bookham Tunnel remained open. The team set off back to Bookham station with the PIC leading, followed by trackworker 2 and trackworker 1. At the same time, train 2D23 left Leatherhead station.
