Rail Accident Investigation Branch

Rail Accident Report

Collision between two passenger trains near Talerddig, Powys 21 October 2024

Report 08/2026
June 2026

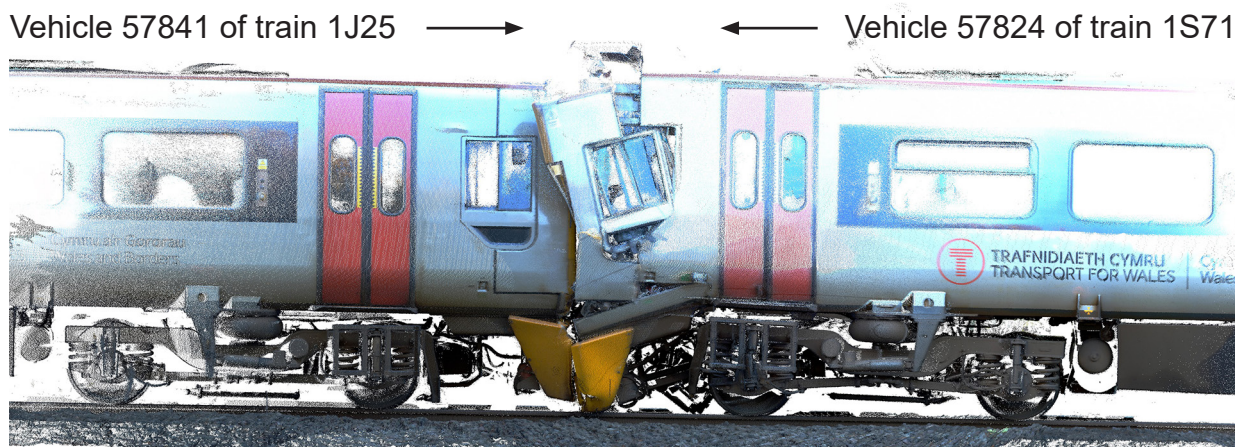
- 11 The leading ends of each train (vehicle 57841 of train 1J25 and vehicle 57824 of train 1S71) suffered damage in the collision (figure 3). The driving cab of train 1S71 received the most damage and was significantly deformed. The basic structural integrity of the passenger compartments on each train was maintained although a number of internal panels became displaced, and some internal and external doors became inoperable. Underframe equipment on both trains was displaced but did not become detached.

Figure 3: Side view of the collision showing the leading vehicle of each train (image created from laser scans).

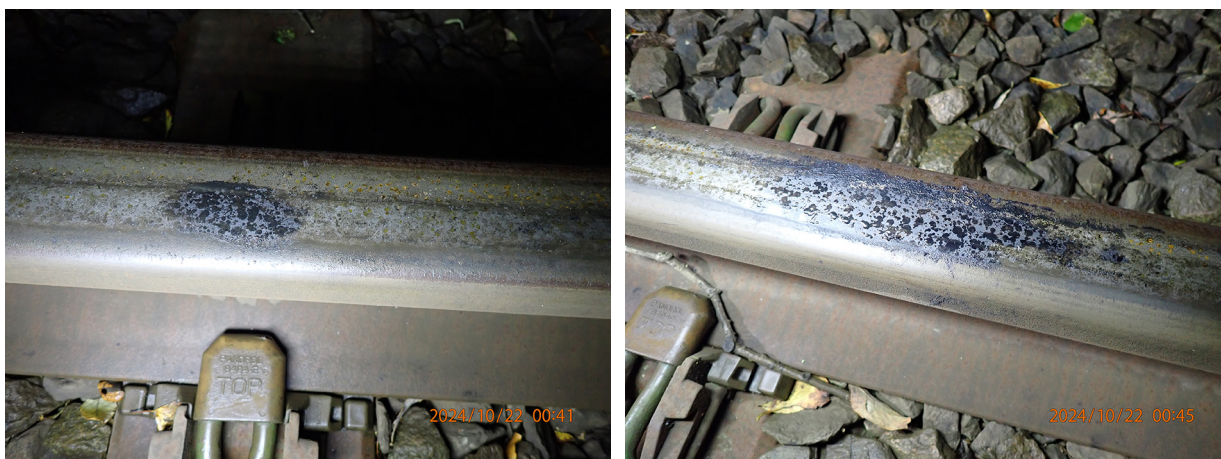
Figure 24: Example of visible contamination observed on the railhead between the collision location and Talerddig loop at around 00:45 hours on 22/10/2024.

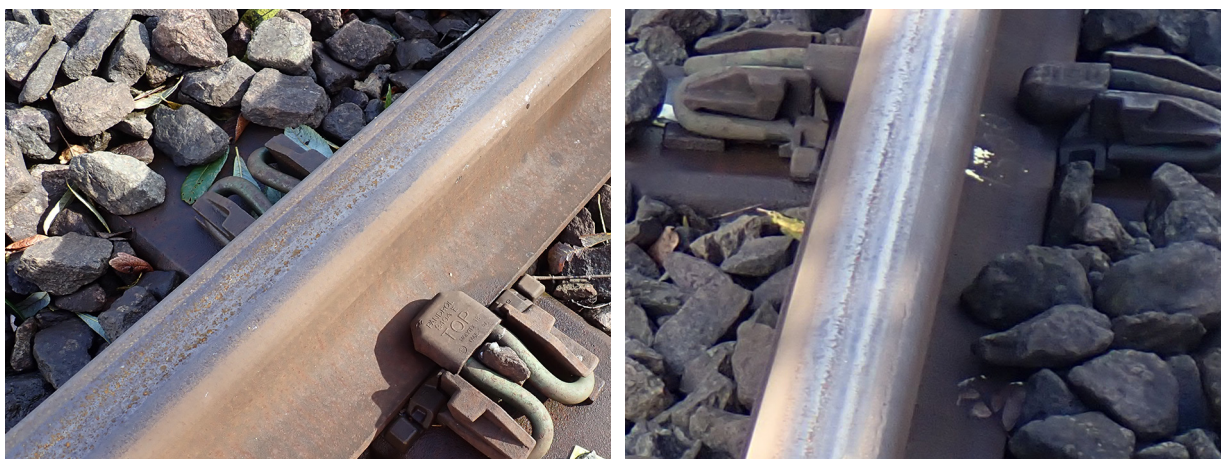
Figure 25: Example of visible contamination observed on the railhead at around 11:25 hours the morning after the accident, on the approach to the loop at 1400 metres (left) & 1500 metres (right) on approach to the point of collision.

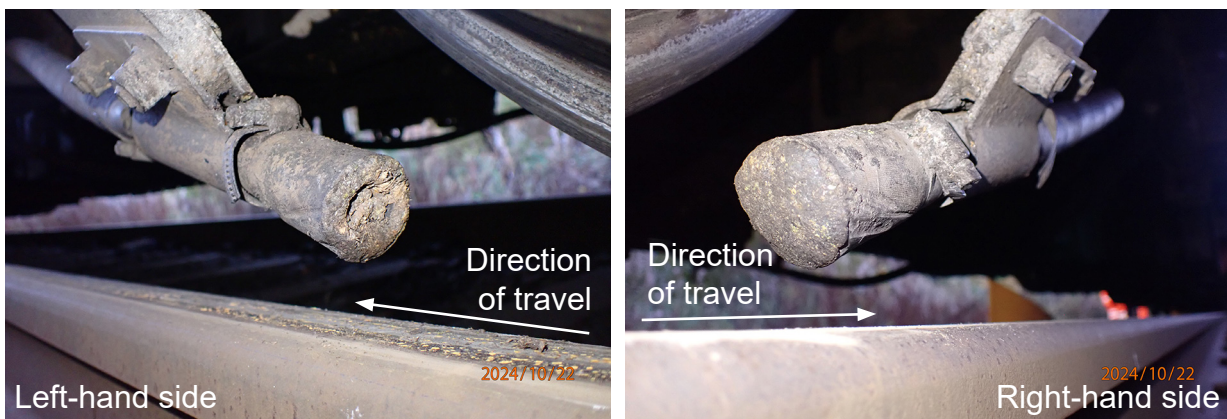
Figure 28: The blocked sand delivery hoses, as found on leading vehicle 57841; left: driver side hose; right: non-driver's side hose.

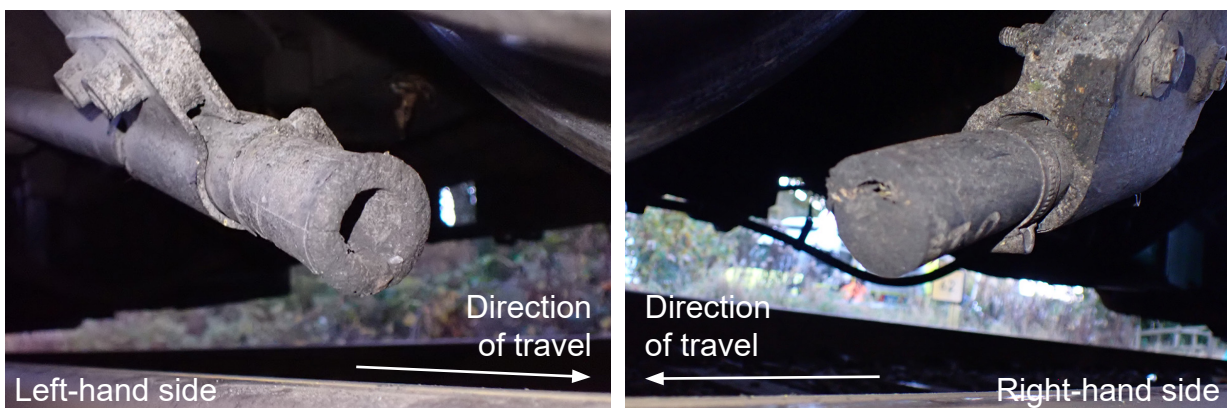
Figure 29: The sand delivery hoses, as found on trailing vehicle 52841; left: driver side hose; right: non-driver's side hose.

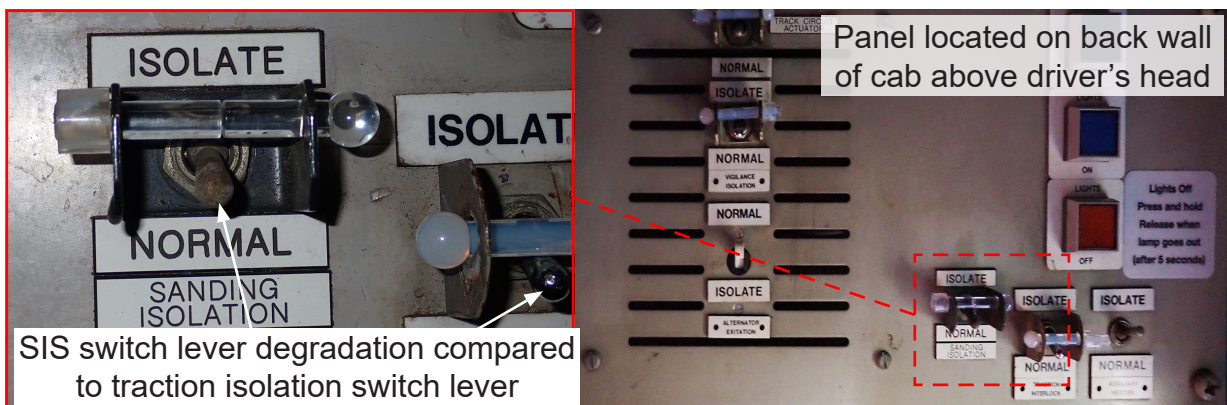
Figure 31: The sand isolation switch located at the rear of the cab of unit 57841 showing the condition of the switch and seal.

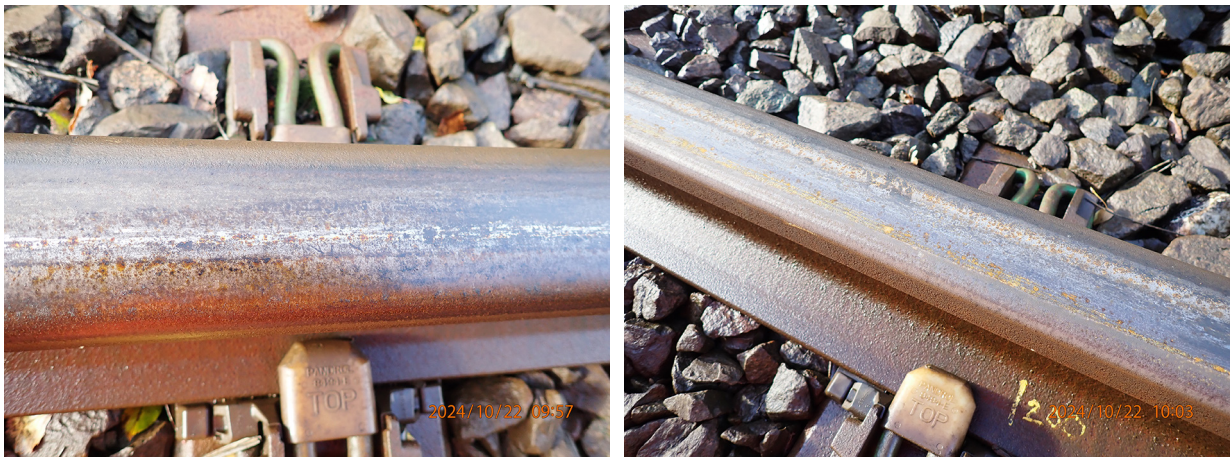
Figure 47: Example of visible contamination observed on the railhead on 22/10/2024 (the day after the accident) on the descending gradient at 100 metres (left) and 200 metres (right) before the collision location.

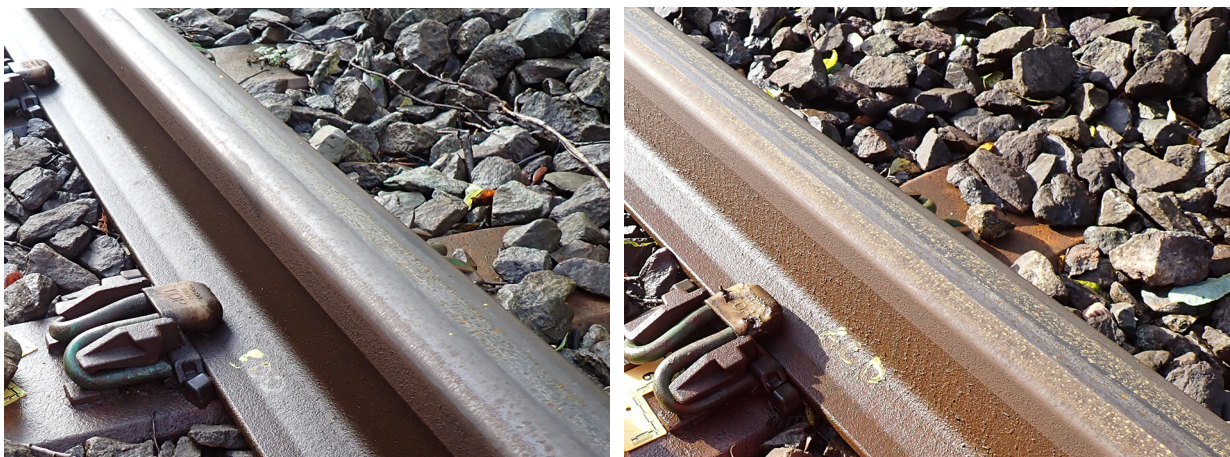
Figure 48: Example of visible contamination observed on the railhead, at around 10:20 on 22/10/2024 (the day after the accident), after the loop on the descending gradient at 500 metres (left) and 600 metres (right) before the collision location.

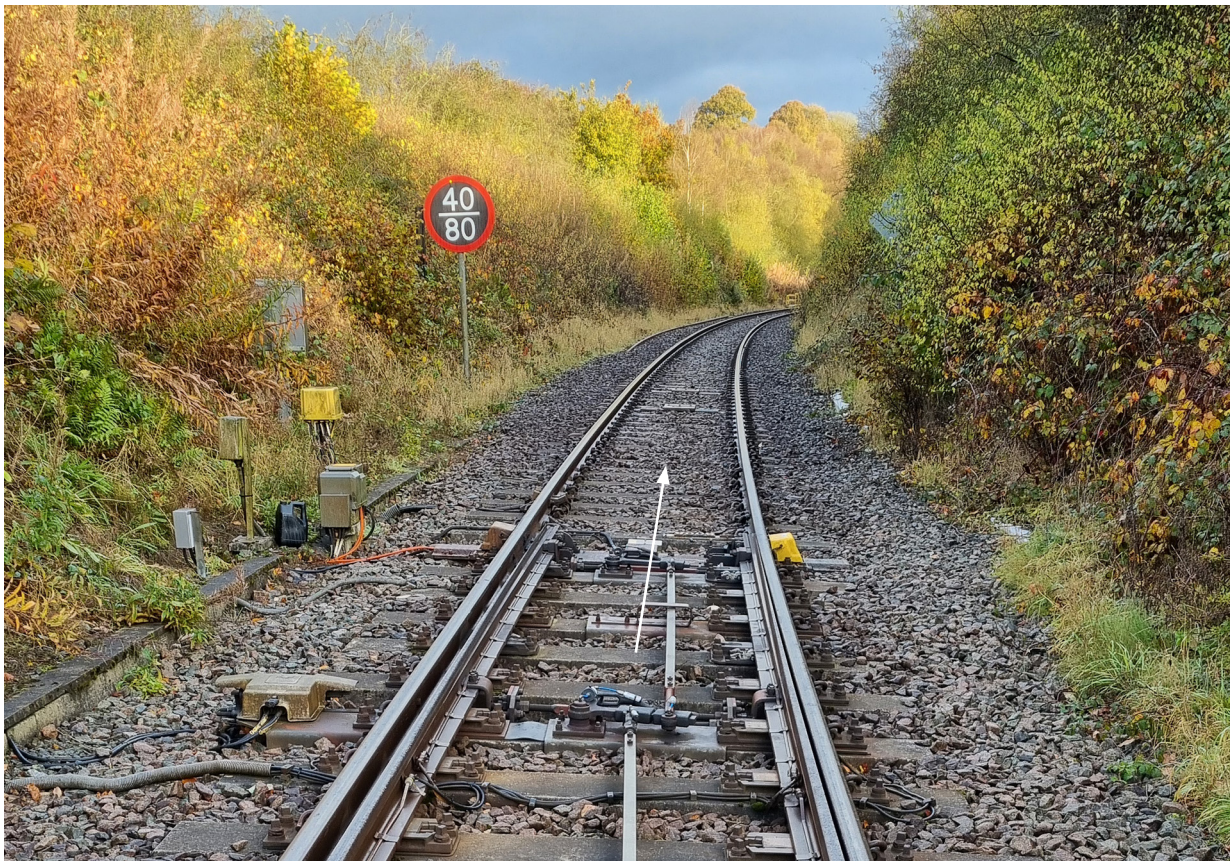
Figure 50: Lineside vegetation, in vicinity of the exit points of Talerddig loop at around 09:20 on 22/10/24 (the collision location is approximately 900 m away).

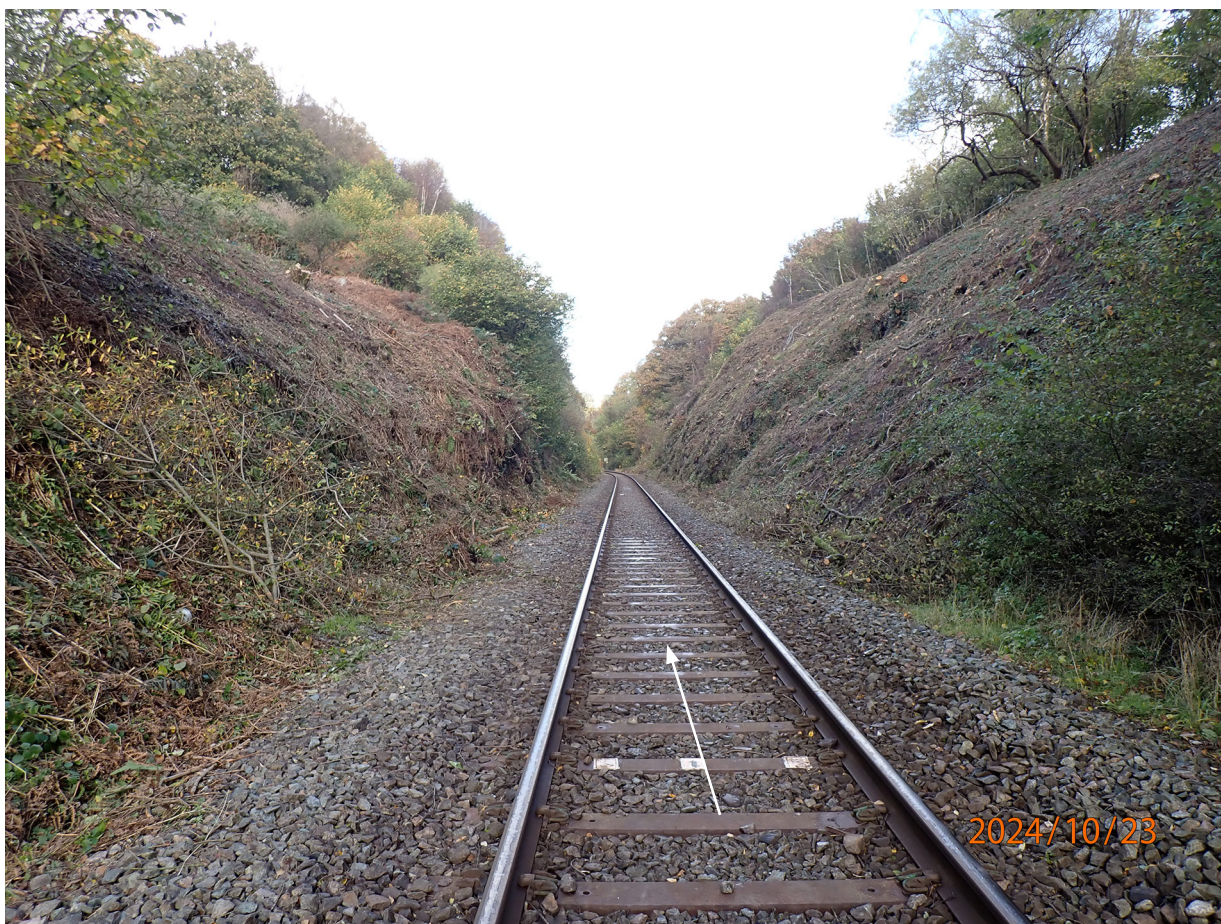
Figure 51: Lineside vegetation approximately 530 m from the collision location.

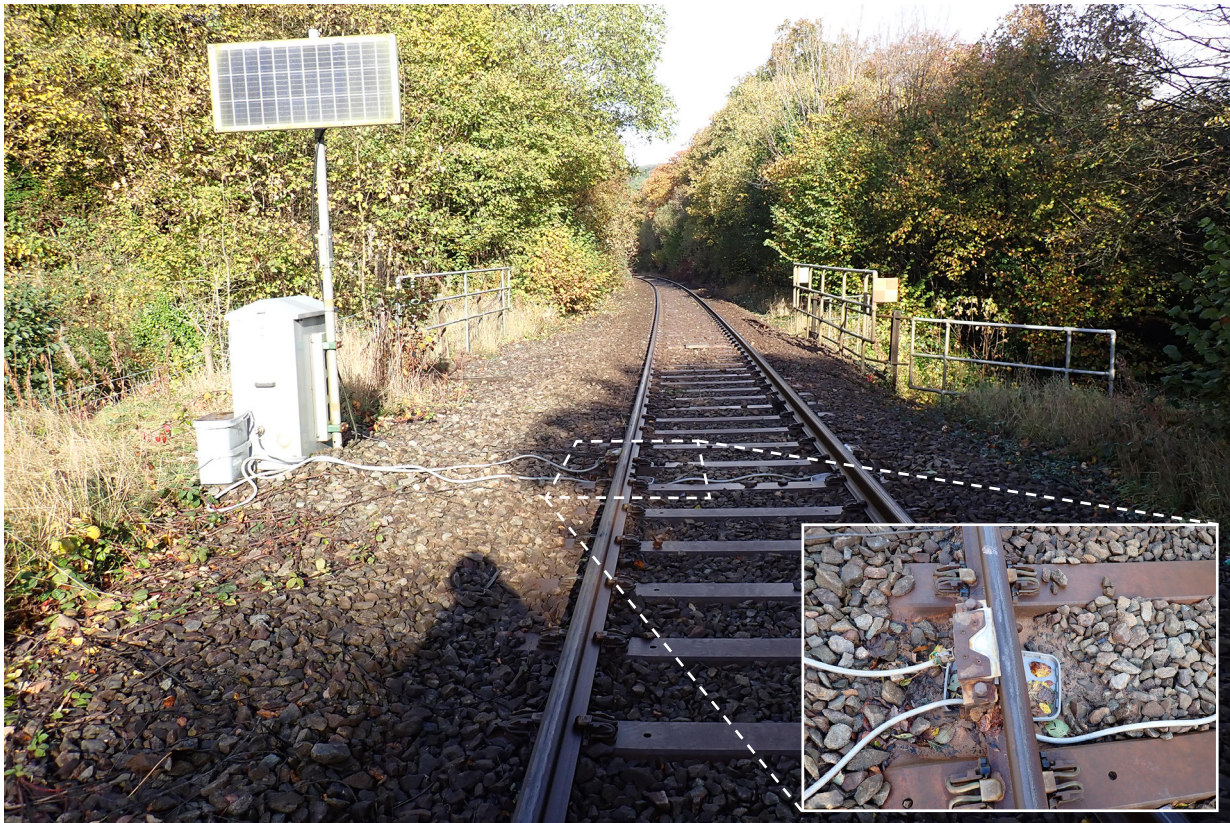
Figure 52: Non-functioning Talerddig 1 TGA; note the plastic lid under the rail which has collected small sand particles from the traction gel (likely when they are washed off the rail by rain).

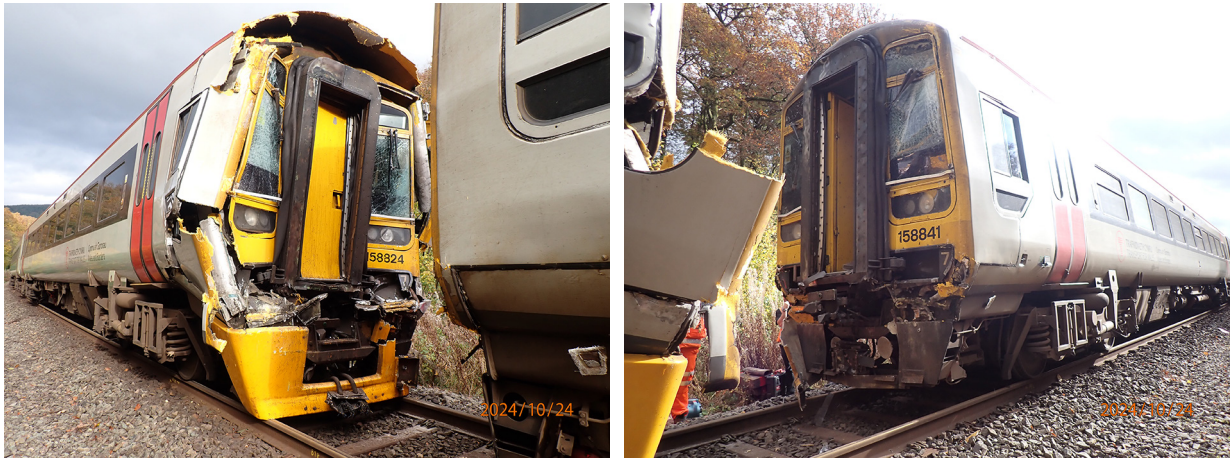
Figure 56: Damaged cab ends side-by-side on site (after separation) to show difference.

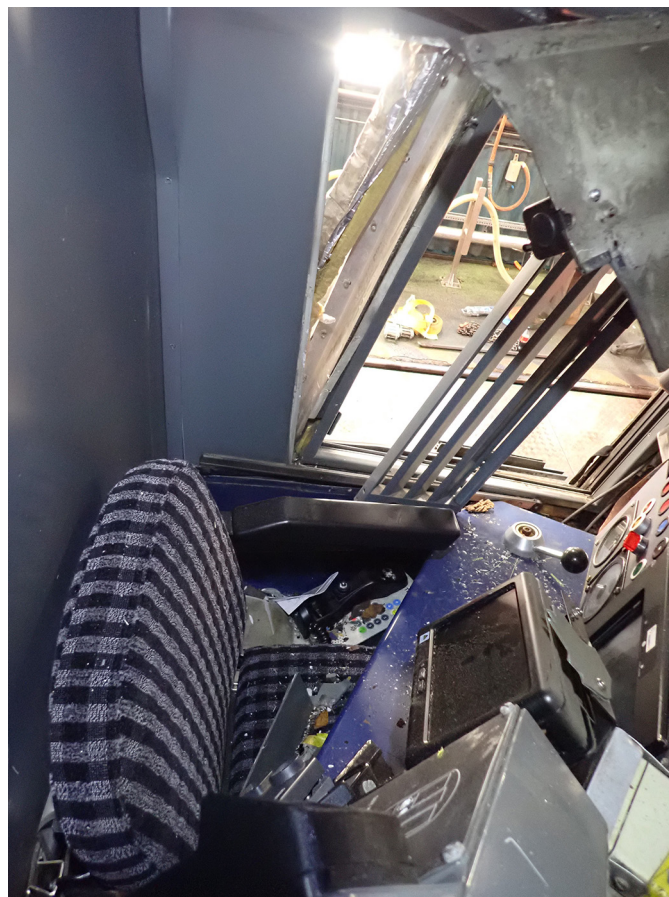
Figure 57: Cab of vehicle 57824 after the collision, showing loss of survival space.

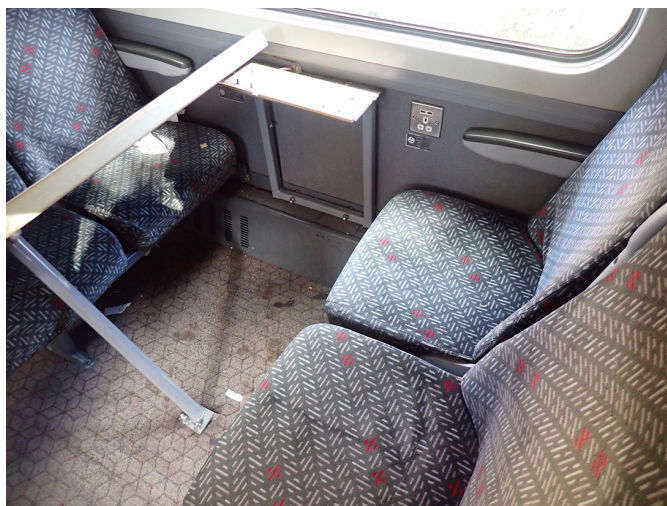
Figure 59: A typical detached table.

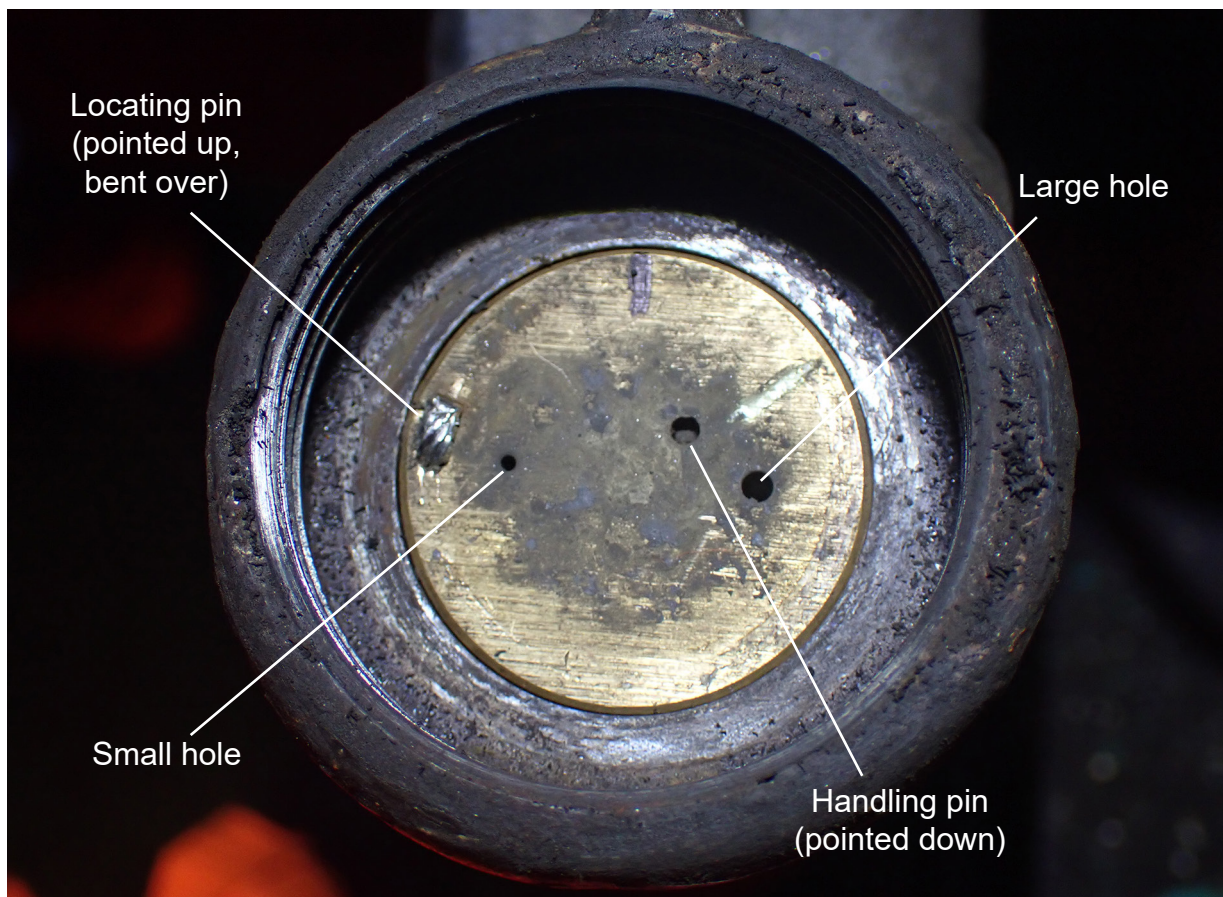
Figure C5: Sand valve casting from non-driver's side of 57841, after partial reassembly to demonstrate the orientation at the time of the accident.

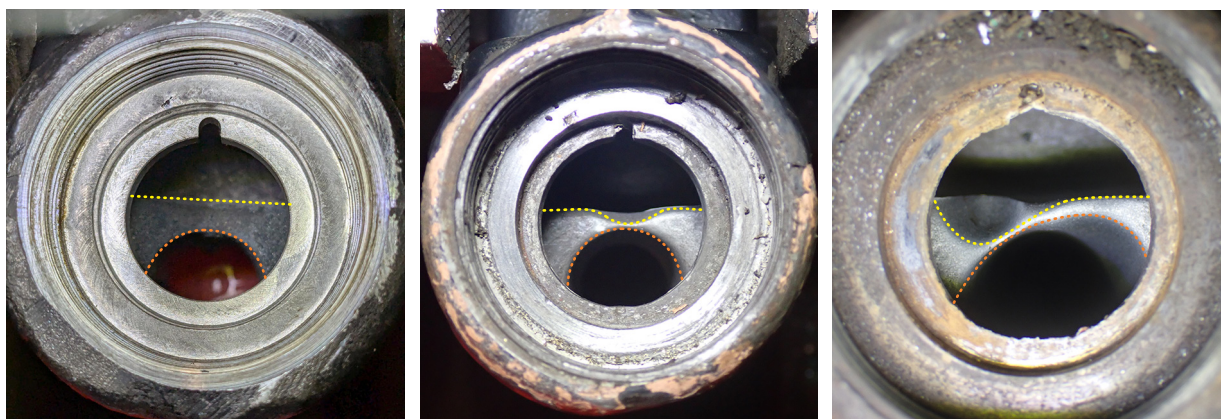
Figure C6: Sand valve weir wear: new valve (left), typically worn valve (centre) and unusual wear of 57841 valve (right).

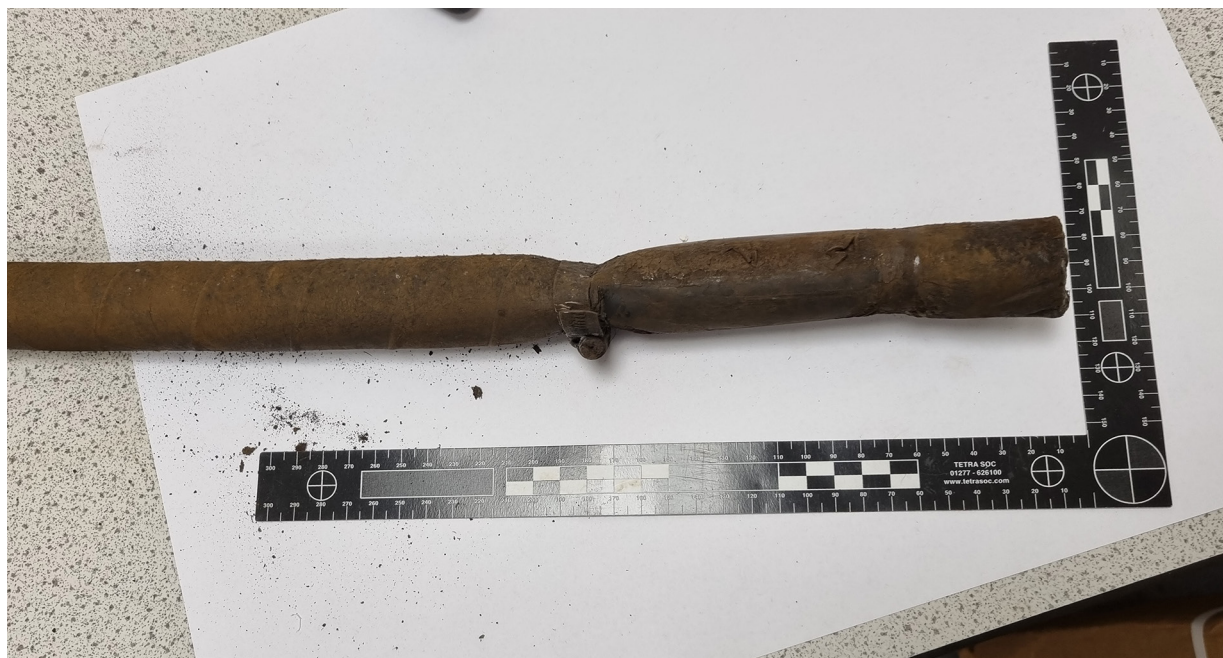
Figure C8: The sand hose taken from the driver's side of 57841. In this image, one of the hose clamps and the pipe clamp have been removed, leaving in place the deformed hose clamp.

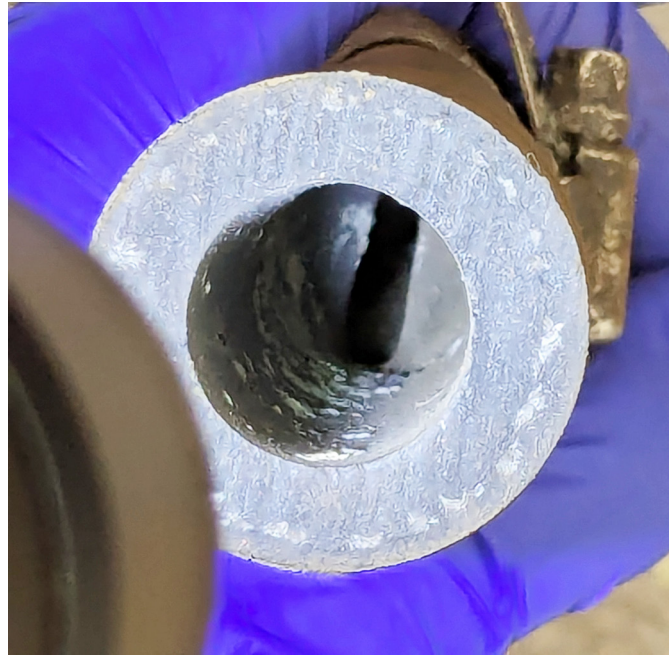
Figure C9: After cutting the hose near the hose clamp, the restriction in the sand hose can be seen, accounting for approximately a 60% loss in cross-sectional area of the sand hose.

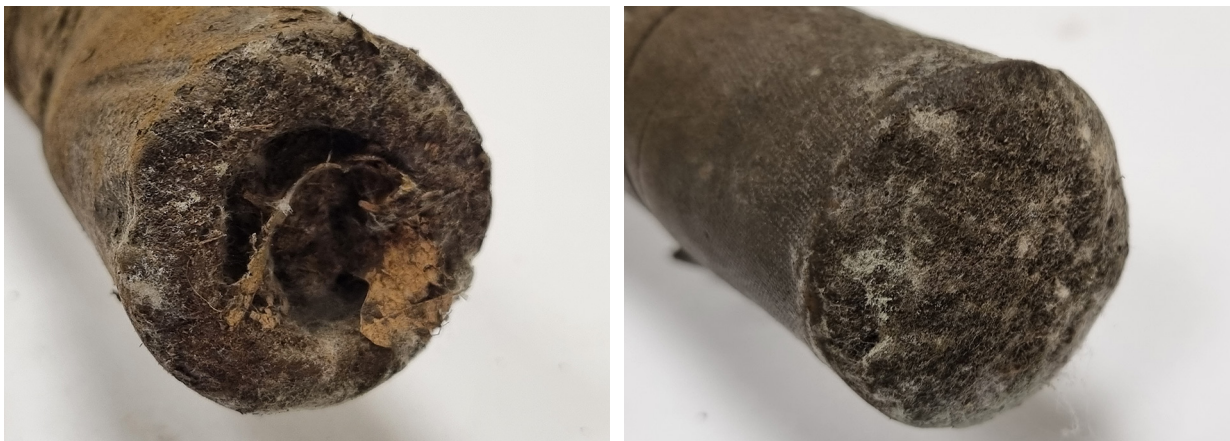
Figure D1: The blocked sand delivery hoses from leading vehicle 57841 during inspection.

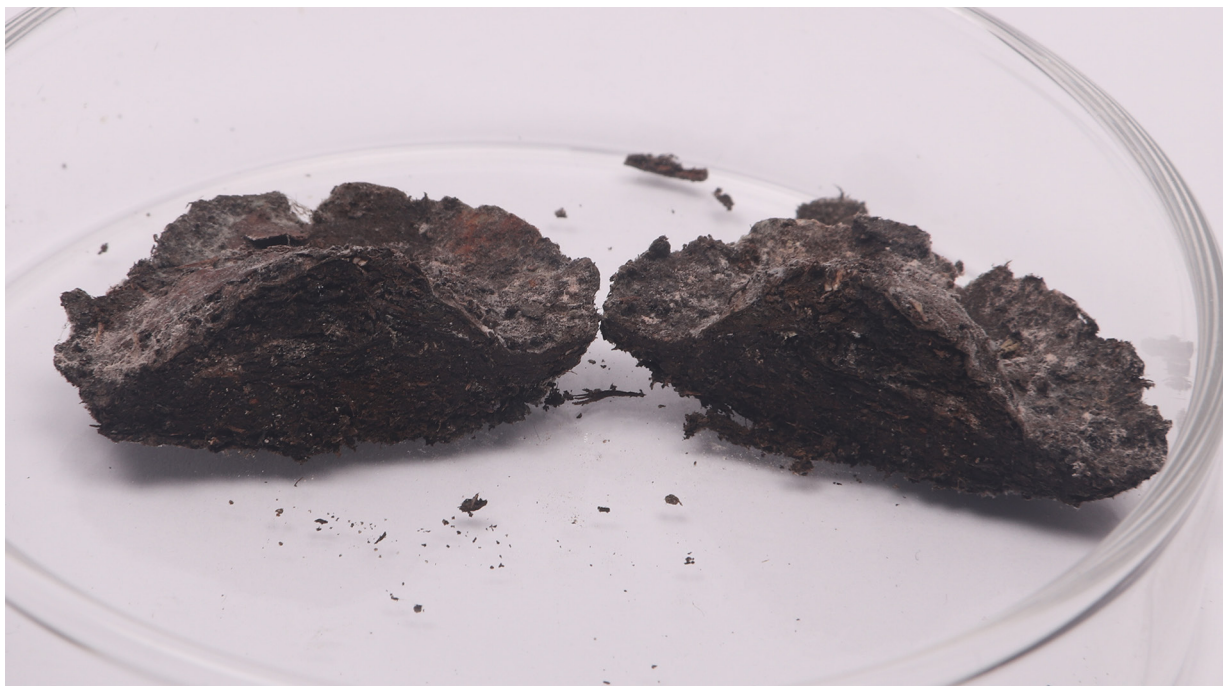
Figure D2: The plug of material from the end of the non-driver's side hose after being cut in half.

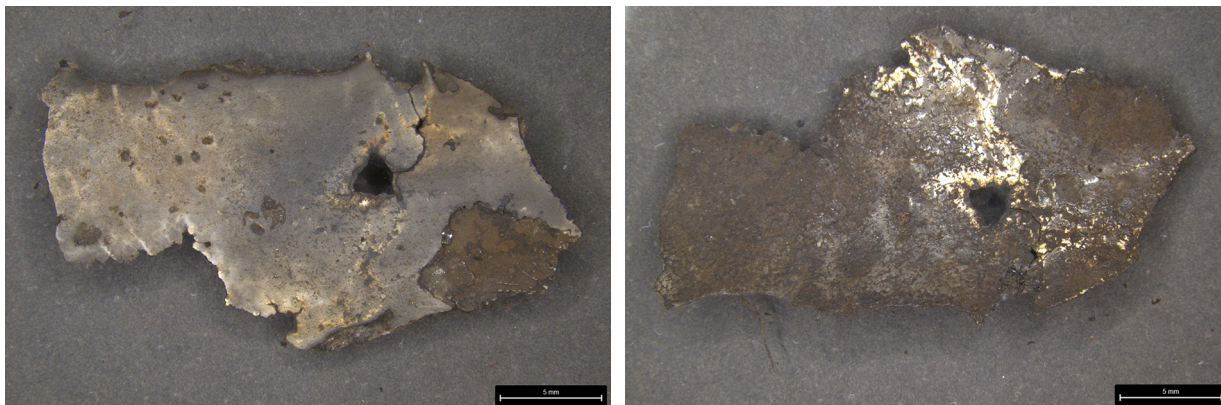
Figure D5: Curved piece of polymeric material found in the sand hose blockage material.

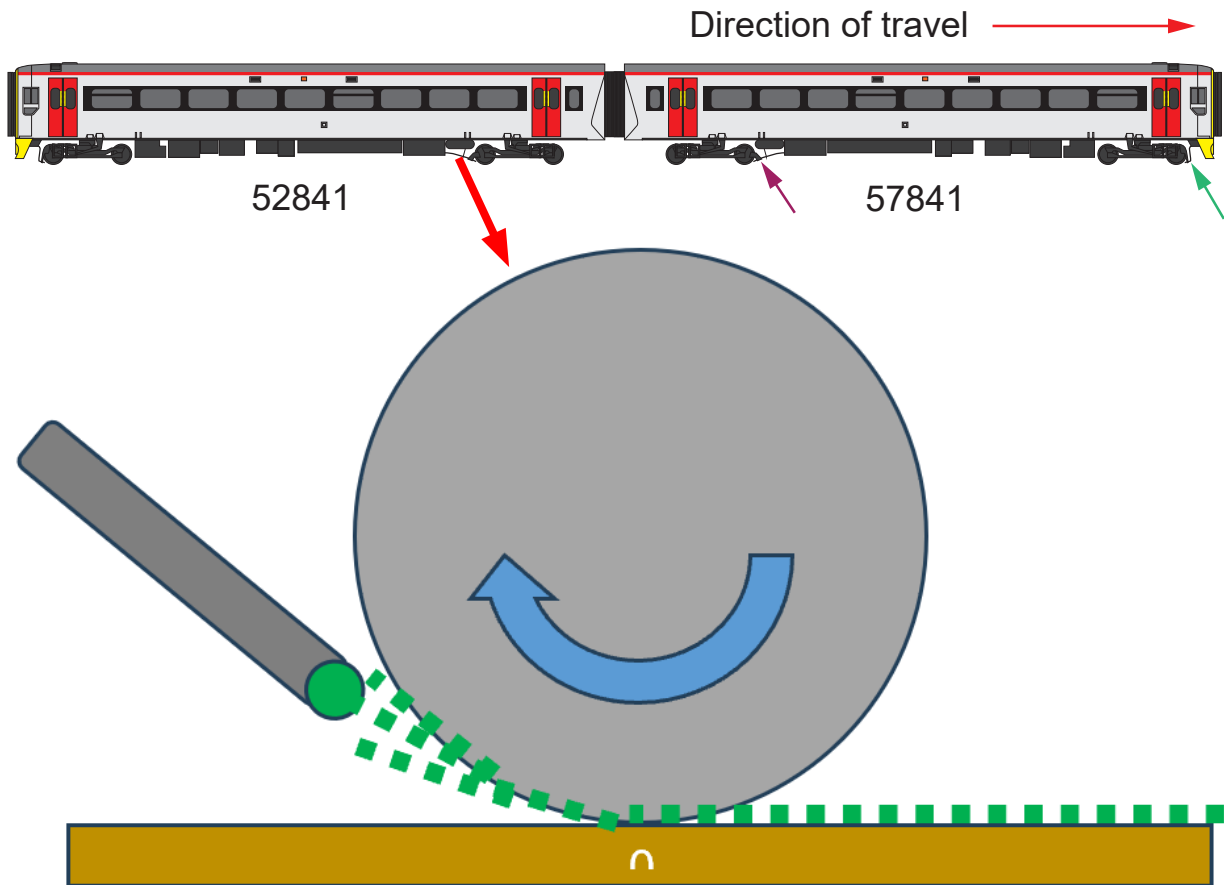
Figure D6: Automatic sanders on vehicle 52841 at risk of being blocked by material flicked up by the wheels.
