Report on the investigation of
a fall overboard from the crab potting vessel

Amadeus (TH7)

resulting in one fatality

on 13 December 2023

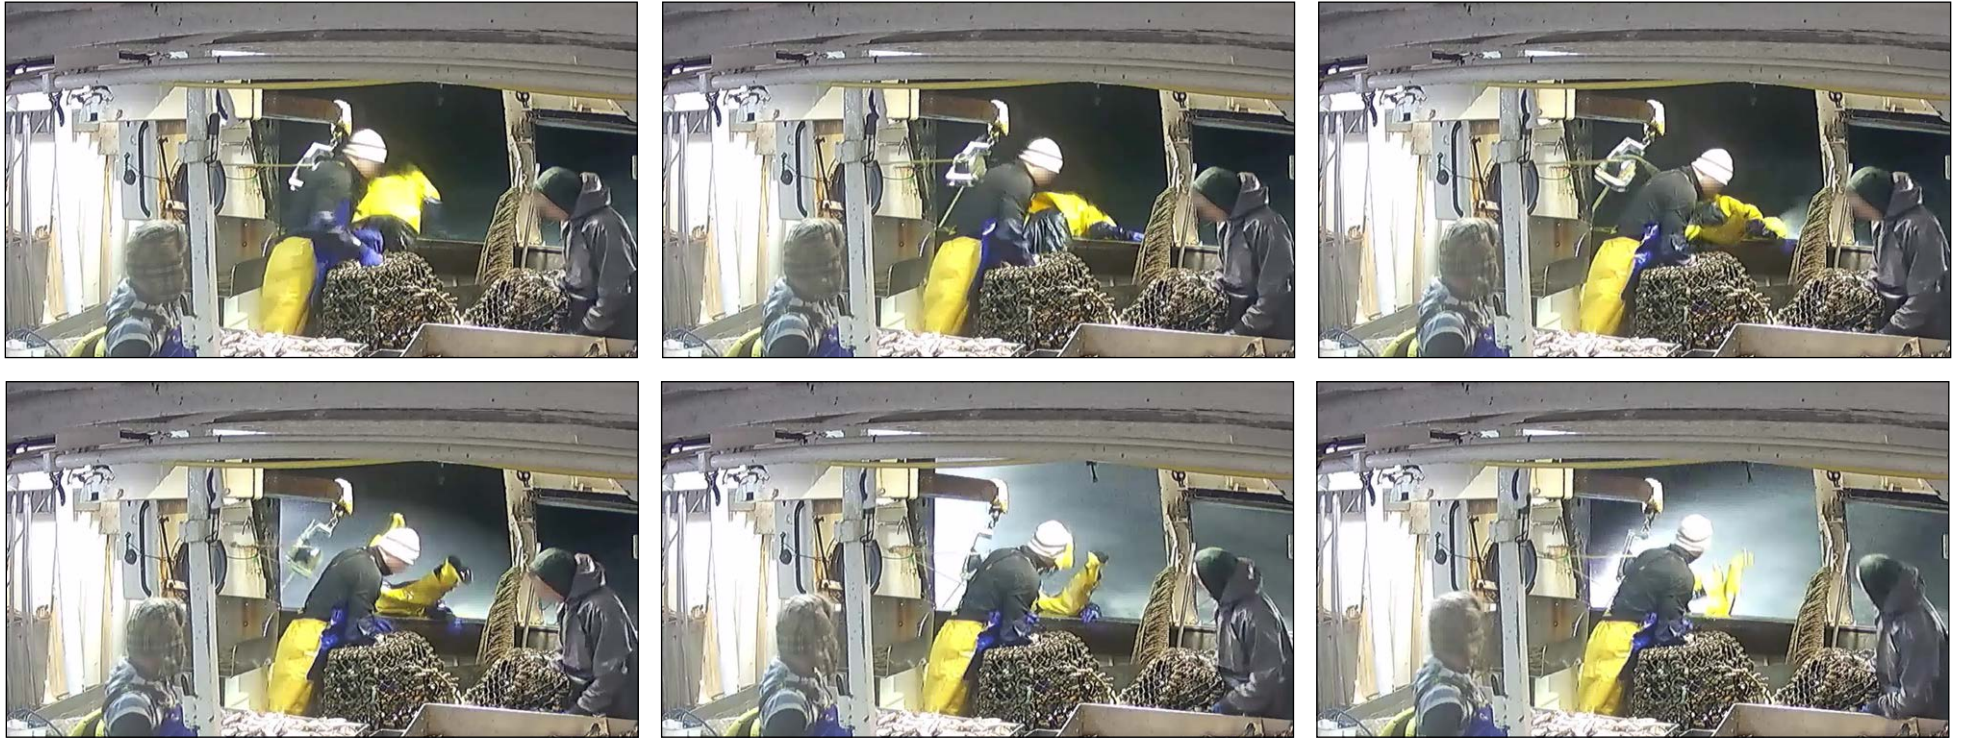
Working at the hauling hatch, Aleksandrs leaned over the low bulwark to bring pots on board, placing them first on top of the bulwark and then lifting them across to the clearing table for processing. Between 2356 and 0008, he repeated this task 47 times in quick succession as the vessel rolled heavily in worsening conditions.

Figure 2: CCTV stills showing the moment the deckhand fell overboard

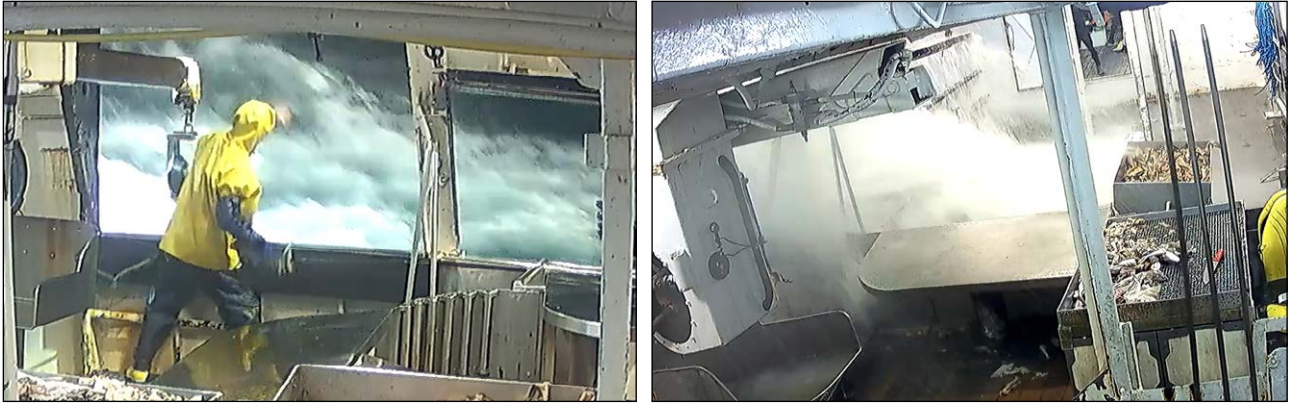
At the time of the accident the wind was Beaufort force 7, gusting force 8, and wave heights were between 2m and 2.5m. Waves frequently washed over the working deck (**Figure 3**), causing significant vessel movement. These conditions were typical of those encountered by *Amadeus* during fishing operations. The air temperature was approximately 6°C and the sea surface temperature was about 9°C.

Figure 3: CCTV stills showing the weather and environmental conditions in the German Bight on 12 December 2023

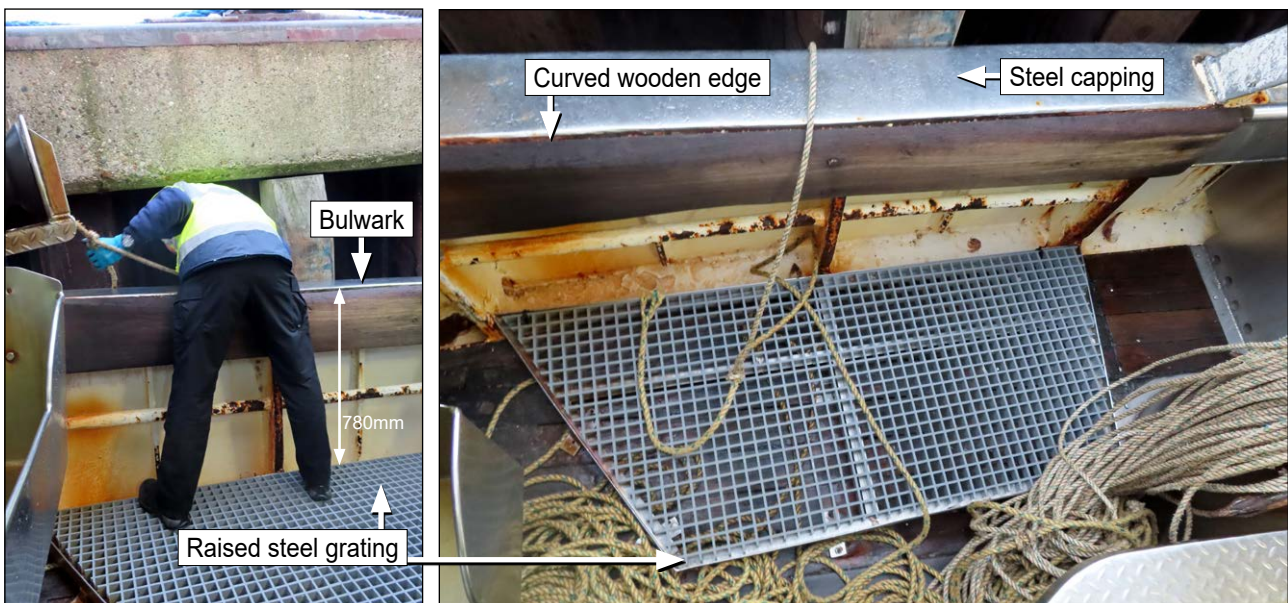
At construction, the bulwark height at the hauling position was 915mm from the deck. Following a fatal accident in 1994 (see section 1.15.2), a raised steel grating was installed on the deck adjacent to the hauling hatch, reducing the effective bulwark height at that position to 780mm. The top of the bulwark was fitted with steel capping and finished inboard with a curved wooden edge, which crew commonly braced against during hauling (**Figure 4**).

Figure 4: Bulwark and raised steel grating at the hauling position

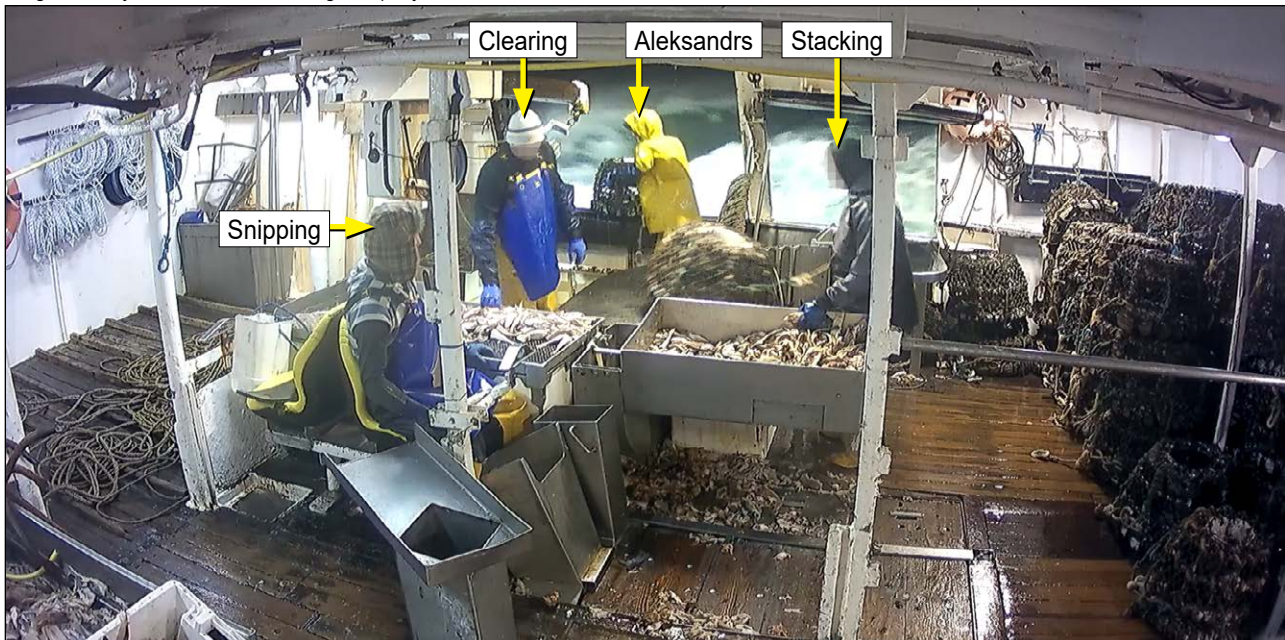
Each pot recovery typically took 12 to 16 seconds, repeated about 100 times over a 20 to 25-minute hauling cycle. Lifting each pot required a combination of the deckhand's physical effort, the pot's momentum, and, where possible, assistance from the vessel's roll period. Comparable vessels operating similar potting methods reported haul durations of 40 to 45 minutes per string.

Figure 6: CCTV still showing the deckhands' positions during pot-hauling operations shortly before the accident

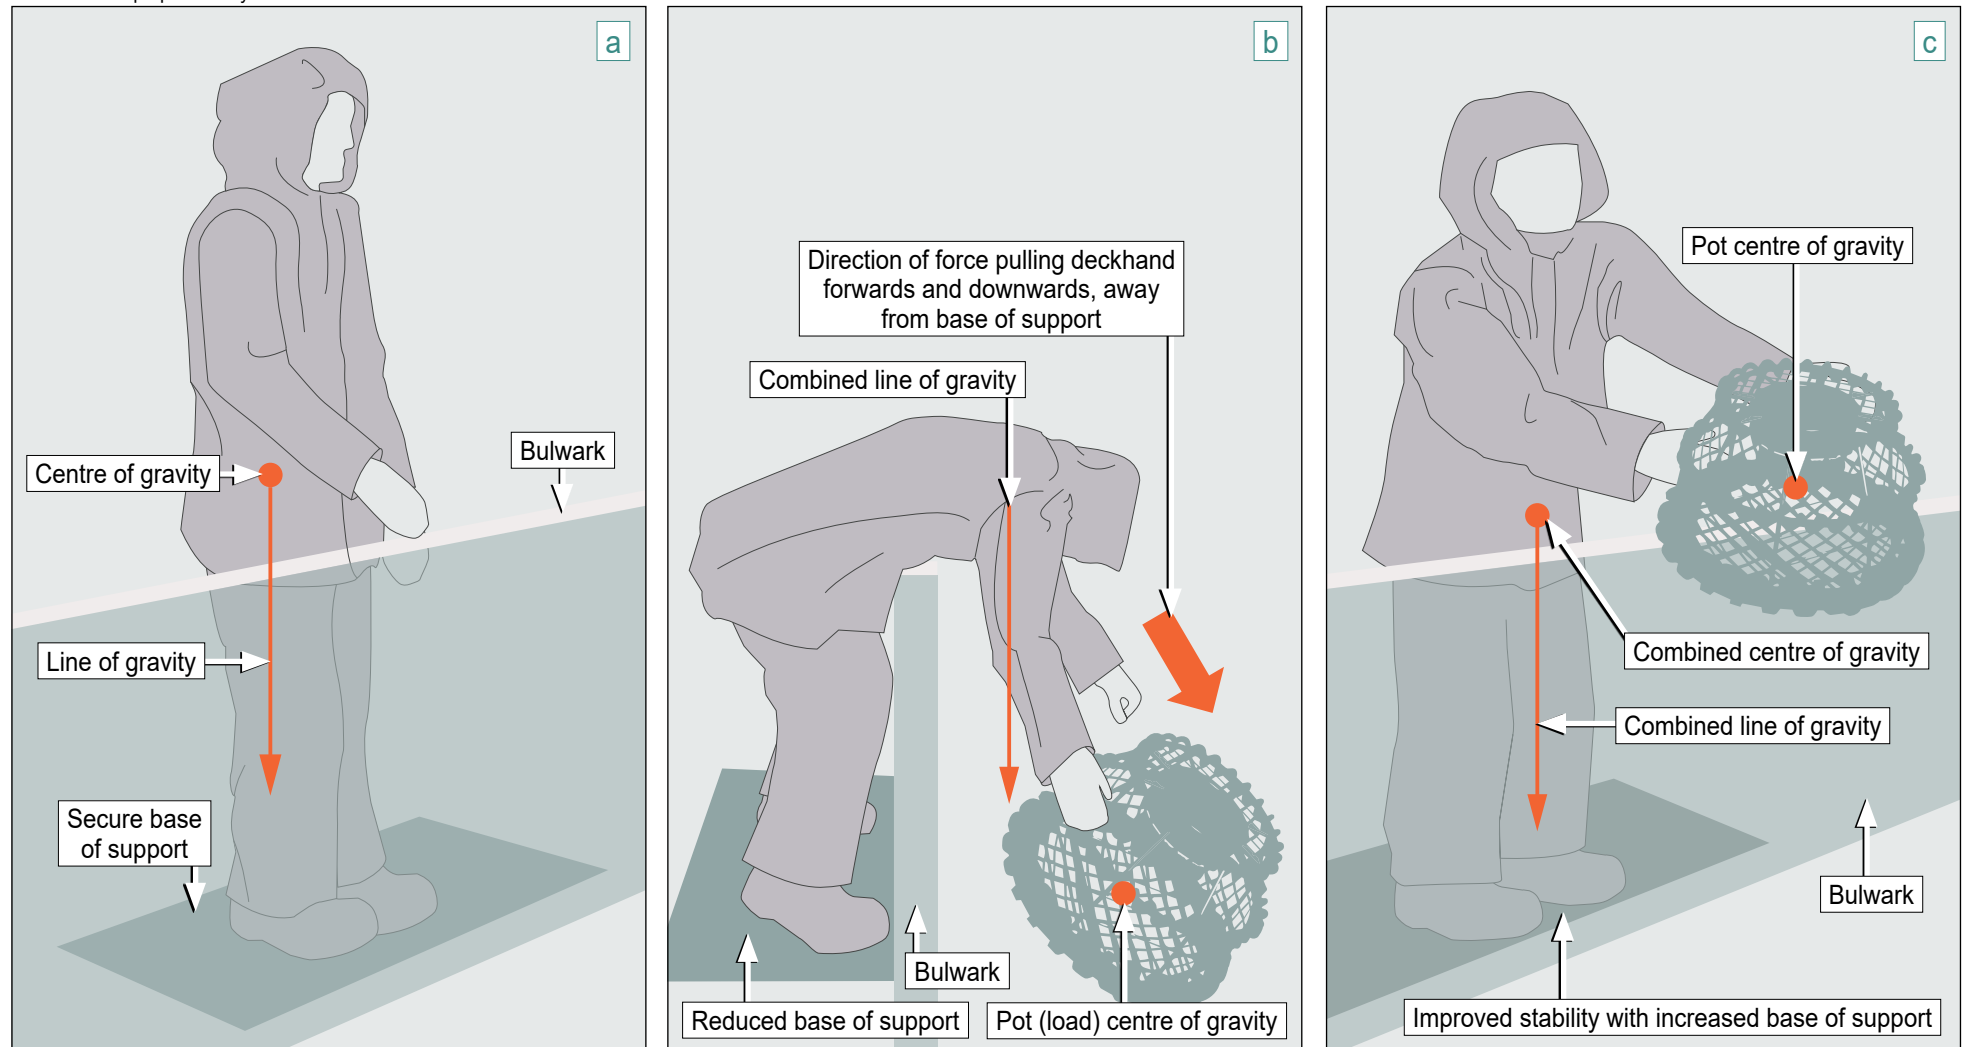
Figure 7: Biomechanics of pot hauling, illustrating how a deckhand's centre of gravity shifts when reaching, lifting, and bringing a pot inboard

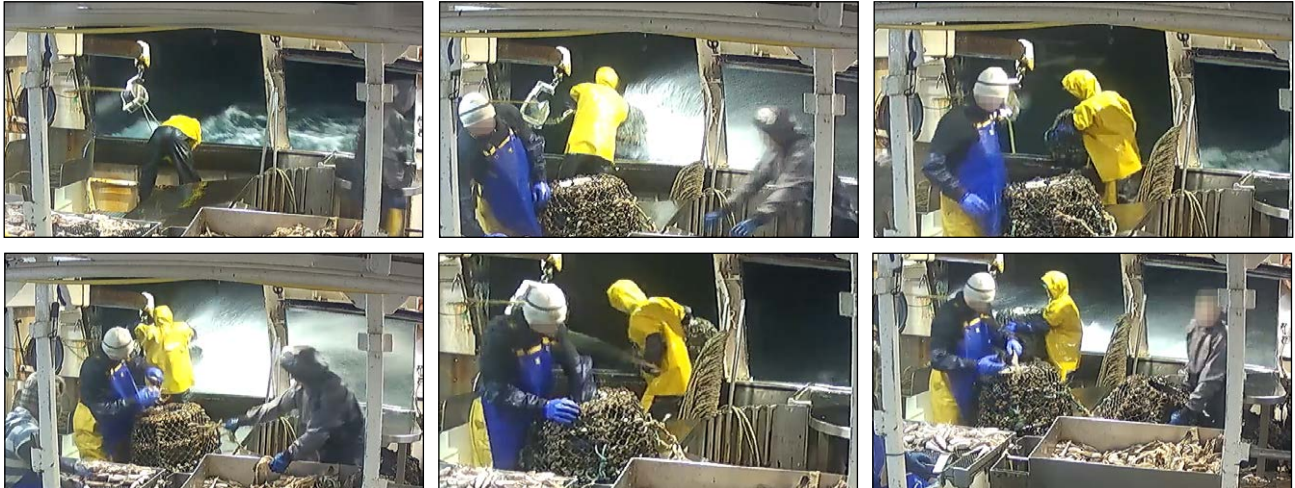
The Revised NIOSH Lifting Equation evaluated manual lifting tasks to prevent lower back injuries and identify where redesign may be required. The investigation found that the most concerning aspect of the pot lifting task on *Amadeus* was the low position at which pots were initially reached. Deckhands were required to bend forward significantly, hyperextend, and then twist their trunks and hips to bring each pot inboard. The task also involved handling a heavy and awkward load without mechanical support, increasing biomechanical strain.

The footage also showed that the pot was handled from a low, offset position, requiring repeated bending, twisting, and shifting of body mass as the deckhand worked to clear the hauling block and deck machinery. These movements closely reflected the biomechanical risks identified by the NIOSH assessment, including high load forces, non-neutral postures, and rapid task repetition.

Figure 8: CCTV stills showing typical postures adopted during pot recovery, assessed using REBA and NIOSH criteria

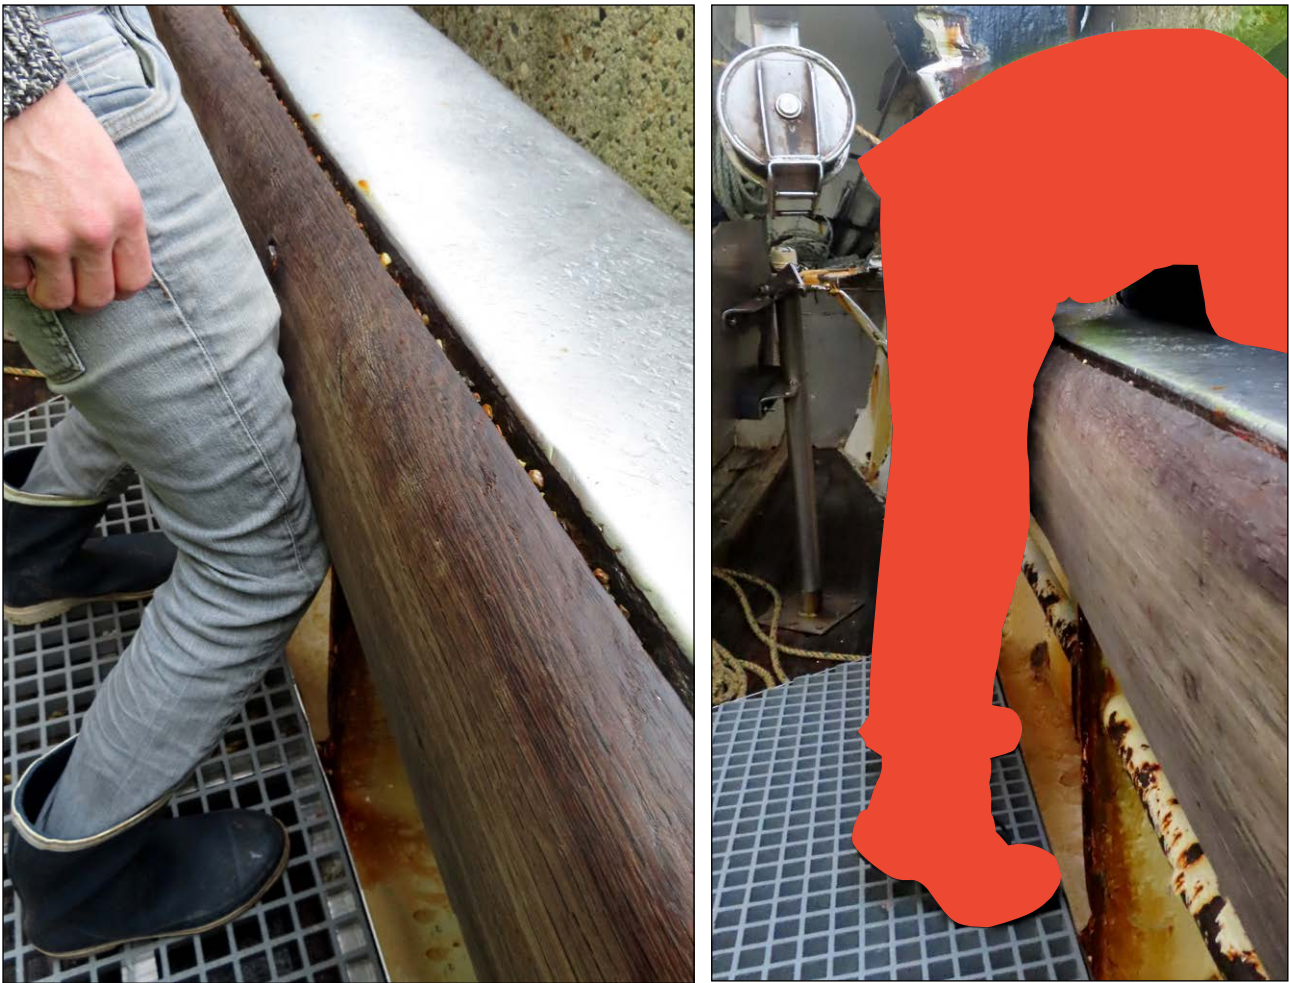
Figure 9: Reconstruction of a deckhand bracing against the bulwark during pot recovery

Human factors guidance recommended that safety-critical workstations (in this instance the pot hauling bulwark) be designed to accommodate the majority of the working population – ideally up to the 99th percentile. For tasks involving forceful manual handling, such as pot hauling, a working surface close to elbow height would be considered optimal. The 50th percentile elbow height was 1,097mm for British men, and 1,004mm for British women. A workstation at this height would reduce the need for crew to lean over the bulwark, thereby lowering the risk of toppling. If the workstation was positioned at or below this height, additional safety measures – such as tethering – would still need to be considered.

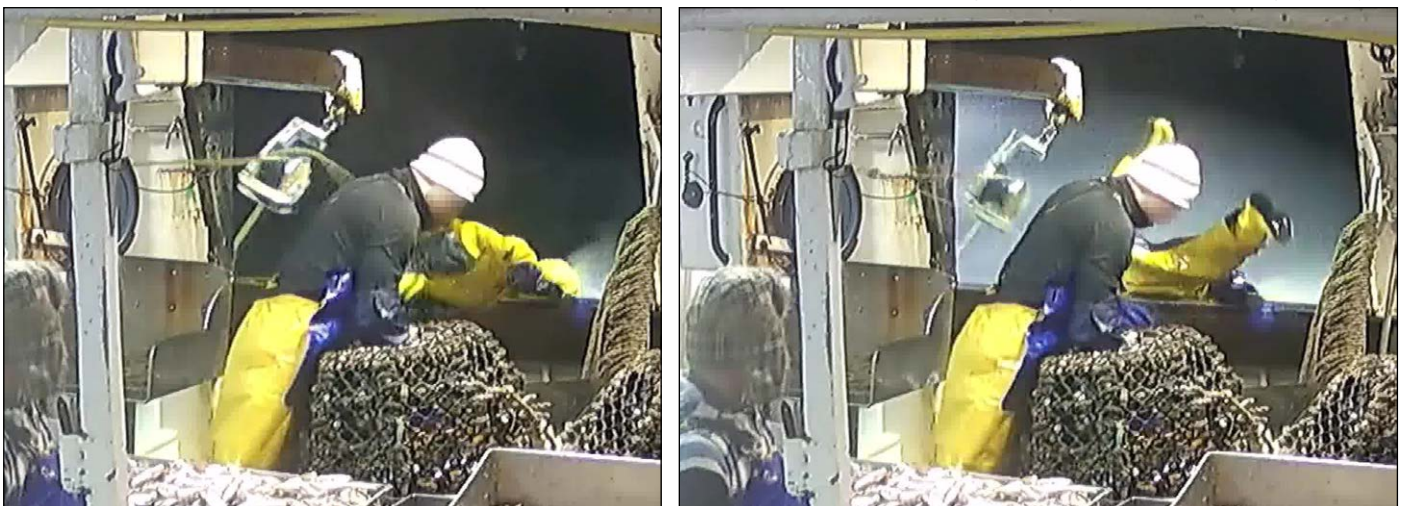
The crew cut the back rope, and the vessel was manoeuvred to recover the deckhand. Although initially seen swimming, the deckhand was unable to stay afloat and became unresponsive within minutes in the 9°C water. Several attempts were made to reach him with a boat hook, but he was struck by a wave and disappeared. A major search and rescue operation ensued, but the deckhand was not found.

Figure: CCTV stills of the moment the deckhand fell overboard
