## 11. Overspeeding

### Purpose of this summary

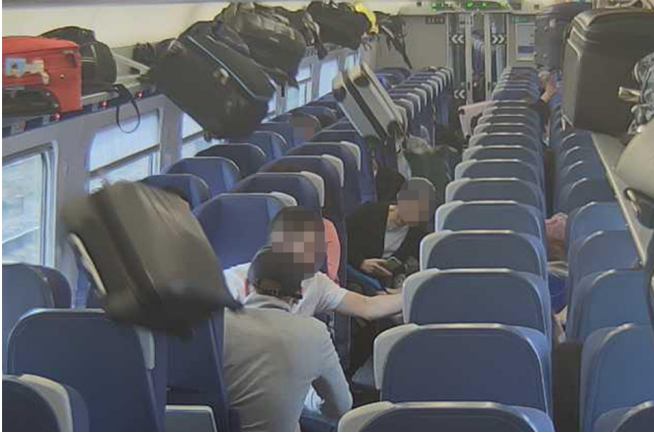
Two serious incidents occurred at Spital Junction, to the north of Peterborough station. These occurred on 17 April 2022 ([report 06/2023](#)) and on 4 May 2023 ([report 10/2024](#)). In both cases, trains travelling south passed through points at the junction at excessive speed. The coaches of the trains were subject to sudden sideways movements, leading to minor injuries to passengers. Post-incident analysis for the April 2022 event has indicated that the train was close to a speed that would have led to it overturning, and it was likely that some of the train's wheels lifted off the rails. In both cases, the drivers of the trains did not react appropriately to the signal indication they had received on approach to Spital Junction. This signal indication was a warning that the train was to take a diverging route ahead which had a lower speed limit than the straight-ahead route which the drivers expected to take. The drivers' awareness of the signal conditions that could be presented on approach to this junction and their training were insufficient to overcome this expectation. Common to both investigations was that neither train operators nor Network Rail had effectively assessed and controlled the risk associated with trains being unexpectedly routed on a slower, diverging route at this location.

*Luggage falling from the overhead racks during the incident at Spital Jn (April 2022).*

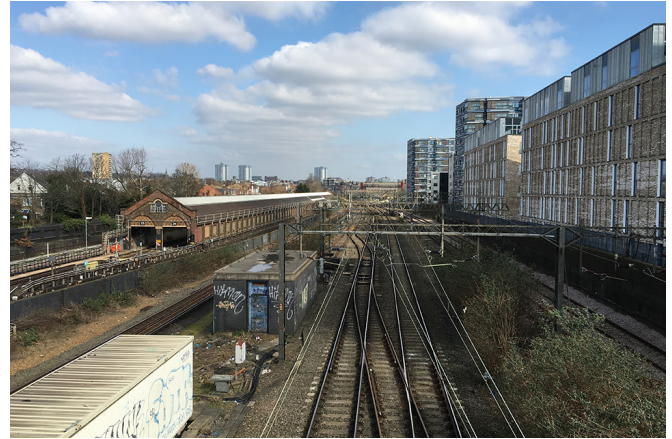
At Queen's Park (north London) on 5 January 2016, a driver manager who was being assessed by another driver manager travelled through a 5 mph (8 km/h) ESR at 75 mph. During its investigation ([report 19/2016](#)), RAIB found that the driver manager who was being assessed did not slow the train for the emergency speed restriction due to misunderstanding details of the restriction given in an email.

*Location of the incident at Queen's Park.*

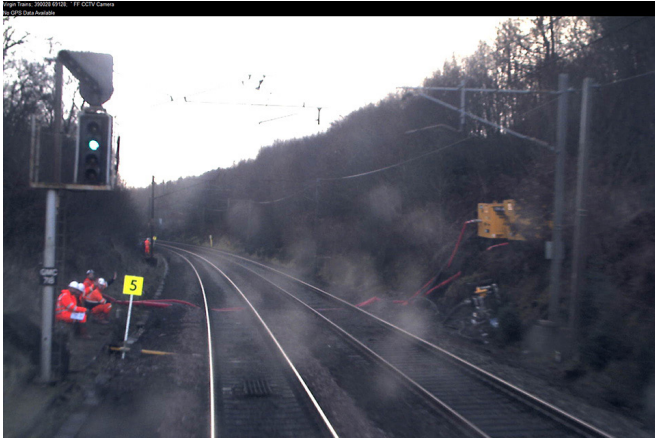
On 19 December 2020, heavy rain led to a closure of the West Coast Main Line near to Beattock. After remedial work, the railway reopened with a 5 mph (8 km/h) ESR in place. A passenger train passed through this section at about 45 mph (72 km/h), with no injuries or damage resulting. Lineside signage had been put in place, and this had removed the need for signallers to caution each train passing the location. RAIB's safety digest ([safety digest 02/2021](#)) reported that the distance between the ESR's warning board and its start was too short for trains that could approach the ESR at 125 mph (201 km/h). The work to calculate the locations for the various temporary ESR signs had not accounted for the significant falling gradient on the railway approaching the location.

Forward-facing CCTV showing the speed indicator at the start of the ESR near Beattock.
