Housing Health and Safety Rating System (HHSRS)

Case Studies

Hazard A1
Falls on the Level

Example A1.1
Pre-1920
Semi-detached House
(Non-HMO)

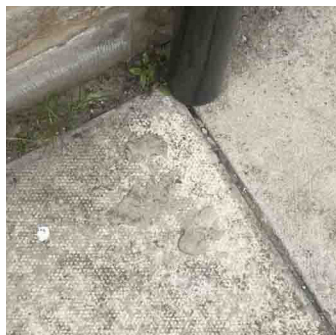
3
Downpipe to the side of the front door discharging straight to concrete

The two downpipes discharge water directly to the concrete surfaces, which are likely to ice over during winter. Over a 12-month period, the surface remains constantly damp and is likely to cause the growth of green algae which will be slippery. Both downpipes are in areas of the garden which will be frequently accessed, one being next to the front door and the other being in the vicinity of the most suitable refuse storage area. The presence of a raised inspection-chamber lid in the vicinity of the refuse storage increases the likelihood of an occurrence that will cause harm to a member of the vulnerable age group, particularly given that when accessing the bins, people are likely to be distracted if carrying rubbish.

Meeting the baseline indicators will require connection of the downpipes to the drainage system and alteration of the inspection chamber to provide an even surface, reducing the likelihood of a fall externally. This will result in the likelihood and harm outcomes being reduced to the national average. Given the deficiencies associated with the ensuite, namely the lack of space, the trip associated with the shower and the glass shower screen, the hazard would still exist, albeit as a Category 2 hazard.

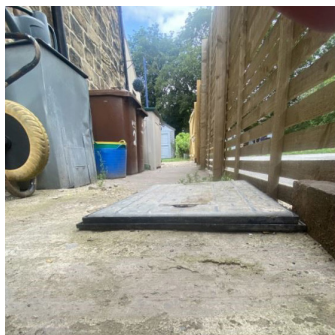
4
Raised inspection chamber lid in the yard area at the side of the dwelling

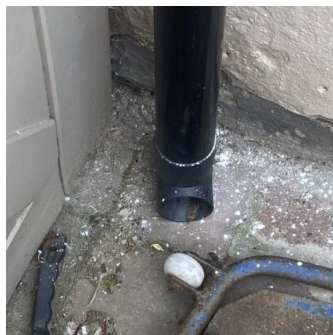
5
Downpipe to the yard area at the side of the property discharging straight to concrete surface

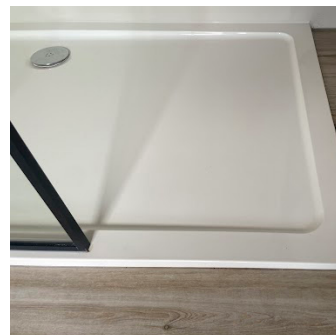
6
Raised edge to shower and short width shower screen

Both the raised edge to the second-floor ensuite shower, and the short width of the shower screen (that allows spray to escape onto the tiled floor) will increase the risk of slips occurring on the wet surface.

Serious harm outcomes are increased by 1 RSP to 50% to reflect the external surfaces, particularly, but also in consideration of hazard within the small ensuite on the second floor, namely the increased harm associated with falling in a restricted space and onto a glass shower screen.

Works could also be requested for the glass shower screen to be replaced. Reconfiguration of this room could be required as a means of improving the usable space.
