Housing Health and Safety Rating System (HHSRS)

Example A3.5
Post-1979
Detached House
(Non-HMO)

Case Studies

Hazard A3
Falling Between
Levels

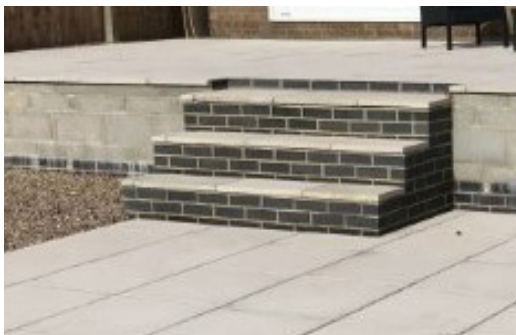
2
Rear garden showing
changes of levels

There is a raised patio area of smooth concrete flagstones across the whole of the rear of the house, with a further lower level of flagstones below. The garden slopes gently across the width of the site so there is a drop of 700mm onto a gravelled area at one side, increasing to an 860mm drop onto concrete flagstones at the other side. There is no guard rail or barrier at the edge of the raised patio. When viewed from the house, the change in level between the two levels of concrete flagstones is not immediately apparent. There are no exterior lights at the rear of the property.

Lack of demarcation along the edge of the raised patio combined with absence of any guarding or handrail increases, over the course of a year, the likelihood of a fall causing injuries that require medical intervention. Absence of external lighting also adds to the risk of falls occurring.

Young children lack situational awareness and could jump, walk off, crawl over or fall from the raised patio when playing in the garden. Whilst they are less likely to sustain an injury when falling the shorter distance onto gravel, a fall at the higher end onto concrete slabs, or a fall onto the hard edges on the brick-faced steps could result in bruising, fractured bones or a head injury/ concussion.

Although the height is by no means excessive (compared to falls from a window, for example), falling head first onto concrete would be more likely to cause severe, and serious harms such as major fractures or concussion, thus resulting in the score being higher than the national average.

Baseline indicators would require the installation of suitable guarding, between 900 and 1100mm high along the edge of the raised patio, except for immediately in front of the steps. The guard should be capable of supporting normally imposed loads and designed to avoid gaps greater than 100mm, with no climbable cross-pieces. A solid structural glass balustrade could be installed if the owner wanted to retain a clear view over the garden.

Baseline indicators would also require the installation of external sensor lighting capable of illuminating the raised patio and step area after dark. These measures combined would return the likelihood and harm outcomes to the national average.
