## Housing Health and Safety Rating System (HHSRS)

## Case Studies

Hazard A4  
Fire and Explosions

Example A4.6  
Post-1979  
Common parts of  
Residential High-rise

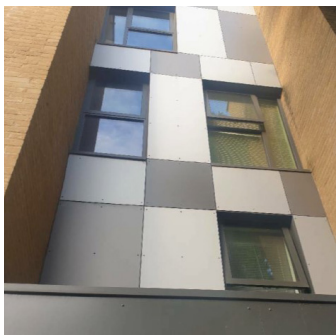
Timber-effect panels are present to the external façades from the ground to 8th floors on the north and south elevations. They are 8mm thick and have the appearance consistent with HPL panels.

The cladding report identified the particular HPL product used on the building. The BBA certificate for this product states it has an Euroclass reaction to fire of B-s2-d0 and is therefore not of limited combustibility.

2  
HPL panels compromising  
escape stair

There is a single staircase serving the building. There are openable windows to the staircase, which are adjacent to ACM and HPL cladding. If a cladding fire occurred, this could impact the escape stairs.

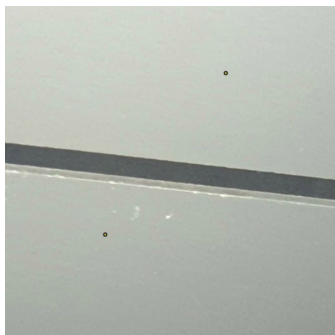
Grey-and-white coloured ACM panels are present to the façades of the top three floors on the south, west and north elevations. White coloured ACM panels were also present in vertical columns from the ground to 9th floors as well as to balcony facias and soffits.

The panels had an appearance consistent with being ACM. They were approximately 4 mm thick and laminations were observed to the cut edges; they consisted of two metal sheets sandwiching a grey-coloured core.

A cladding report provided by the building owner also identified this ACM product being present to the external walls. According to the BBA certificate for the product, it has a polyethylene core and an Euroclass reaction to fire of D-s1-d0 and is therefore not of limited combustibility. A cladding screening test result report states that two samples of ACM from the building were tested and categorised as Category 2 ACM.

3  
ACM panel, showing  
sandwich of aluminium  
sheets and combustible  
core.

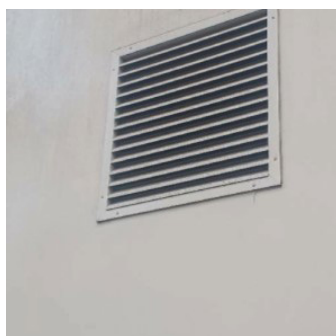
Numerous vent terminations are present around the building to ACM and HPL cladding panels. A number of these vents are directly below the ACM soffits to balconies. These are presumed to be for ventilation to flats. No documentation evidencing fire-stopping to these extract points has been seen. The vents could also be a route for fire to spread from within flats to the external walls or vice versa.

4  
External penetrations to  
ACM cladding

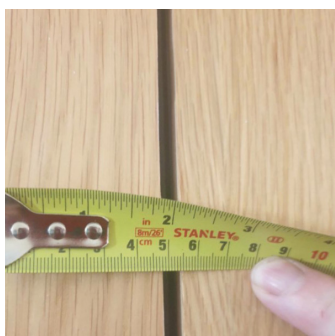
5  
Excessive gap to service  
cupboard doors

Doors to staircases, communal lobbies and service cupboards are marked as FD60 and entrance doors to flats were marked as FD30. The doors appeared satisfactory on the whole, although defects were noted to a few (both communal doors and flat entrance-doors), such as excessive gaps between door leaf and frame.

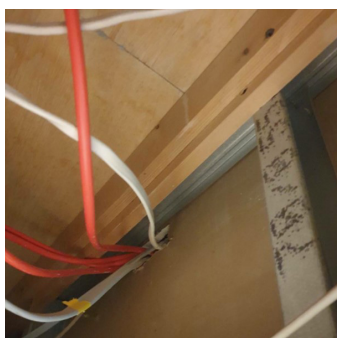
Inadequately fire-stopped service penetrations are present between several service cupboards and routes of escape.

The walls between service cupboards and corridors are constructed with a steel framing system. The steel framing system in some of the cupboards is unprotected from fire on the inner side, which could allow it to fail in the event of a fire, causing it to spread to the means of escape.

6  
Unprotected framing and penetrations to service cupboard

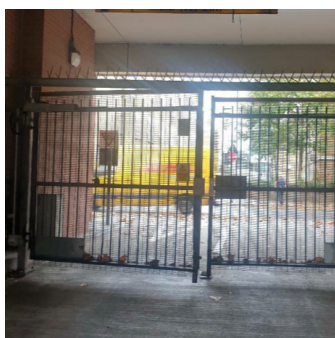
From the car park, exit is through a set of automatic gates. The gates can be overridden to operate as manual gates, but there are no signs informing occupants of how to do this. This route is an unsuitable fire exit and escape route as there is no clear way for escaping occupants to reach an ultimate place of safety.

7  
No signage informing how to manually override car park gates

Compliance with BI 19.7 would require an override function to be installed to the exit door onto the street at the front of the building, so that it can be opened in the event of a loss of local power to the automatic motors. Whilst the gates from the car park can be overridden, signage is needed to instruct how this can be achieved.
