## Housing Health and Safety Rating System (HHSRS)

## Case Studies

Hazard A4  
Fire and Explosions

Example A4.7  
Post-1979  
Common parts of a  
Residential High-rise

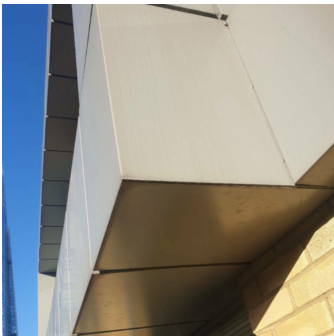
1  
Front exterior ACM panels  
abutting masonry –  
showing flat windows

ACM cladding panels were seen to the top-floor roof facias.

A cladding screening test result report states that a sample of ACM from the building was tested and was categorised as Category 3 ACM, the most combustible category.

A properly conducted FRA, supported by an intrusive report and assessment would be necessary. This should see replacement/mitigation of combustible external wall systems including removal of flammable materials from the balconies. There would be an overhaul of the smoke management system, and testing/upgrade to the emergency lighting. The issue with the atrium would be resolved by enclosing the MOEs that open onto it. Fire doors should be confirmed as conforming to BS 476 or replaced with correct door and full compartmentation should be achieved by stopping up gaps with correct intumescent collars etc. Generally, management improvements should be recommended and implemented. It is likely interim measures would be recommended as a result of the FRA such as a waking watch, an audible communal fire alarm system and/or a review of the stay put policy, and the installation of a SIB, wayfinding and fire action notices required. Overall, these further works would return the likelihood and harm outcomes to the national average.

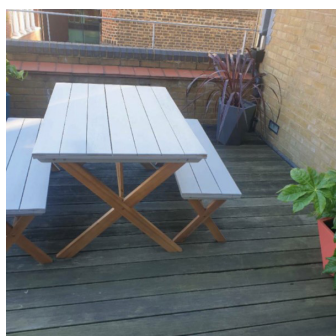
2  
Timber decking to balcony

The majority of flats have balconies. Balconies are supported on a steel frame and have timber joists. There is timber decking to balcony floors and timber to balustrading. No certification has been seen confirming whether the timber has been treated. Balconies are positioned in series (one above the other) at numerous locations around the building. This could allow for fire to spread between balconies.

A similar result would occur from any fire involving an exterior balcony because the balconies are positioned in series (one above the other) and have wooden floors and joists. It is likely that a fire would jump from balcony to balcony and possibly spread via open (or thermally cracked windows) into the flats above, with a similar outcome to the previous scenario.

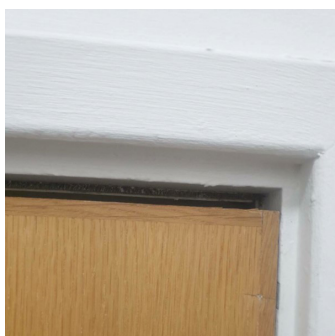
3  
Excessive gap to head of fire door on escape stair

Several doors between corridors and staircases and cross-corridor doors had defects such as not closing fully by the action of their self-closing devices, having excessive gaps or being warped.

Compliance with BIs would see some work done to improve the building: BI 8.1 would see some repairs made to the internal doors where necessary. BI 19.5 would see the automatic fire detection upgraded encompassing an appropriate fire alarm system to common parts.

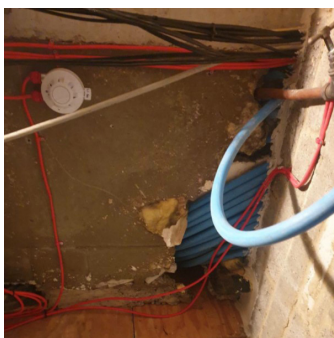
Several service cupboards are located on each floor of the building. Attempts have been made to fill penetrations with a pink or yellow expanding foam. Some service pipes had fire collars visible, but not all.

Numerous doors to service cupboards do not fit their doorways, with gaps between door frames and walls being sealed with yellow or pink expanding foam in many cases.

Yellow expanding foam is unsuitable as a fire barrier. Pink (fire-resisting) expanding foam is not suitable for sealing excessively large gaps.

4  
Penetrations to service  
cupboards and damaged  
ceiling
