Housing Health and
Safety Rating System
(HHSRS)

Hazard A7
Structural Collapse
and Falling Elements

Example A7.1
1920–1945
Semi-detached House
(Non-HMO)

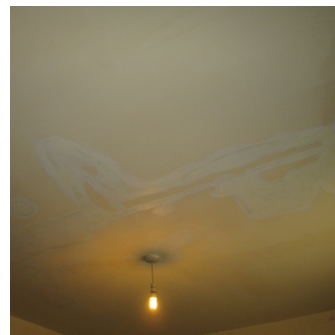
4
Water ingress and bulge
to kitchen ceiling

The fact that the joists are compromised as a result of deterioration of the timber, there has already been movement to the floor, and the ceiling beneath is bulging would all suggest that collapse within the next 12 months would be very likely, with probable risk of injury.

A collapse of the kitchen ceiling would likely occur onto the wall-mounted units in the first instance. However, if an occupant were to be in the immediate vicinity, then the units and any ceiling debris could fall onto that person. 'Severe' and 'Serious' harms have consequently been slightly increased beyond the national average score.

Compliance with the baseline indicators would ensure replacement of the defective kitchen ceiling and full examination of the bathroom floor joists, replacing where required. This, alongside dealing with all problem areas in the bathroom where water is escaping, making sure sealant is properly applied at all relevant junctions and providing a replacement water-resistant bathroom floor covering, would effectively deal with the defect.
