Housing Health and Safety Rating System (HHSRS)

Example B9.5/B11.5
Post-1979
Mid-terraced House
(Non-HMO)

Hazard B9
Excess Cold

Hazard B11
Damp and
Mould Growth

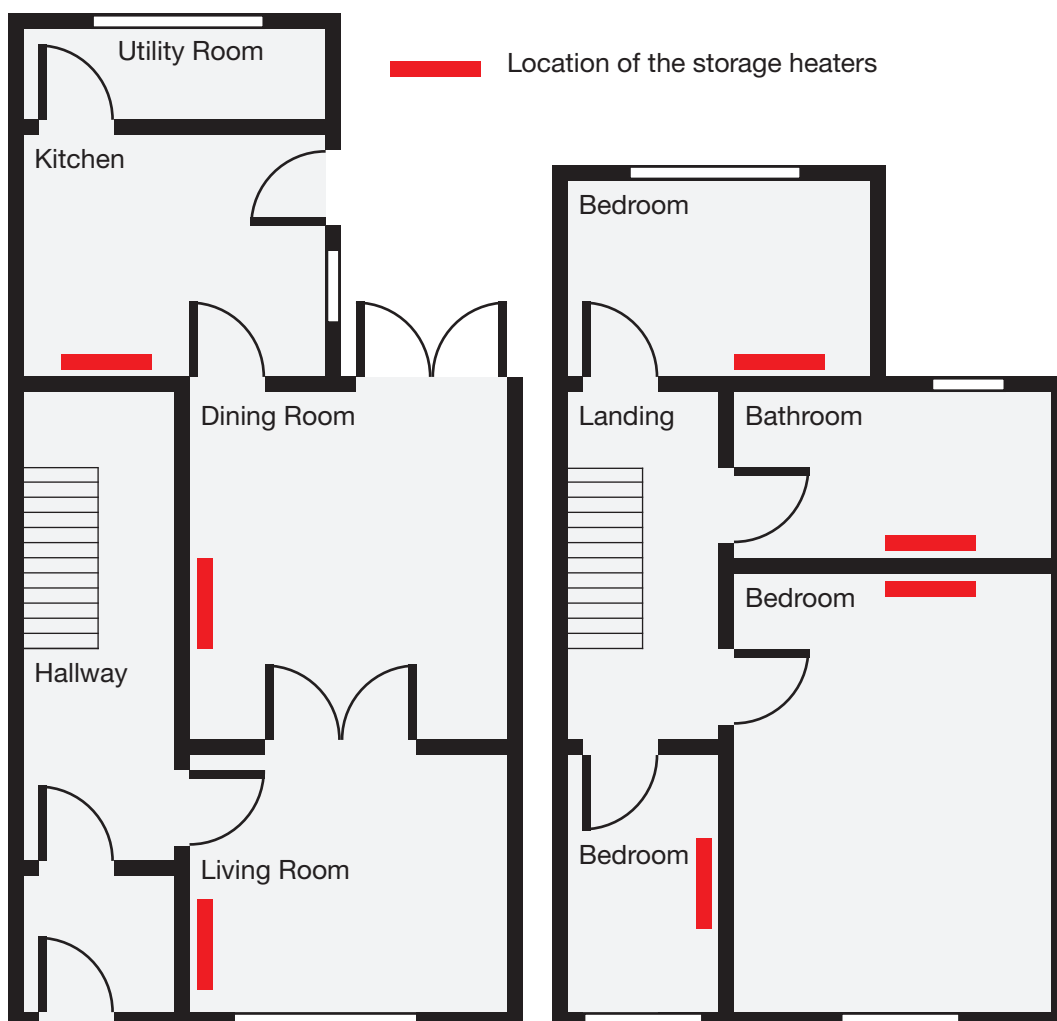
2
Floorplans showing
location of radiators

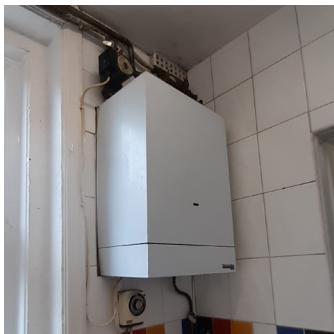
The non-condensing gas boiler is over 30 years old and has not been serviced for the last 5 years. While it has a time clock, it does not have a room thermostat, nor are there any thermostatic radiator valves. The radiators are also old and are positioned on the internal walls of the rooms to minimise the pipe runs, rather than being positioned under the windows, but there is no radiator in the utility room. The front living room has a solid-fuel room heater in the fireplace. Hot water is via the boiler, but there is no cylinder thermostat.

2
30-year-old
non-condensing boiler

Compliance with the baseline indicators relevant to Excess Cold would require the replacement of the existing boiler with a modern and more efficient condensing boiler. This would be implemented alongside the installation of a fully controllable modernised heating system, including room thermostat, programmer and thermostatic radiator valves to radiators. The further provision of a minimum of 250 mm loft insulation will assist with retention of heat at a comfortable level. Compliance with the baseline indicators relevant to Damp and Mould Growth would require the installation of mechanical extract ventilation to the kitchen and bathroom, and completion of necessary repairs to the structure of the property to resolve the areas of penetrating damp, leaving a sound, watertight finish.

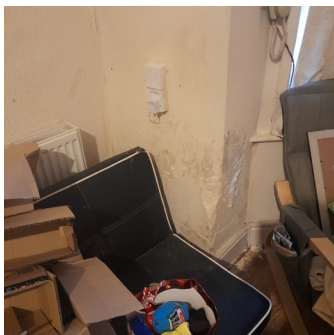
3
Radiator on
internal wall

The old, inefficient boiler completely lacks proper controls for both programming the system on a timer/ thermostat basis and via any thermostatic controls to radiators. The poor siting of the radiators will further contribute to the structure not being able to efficiently reach a comfortable temperature.

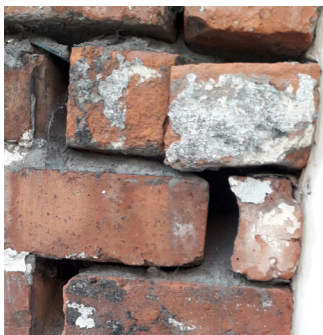
In the unheated rear utility room where the boiler is situated, the single-leaf exterior end wall has patches of perished plaster and flaking paint. Externally the rear wall requires some repointing. A number of bricks are perished and there are open mortar joints (the affected area is 5m², which is the majority of the rear wall).

4
Damaged brickwork

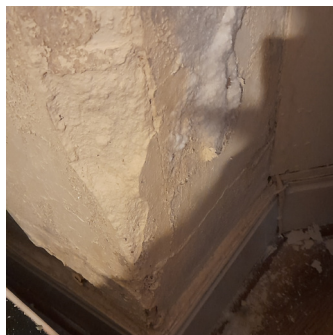
There are small areas of penetrating damp under the bay window in the living room. The brickwork under the bay requires some repointing and there is salt on the surface of the bricks, indicating that the wall does not dry out after heavy rain. Internally there is some mould growth on the wall under the bay window (less than 5% of the wall area of the room) and the plaster is damp to the touch after heavy rain in winter months.

5
Damp salted
internal plaster

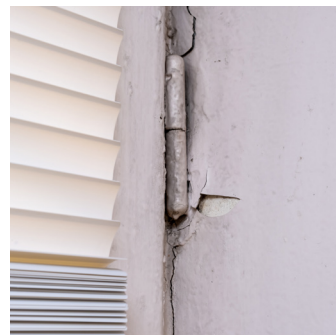
The double glazed windows do not have trickle vents. There is no extractor fan in either the bathroom or kitchen, and there is some mould growth to the window reveals in the bathroom and bedrooms. The small front bedroom (used as a bedroom) smells of mildew.

6
Damp and crumbling
plaster to window reveal
