Housing Health and Safety Rating System (HHSRS)

Hazard B11
Damp and
Mould Growth

Example B11.1
1946-79
End-of-terrace House
(Non-HMO)

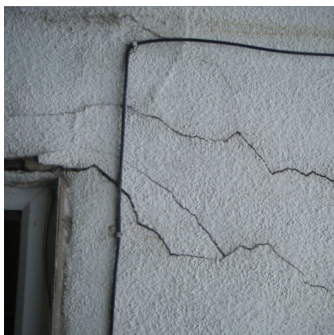
The house does not have an EPC; the family has lived in the property since the 1990s. The roof, gutters and downpipes are in reasonable condition for their age. There is hairline cracking to the external render generally.

2
External wall with
cracks to rendering

The baseline indicators adequately address the issue of penetrating damp (by repairing the rendering). The installation of mechanical extract ventilation will assist in reducing condensation, and loft insulation together with upgrades to the heating system to incorporate room thermostat, time clock and thermostatic radiator valves would help to ensure that condensation and mould growth is reduced. Assessment of this dwelling under the related hazard of excess cold would also be useful, to then consider solutions that would have potential to resolve both hazards. Improvements to the heating system and insulation would enable the property to reach the national average (dependant on the works ultimately carried out, they also have the potential to attain better than the national average).

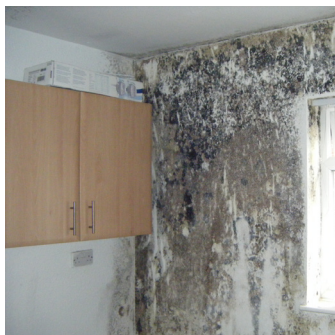
Dampness, caused partly by condensation, affecting the whole of the front external wall surrounding the window and adjacent ceiling and party wall in the small kitchen, however, the location of dampness is consistent with the cracks evident in the external rendering. There are small spots of mould growth, mainly in the corners of the room and at the junctions with the ceiling.

3
Mould growth to the
externl kitchen wall

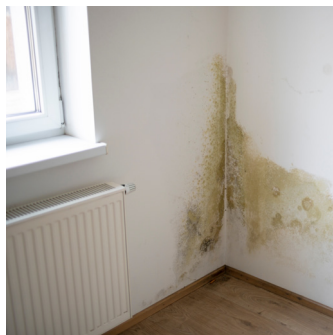
Penetrating damp and some associated mould is affecting the north-facing gable-end wall.

4
Mould growth to the
bedroom wall

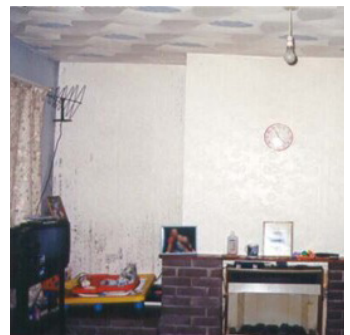
Rising and some penetrating damp with associated tide marks affecting the external gable wall in both recesses to either side of the fireplace in the living room.

5
Mould growth to the
living room wall
