Housing Health and
Safety Rating System
(HHSRS)

Case
Studies

Hazard
Damp and
Mould Growth

Example
1946–79
First-floor Flat
(Non-HMO)

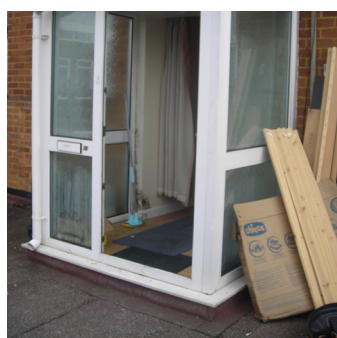
3
Entrance porch and
flat roof exterior

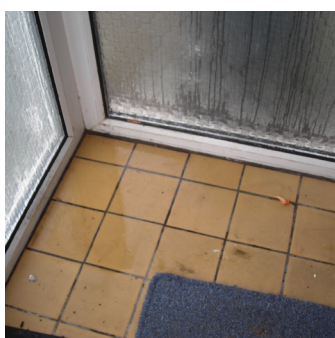
There is some mould growth on the window reveals in the bathroom and, to a lesser extent, in the kitchen and bedrooms. Moisture from condensation was pooling in the porch at the time of the inspection, which was on day when the external temperature was 0°C.

4
Pooling water on porch
floor interior

Extending the heating system to the porch and hallway would further help to reduce the likelihood of an occurrence.

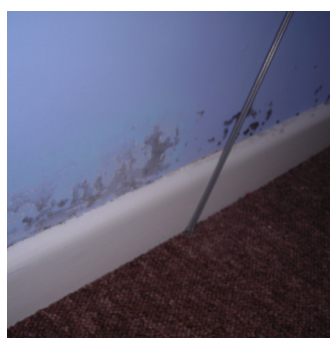
There is black mould growth above the skirting boards due to condensation on the rear external walls and at the junctions with the ceilings in both bedrooms.

5
Mould growth in
smallest bedroom

The poorly insulated flat roof and lack of cavity wall insulation are leading to excessive heat loss. Cold external walls and ceilings result in condensation and associated mould growth. Lack of extractor fans in kitchen and bathroom together with the ventilation issues associated with the blocked airbrick in the kitchen exacerbates the condensation problem. Occupants may be reluctant to leave windows open due to security concerns as these windows are easily accessible from the flat roof. Lack of heating in the entrance hallway combined with lack of timer and thermostatic controls to the storage heaters make the heating system less effective and more costly to run. Black mould growth in both bedrooms, kitchen and bathroom will result in exposure to mould spores, which can trigger allergic symptoms and cause asthma. Whilst mould growth is affecting a relatively small area in each room, it will increase the likelihood of harm.

The baseline indicators require mechanical extract ventilation to be fitted to the kitchen and bathroom, and the kitchen airbrick to be unblocked. If the extract ventilation from the kitchen and bathroom is effective, condensation and further mould growth should be eliminated. Provision of improved insulation to the flat roof combined with cavity wall insulation and a more efficient controllable heating system should allow the surface temperatures of the walls and ceilings to be kept well above the dew point.
